FINAL REPORT

AAIU Report No: 2010-022
State File No: IRL00909108
Published: 13/12/2010

Aircraft Type and Registration:	Robinson R44, EI-MMO (Helicopter)
No. and Type of Engines:	1 x Lycoming O-540-F1B5
Aircraft Serial Number:	1389
Year of Manufacture:	2004
Date and Time (UTC¹):	31 October 2009 @ 16.15 hrs
Location:	Skinstown, Ballyragget, Co Kilkenny, Ireland
Type of Flight:	Private
Persons on Board:	Crew - 1 Passengers - 1
Injuries:	Crew - Nil Passengers - Nil
Nature of Damage:	Aircraft damaged beyond economic repair
Commander's Licence:	Private Pilot Licence (Helicopter) (PPL(H)) issued by the U.K. Civil Aviation Authority (CAA)
Commander's Details:	Male, aged 65 years
Commander's Flying Experience:	287 hours, of which 96 were on type
Notification Source:	Pilot-in-Command (PIC)
Information Source:	AAIU Pilot Report Form submitted by PIC, AAIU Field Inspection

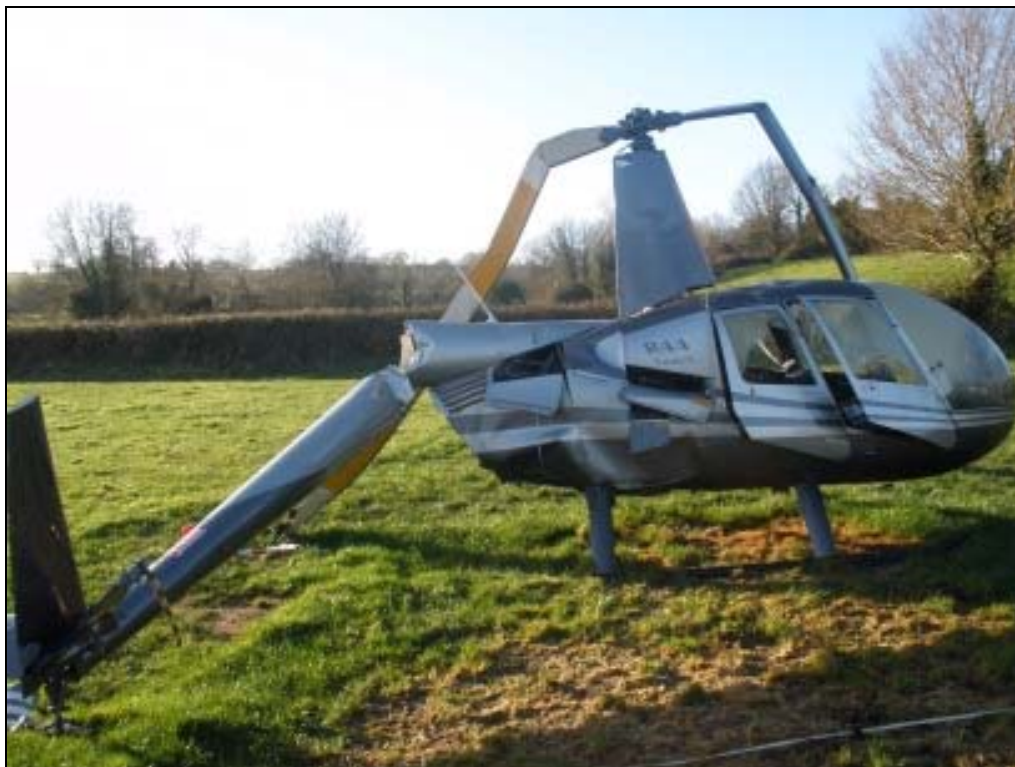
The helicopter fuselage was resting upright on its skids on a heading of 350°M (**Photo No. 1**). The entire airframe structure was distorted although the cabin area had remained intact and relatively undamaged. There was significant distortion of the rear left-hand vertical support tubing.

Photo No. 1: Final Position of EI-MMO

Both main rotor blades were fractured close to the hub, although they had not separated. The outer ends of both main rotor blades were resting on the ground, one forward and to the left of the cabin, while the second blade was resting against the left side of the fuselage close to the area where the tail cone is attached to the fuselage. The forward blade did not show evidence of heavy ground impact, but the second main rotor blade had been severely damaged by rotational ground impact towards the area of the blade tip.

The tailcone had been twisted and torn away from the helicopter fuselage almost all the way around its circumference, to the rear of and close to the area where the tailcone is normally attached to the fuselage. Its final position was approximately 60° to the right of its normal alignment. At the rear end of the tailcone, the tail rotor hub was resting on the ground. One of the tail rotor blades had fractured close to its root but had not separated from the assembly. The second tail rotor blade had fractured and separated. Both blades showed evidence of heavy rotational ground impact.

The distortion of the rear left-hand vertical support tubing indicates high vertical impact forces on the rear of the left skid. The evidence also suggests that one of the main rotor blades made heavy rotational contact with the ground and that both tail rotor blades also struck the ground during the accident sequence, causing one tail rotor blade to separate completely from the hub and the second one to fracture near its root. The consequent complete loss of tail rotor authority would have caused the helicopter nose to yaw rapidly to the right, as described by the Pilot. The final heading of the helicopter was approximately 140° to the right of the aircraft heading at it approached the hover.
