## FINAL REPORT

**AAIU Synoptic Report No: 2005-005**

<b>Aircraft Type and Registration:</b>	S-6IN, EI-CXS
<b>No. and Type of Engines:</b>	2 x GE CT58 140-2
<b>Aircraft Serial Number:</b>	61816
<b>Year of Manufacture:</b>	1978
<b>Date and Time (UTC):</b>	6 February 2005 @ 1640 hrs
<b>Location:</b>	120 NM West of Shannon Airport
<b>Type of Flight:</b>	Search and Rescue (SAR)
<b>Persons on Board:</b>	Crew - 4      Passengers - Nil
<b>Injuries:</b>	Crew - Nil      Passengers - Nil
<b>Nature of Damage:</b>	Perspex roof panel broken by bird strike
<b>Commander's Licence:</b>	ATPL (H)
<b>Commander's Details:</b>	Male, aged 49 years
<b>Commander's Flying Experience:</b>	5,200 hours, of which 4,401 were on type
<b>Information Source:</b>	AAIU Incident Report Form submitted by the aircraft Commander

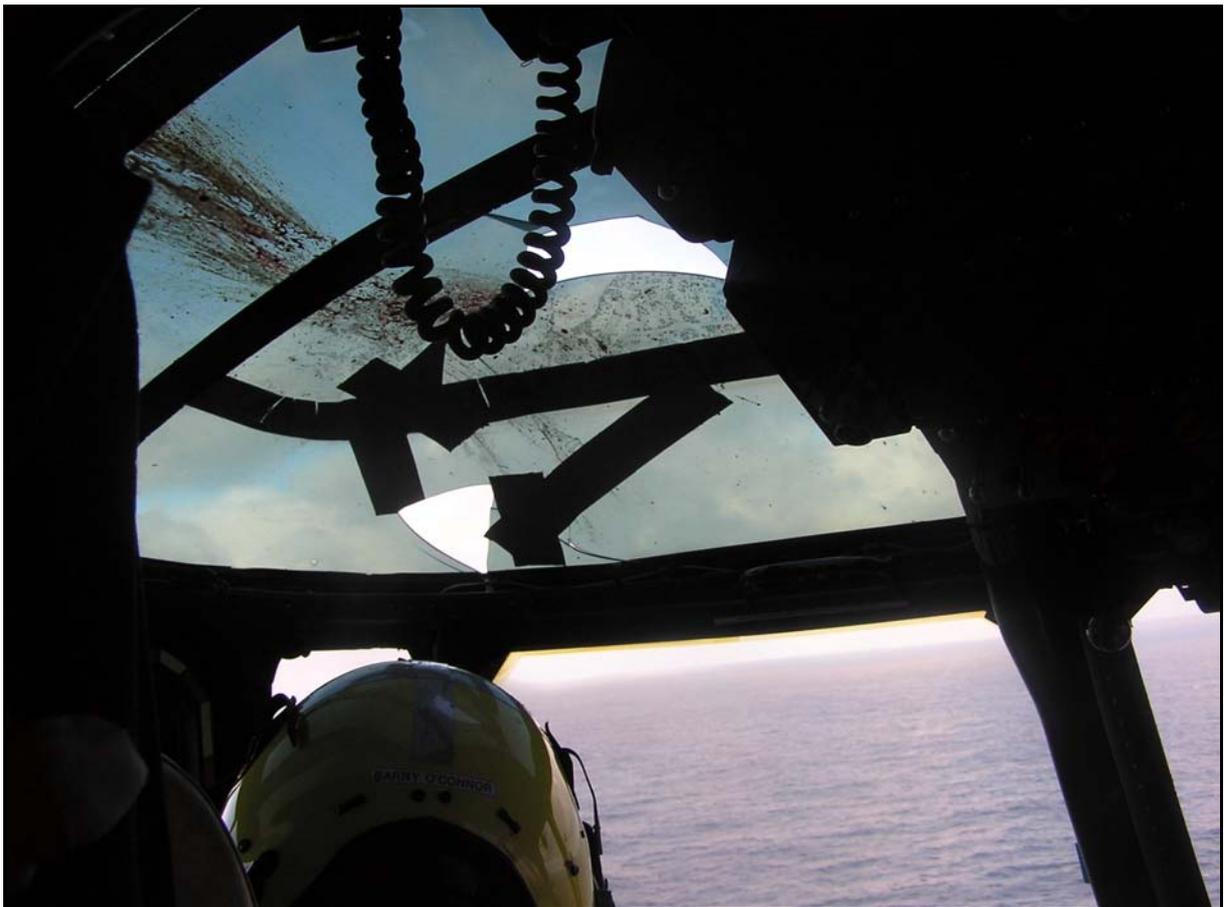
At the conclusion of the search, as the helicopter headed back to Shannon at 300 ft and 110 kts, a large black and white bird was seen directly ahead of the aircraft. The pilot took evasive rolling action to his right. However, the bird impacted on the clear perspex panel and broke it, just above the co-pilot position. In fact, two holes were created in the roof forward perspex panel. The Commander recalled having to avoid other sea birds earlier during the search and despite the amounts of lights on the helicopter, the red anti-collision light, the high intensity white strobe lights on the sponsons and the forward facing white landing light being on, the bird strike still occurred.

Photograph from CHC showing perspex panel damage
