AAIU Synoptic Report No:2005-020

| Aircraft Type and Registration: | Airbus 321-200, EI-CPD |
| Nature of Damage: | LH air conditioning bellows ruptured No aircraft exterior damage |

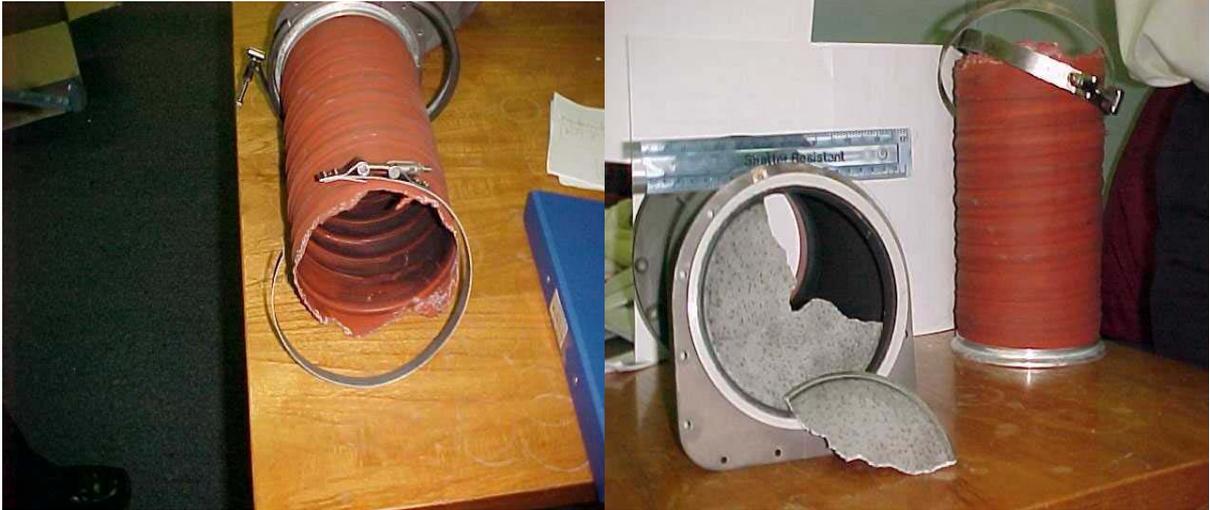
The metal clamp holding the forward bellows to the LH air conditioning condenser unit was found broken. The bellows had detached from the condenser and was found ruptured. The Pack Outlet Check Valve (POCV) flap downstream from the condenser was also found broken. This would have allowed the cabin air to exhaust to atmosphere through the ruptured bellows unit. In addition, a small 1.5 cm piece had broken away from the centre of the flap and was not found. The blow-out panel had opened.

The fractured POCV was sent to the subcontractor for examination and report. On one side of the flap they discovered scratches caused by roughing/cleaning carried out by the casting manufacturer. These scratches should not be evident. Metallographic inspection of the fracture also revealed some abnormal inclusions in the material in the cracked area. They concluded that these inclusions and possibly abnormal severe conditions caused the flap to fracture.

1. The clamp on the condenser in the left hand air conditioning bay fractured, causing the associated bellows unit to rupture
2. The rupture set up an oscillation in the airflow through the Pack Outlet Check Valve, which caused the valve flap to impinge on the valve stops. Foreign inclusions in the flap casting were a contributing factor in its subsequent fracture and failure.
3. The ground inspection failed to find the ruptured bellows during the initial trouble shooting at London LHR (in accordance with aircraft manufacturer's TSM Task 21-50-00-810-801)

The photo on the left shows the broken clamp and the frayed end of the bellows unit. The photo on the right shows the broken check valve. The scratches on the flap casting and the missing centre portion can also be seen.

The clamp, check valve and bellows were replaced and the LH duct and condenser were checked for debris with nil findings. The LH air conditioning pack was operated as per the aircraft maintenance manual (AMM) and found satisfactory. The aircraft was flown back to Dublin with that pack inoperative. The damaged parts were returned to the aircraft manufacturer for inspection.

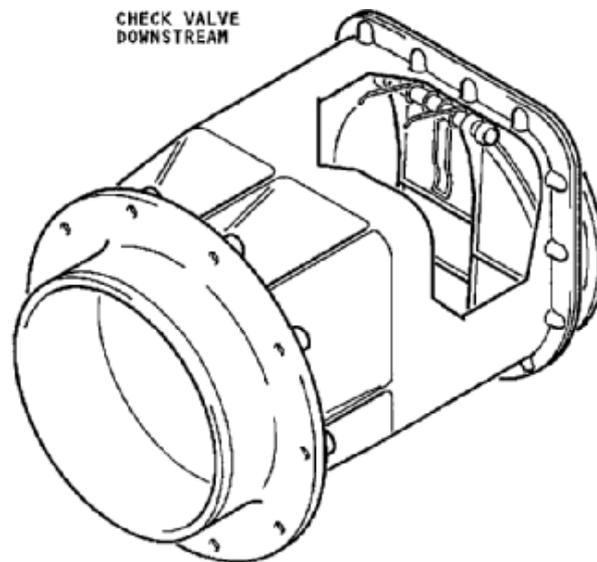
- On some rare occasions, the airflow is not stopped abruptly but the bellows slowly disintegrates or comes loose at the condenser side with the result that the air is partly supplied to the POCV and partly streams into the pack bay. This then will lead to an inconstant airflow in which, at one point, the cabin pressure and the dynamic pressure caused by the remaining pack outlet airflow will have nearly the same value. At this point the flap of the POCV has been seen to heavily oscillate between the two end stops. In this, admittedly very rare scenario, only a couple of heavy bangs against the stopper, which can even be heard in the cabin/cockpit, are sufficient to destroy the metal casted POCV flap, thus leading to depressurization.

Diagram of the Pack Outlet Check Valve (POCV) downstream of the condenser unit. The valve is shown in the closed position under the action of the spring as the inlet pressure from the right reduces.

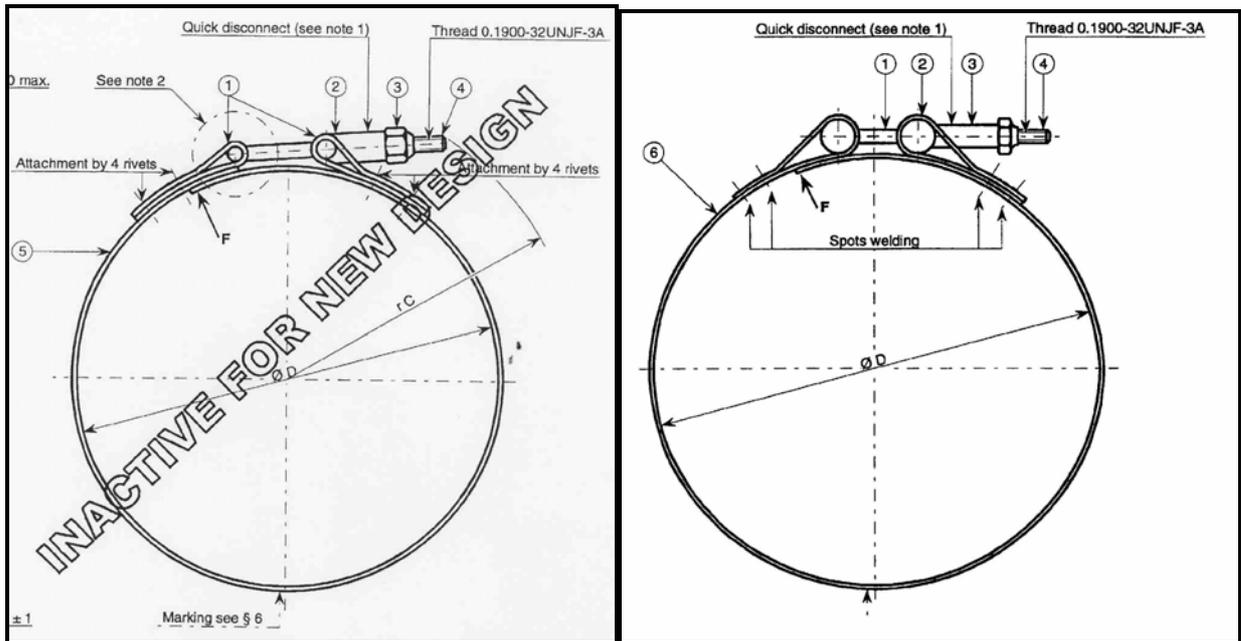
Drawings from the Standards Manual. The drawing on the left shows the older band fabricated using rivets. It indicates where end “F” should be during the tightening process. That on the right is the newer “Style 2” design using spot-welded joints.

After a similar event of clamp rupture in May 2002 the aircraft manufacturer developed a new style of clamp which is made from a different type of material and which is spot welded rather than riveted (**see Appendix B**). However, this new "Style 2" clamp, although promulgated in the Standards Manual in November 2002, has not yet been illustrated in the IPC (parts catalogue).

The new clamp, P/N NSA5532C612, will be introduced by modification No. 35038. The modification is still in the certification process. The embodiment rank has been fixed to MSN 2509 to be delivered in Aug-05. For in-service aircraft, SB No. A320-21-1155, (rated "*Desirable*"), will allow operators to replace old clamps by a new clamp. The target date for SB dispatch to airlines is currently Sep-05.

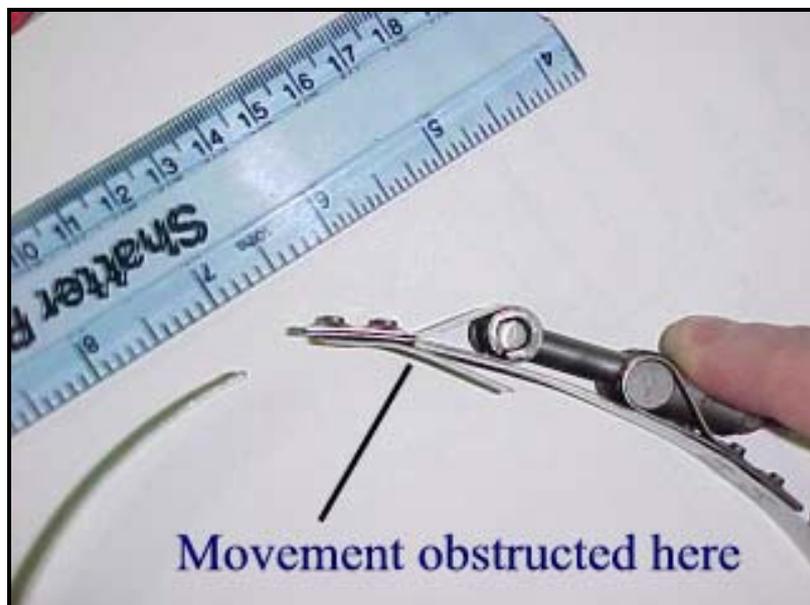
In the opinion of the aircraft manufacturer, following receipt of photographs of the damaged parts, the clamp had originally been installed incorrectly. It appeared that one end of the aluband (clamp) became stuck between the other end of the aluband and the riveted steel lock (see **Appendix C**). This seemed to have bent the free end of the aluband slightly downwards which then had caused a deformation at the location of the second row of rivets. If the clamp is installed in this way, it would need more torque value to get a tight seat of the clamp on the bellows, which as a consequence would imply more stress on the aluband which might not lead to an immediate rupture but, in conjunction with time and vibration could lead to a rupture at a later stage.

The manufacturer was of the opinion that the damage to the bellows, which is only present at the side where the bellows was attached by the clamp, was as a result of the loose bellows rubbing against the clamp at the condenser outlet.

The clamp as found. End “F” was on the incorrect side of the opposite end of the band and became locked by the rivets.

The contractor recommended the out phasing of the older riveted clamps and their replacement by the new standard welded clamp. In the meantime, a review of the installation procedure took place in-house. As recommended by the manufacturer an Engineering Order Inspection (EOI) was issued in April 2004 to cover the fleet inspection of the left and right hand pack condensers, pack outlet valves and attaching ducts. It requested the inspection of the inlet flap valve for signs of damage and/or cracking and the installation of Style 2 clamps. One year after this incident seven out of a fleet of ten A320/321 aircraft had been inspected. Slight deterioration of the bellows was found on only two aircraft with no other damage apparent. In May 2004, a Quality Advisory Notice was issued warning maintenance personnel that it is possible to incorrectly install the older clamp. However, at that time there were none of the older clamps in their stock.

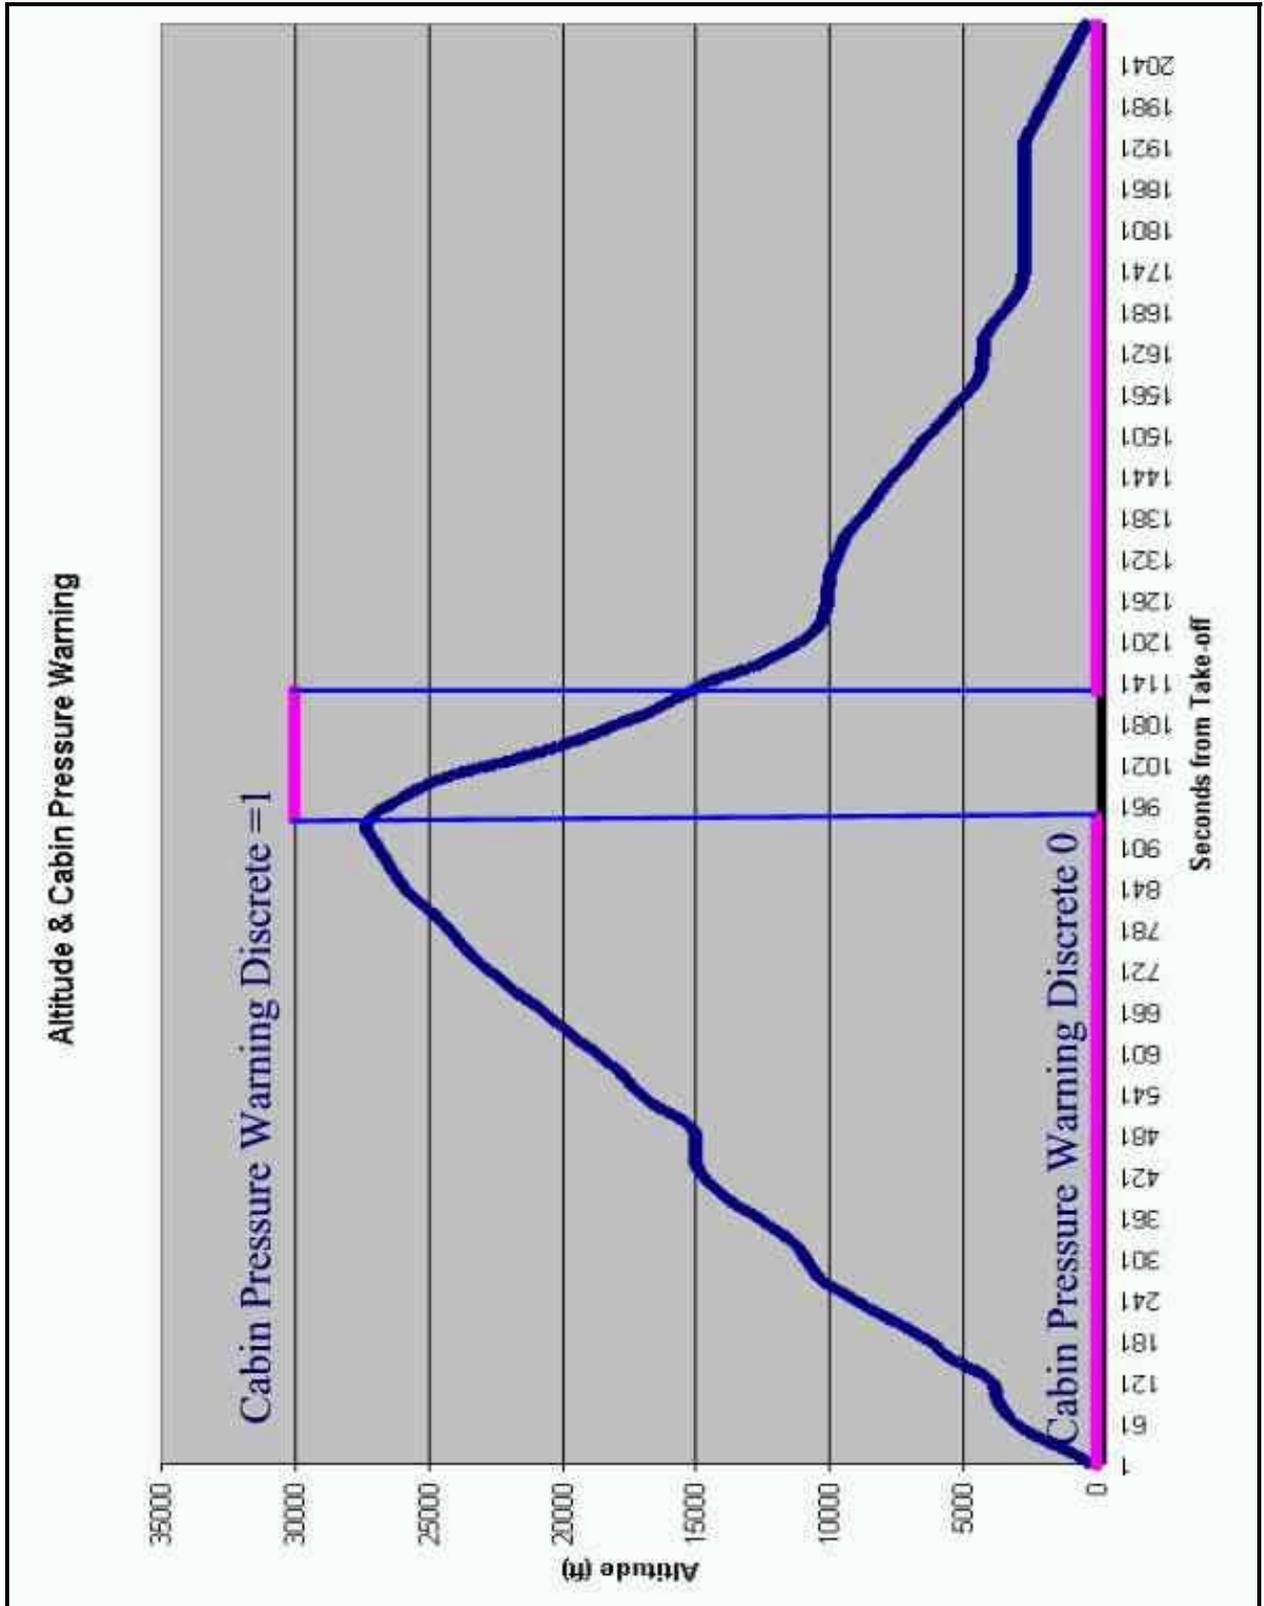
APPENDIX C

The FDR readout for altitude and cabin pressure warning discrete are shown at **Appendix C**. The aircraft took off at 10.36 hrs with an initial climb rate of 2066 ft/min up to FL150. The climb rate then reduced to 1858 ft/min until the aircraft reached a maximum height of 27,324 ft.

The aircraft then started to descend and 17 seconds later at 27,136 ft the Cabin Pressure Warning activated. The aircraft continued to descend at a rate of 4310 ft/min until FL100 was reached. The warning deactivated at 15,176 ft having remained activated for a little over 3 minutes. From FL100 the aircraft continued its descent to Cardiff at a reduced rate of 1293 ft/min.
