**Following the study
performed at the request of
The Minister in Charge of the Department for Public
Enterprise
on
the AER LINGUS VISCOUNT EI-AOM accident
occurred on March 24th, 1968
near TUSKAR ROCK
Ireland**

VOLUME II: APPENDICES AND ANNEXES

TOME 1: APPENDICES

November 27, 2001

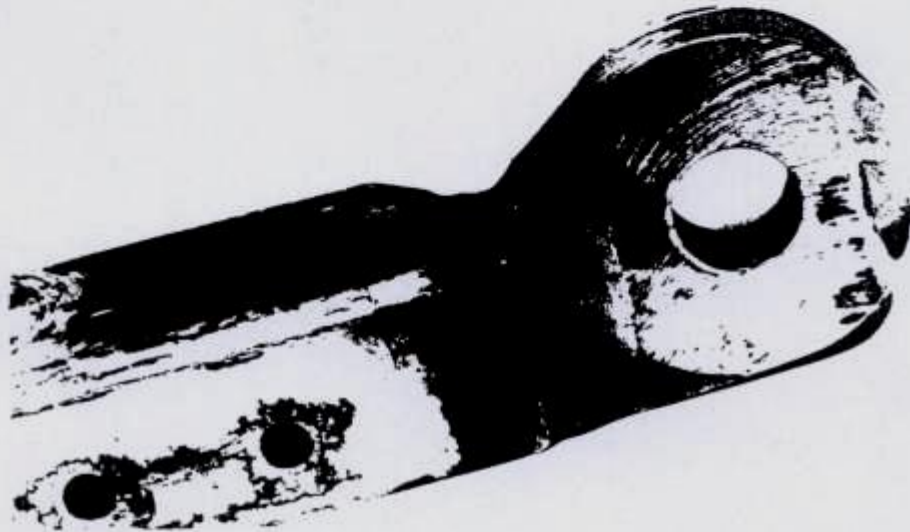
AL DEFECTS / 1420 / VIS.
PLATE I

PLATE I TAILPLANE SPAR JOINT FITTING
WITH 0.65 INCH FATIGUE CRACK

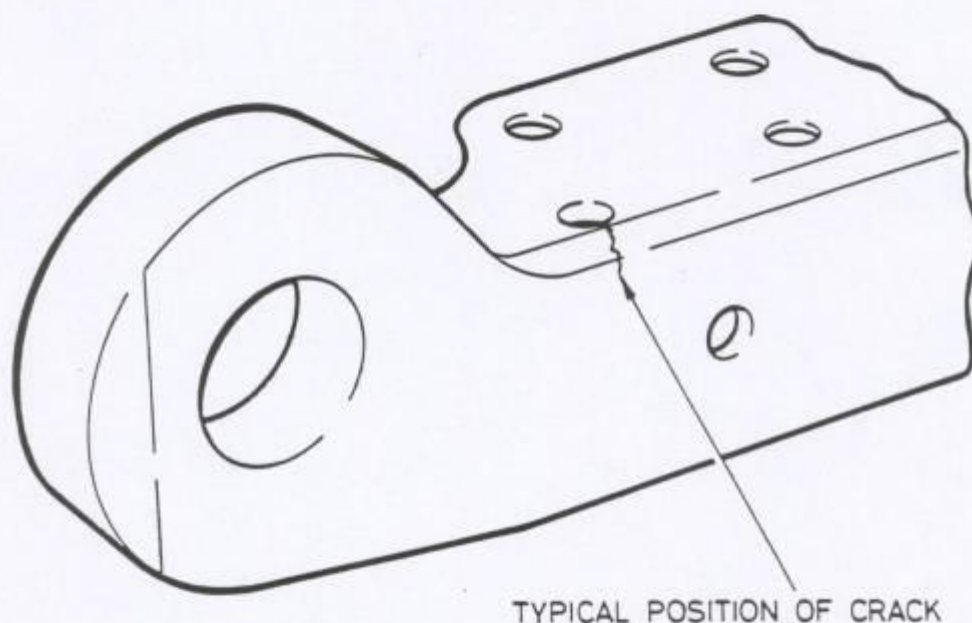
4C-FIS-2

TYPICAL POSITION OF CRACK

TAIL PLANE SPAR JOINT TOP FITTING

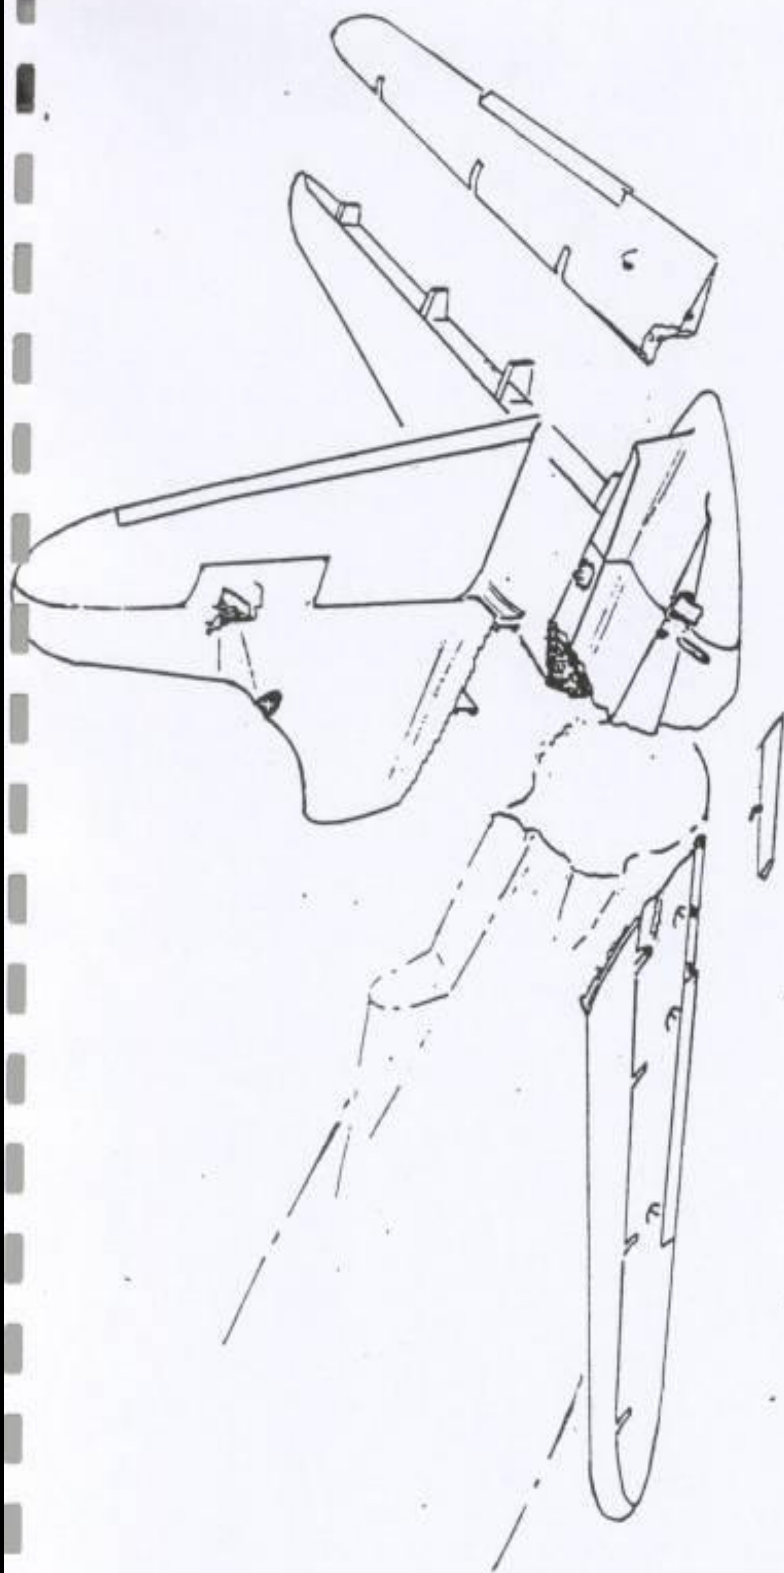
4d2-FIG 1

FRAGMENTATION OF EMPENNAGE OF PK-IIVS
(PORT REAR VIEW)

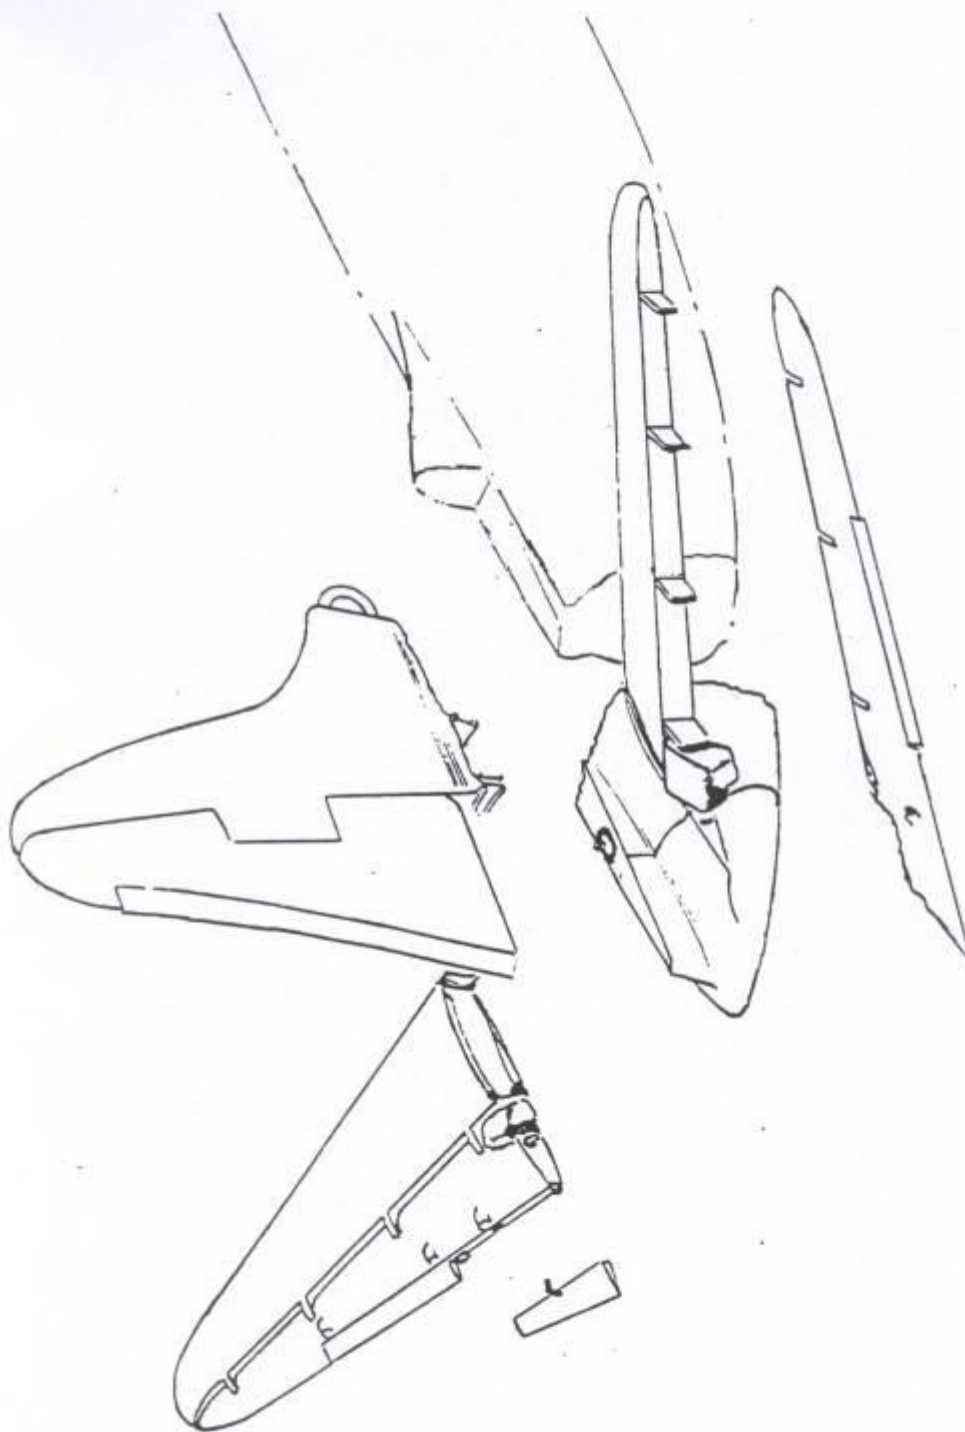
4d2-Fig 2

FRAGMENTATION OF EMPENNAGE OF PK-IVS
(STARBOARD REAR VIEW)

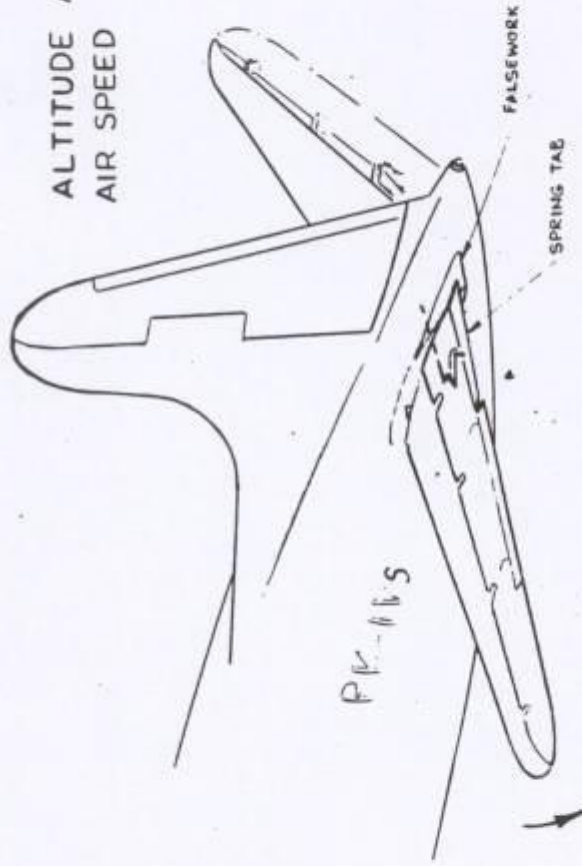
4d2 - Fig 3

AS THE TAILPLANE BREAKS AWAY FROM FUSELAGE THE SPRING TAB CONTROL RODS ARE PULLED TO THE TAB UP LIMIT AND BEYOND UNTIL THE TAB CENTRE HINGE REACHES ITS LIMIT OF TRAVEL AND BOTH THE HINGE AND THE TAB DRIVE ROD FAIL.

THE INBOARD END OF THE SPRING TAB CONTACTS THE FALSEWORK AND THE TABS INBOARD HINGE IS PUSHED OFF ITS PINTLE. TAB DISTORTION AT THE MOMENT OF ROD FAILURE & THE CONSEQUENT SUDDEN RELEASE OF STORED ENERGY MAY HAVE BEEN A CONTRIBUTORY FACTOR.

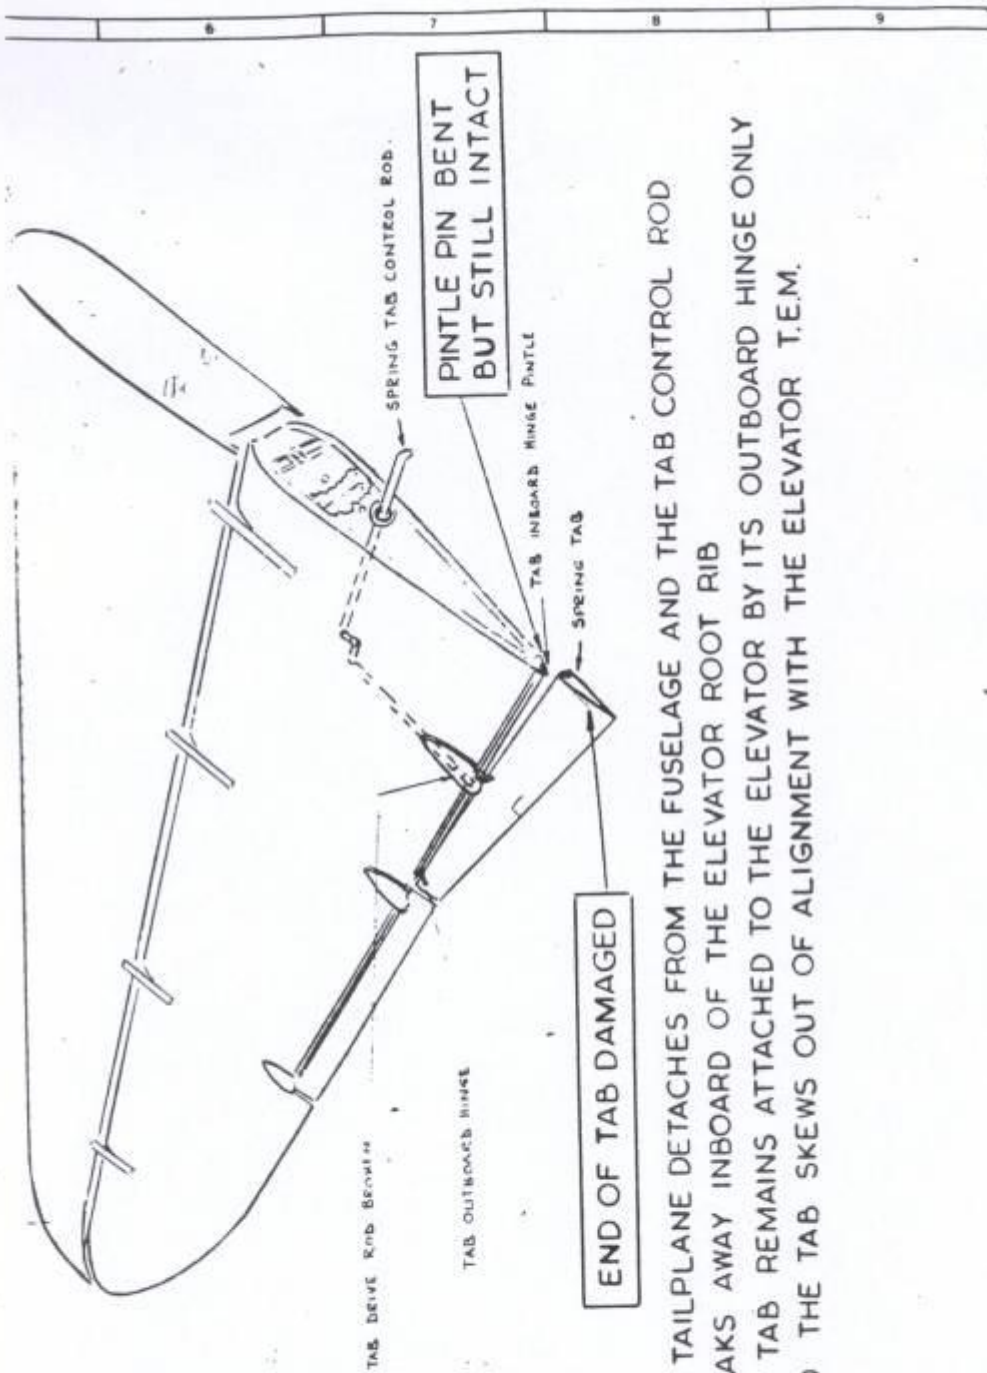
4d2-FIG 4

THE TAILPLANE DETACHES FROM THE FUSELAGE AND THE TAB CONTROL ROD BREAKS AWAY INBOARD OF THE ELEVATOR ROOT RIB. THE TAB REMAINS ATTACHED TO THE ELEVATOR BY ITS OUTBOARD HINGE ONLY AND THE TAB SKEWS OUT OF ALIGNMENT WITH THE ELEVATOR T.E.M.

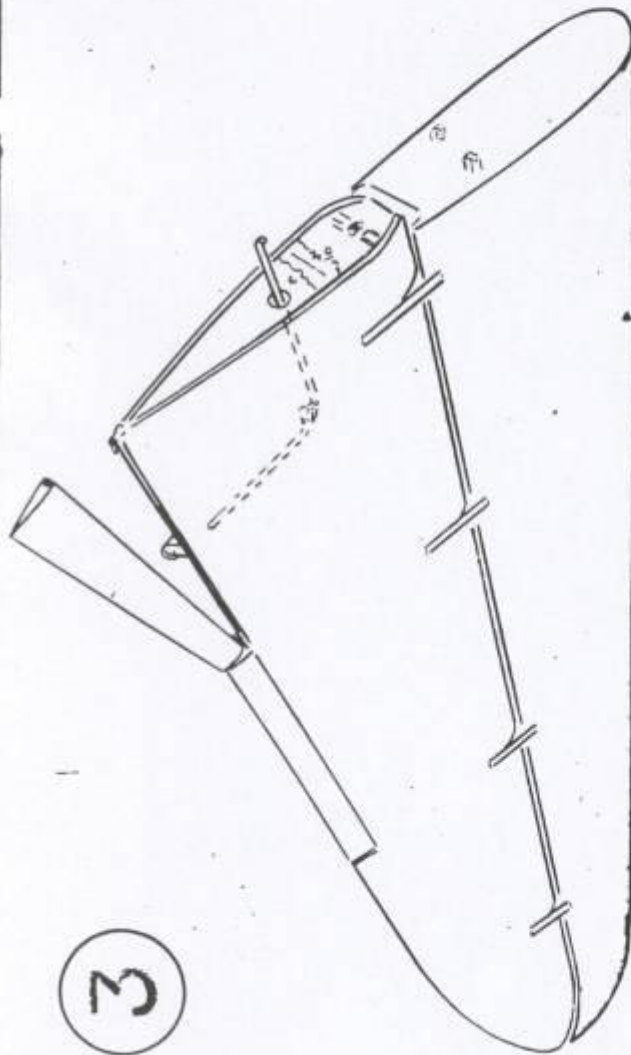
THE TAB FALLS WITH THE ELEVATOR AND THE PORT TAILPLANE UNTIL THE TAB IS TORN FREE FROM ITS REMAINING ATTACHMENT POINT AT THE OUTBOARD END TAB HINGE POSITION, EITHER DURING THE FALL OR POSSIBLY WHEN CRASHING THROUGH THE UNDERGROWTH.

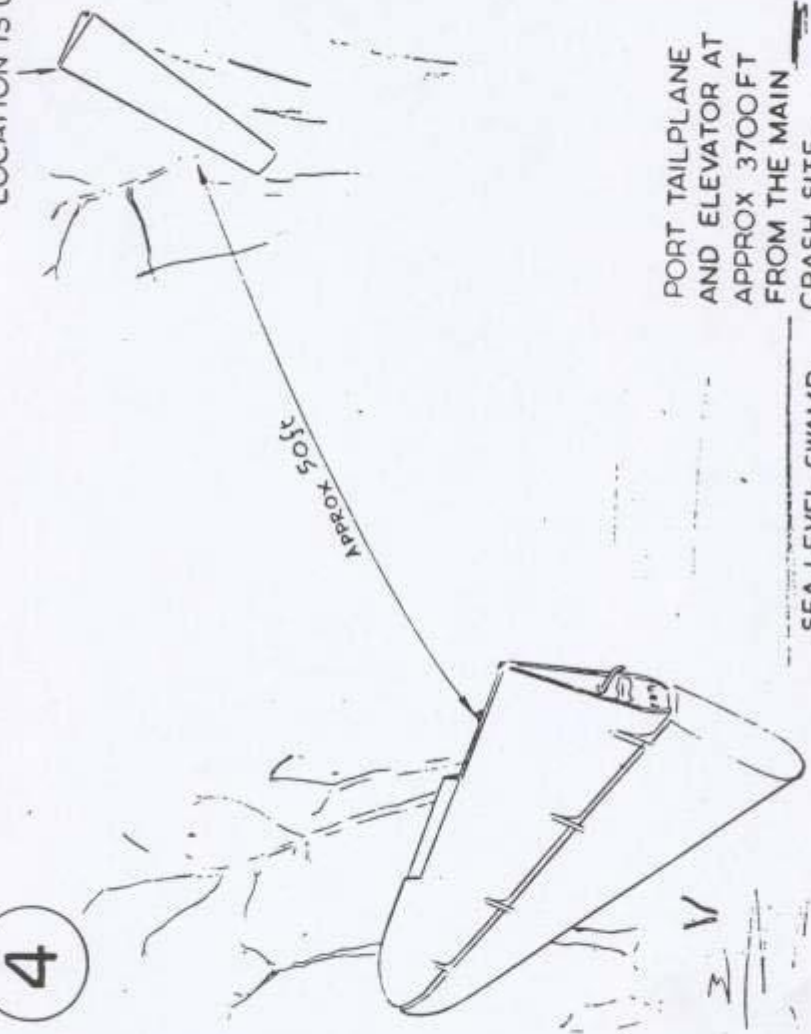
PORT TAILPLANE
AND ELEVATOR AT
APPROX 3700 FT
FROM THE MAIN
CRASH SITE.
