# **TECHNICAL REPORT**

## **IN-033/2022**

**Incident on 4 June 2022 involving a  
BOEING 737-800 aircraft operated by  
Ryanair, on registration EI-GJS, and an  
AIRBUS A-300 aircraft operated by DHL,  
on registration D-AEAO, at Josep  
Tarradellas Barcelona - El Prat Airport  
(Barcelona, Spain)**

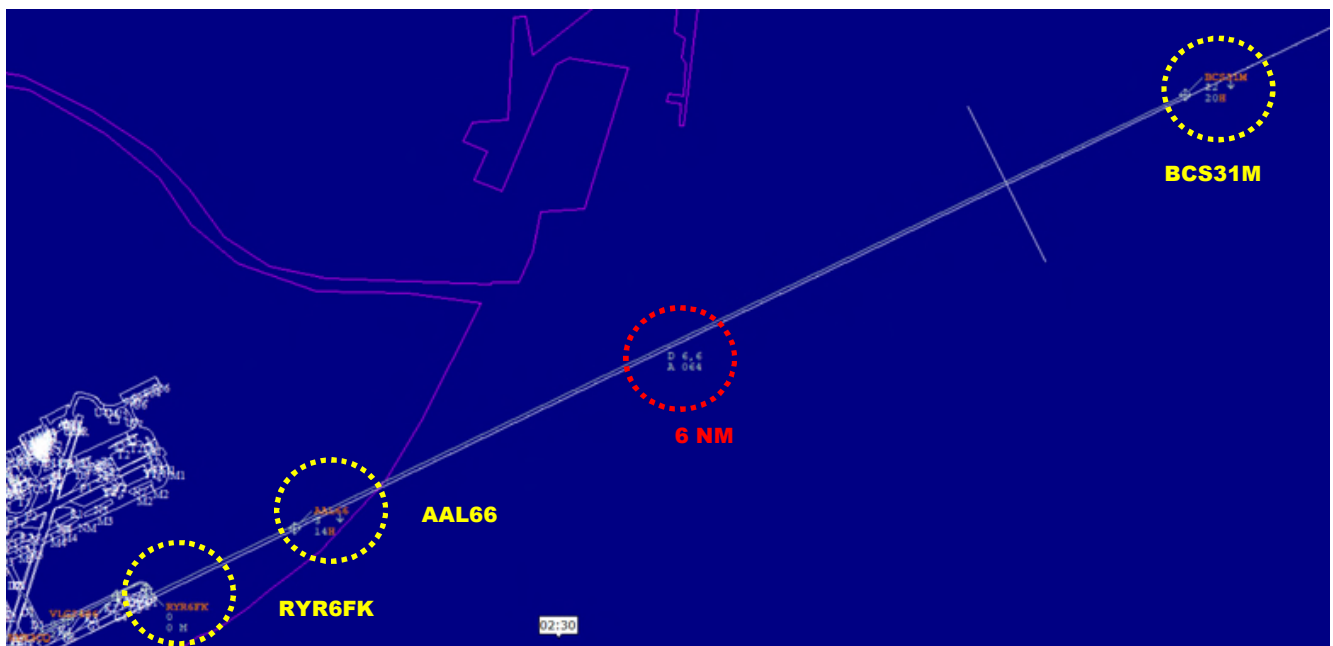
Figure 1. Positions of the aircraft at 6:30:13 h

At 6:29:02 h, the crew of the BOEING 737-800 with registration number EI-GJS and call sign RYR6FK informed the tower (TWR LCL 24L) that they were ready for departure. At 6:30:13 h, TWR LCL 24L asked if they had sight of the aircraft with call sign AAL66 on short final and the reply from the BOEING crew was affirmative.

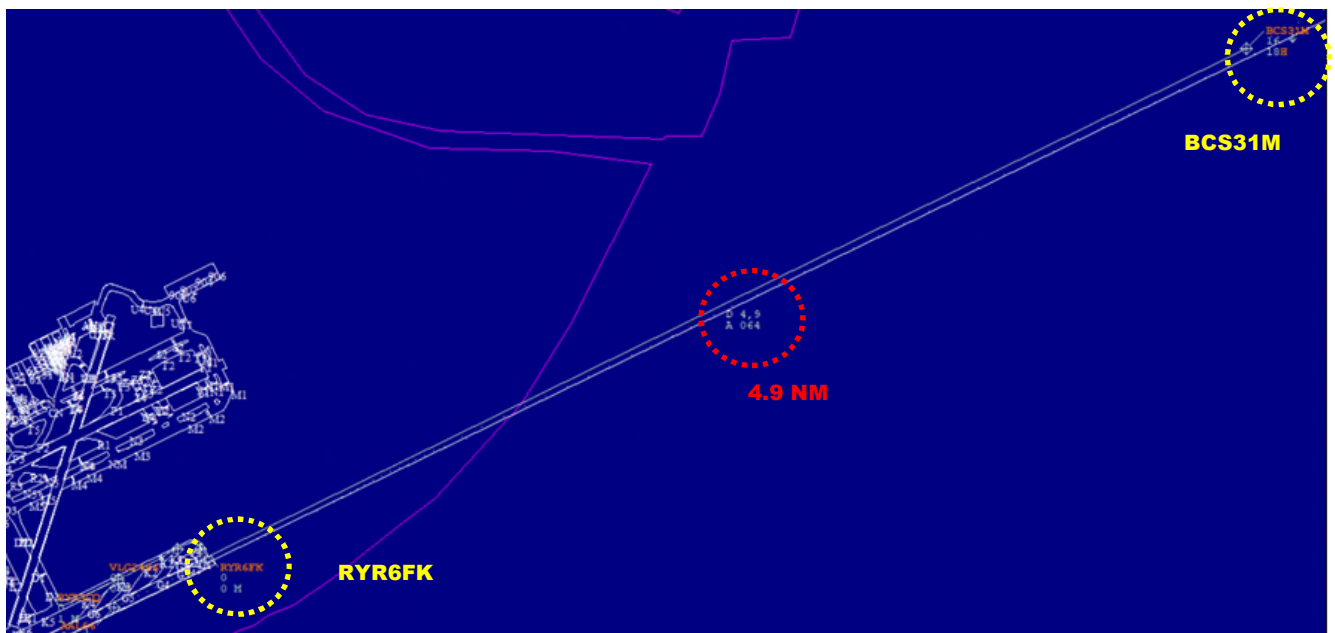
Figure 2. Positions of the aircraft at 6:30:46 h

At 6:30:46 h, the RADAR trace shows the RYR6FK aircraft lined up on the runway and the BCS31M aircraft at 4.9 NM on final for the same runway and descending through 1,600 ft.

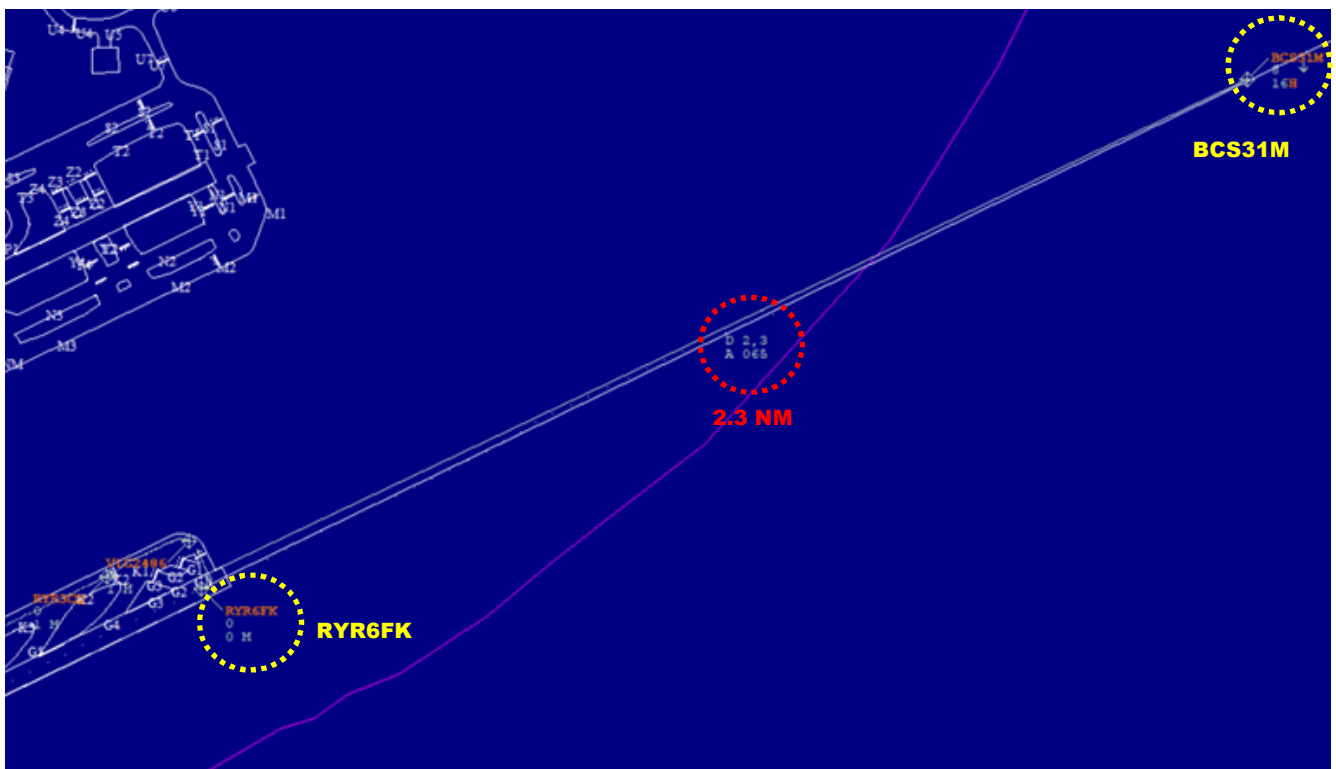
Figure 3. Positions of the aircraft at 6:31:44 h

At 6:31:44 h, the RYR6FK aircraft lined up on runway 24L was cleared for take-off while the BCS31M aircraft had reached 2.3 NM on final and was descending through 800 ft, its minimum altitude during its approach.

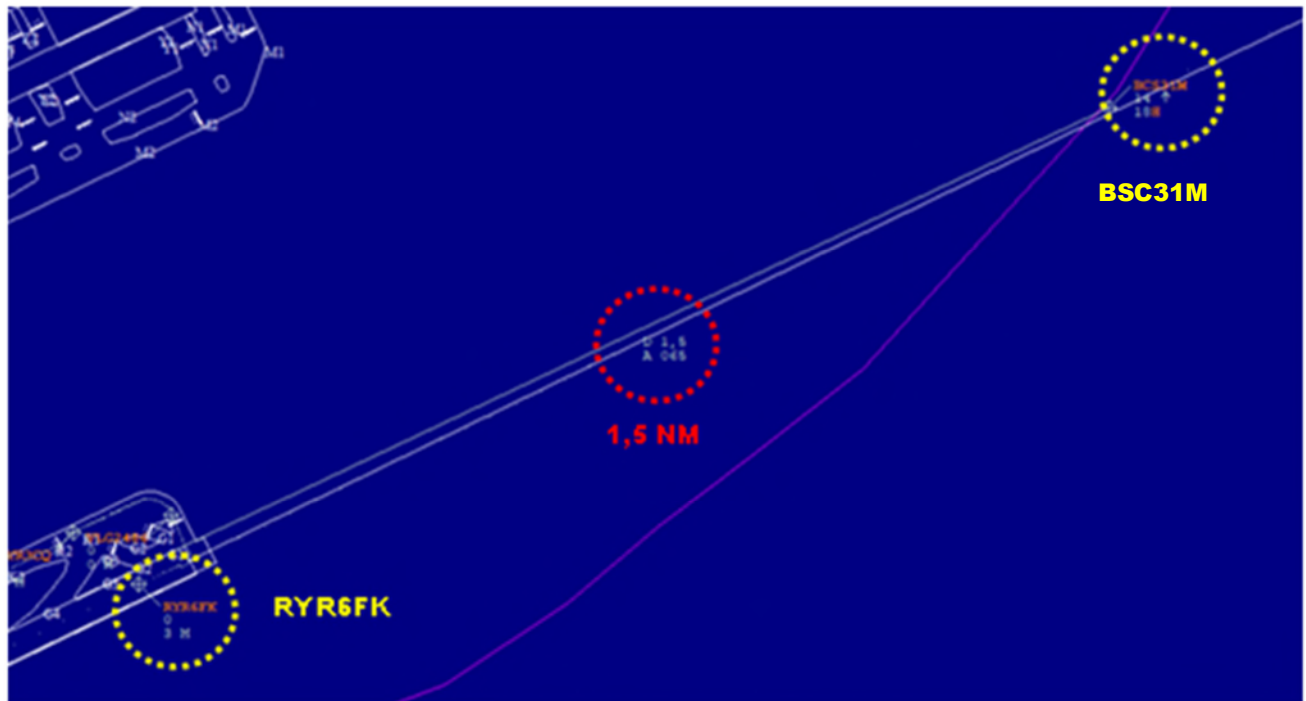
Figure 4. Positions of the aircraft at 6:31:59 h

At 6:31:58 h, the BOEING aircraft with call sign RYR6FK commenced its take-off run. The aircraft executing the missed approach was 1.5 NM behind the threshold, climbing through 1,400 ft.

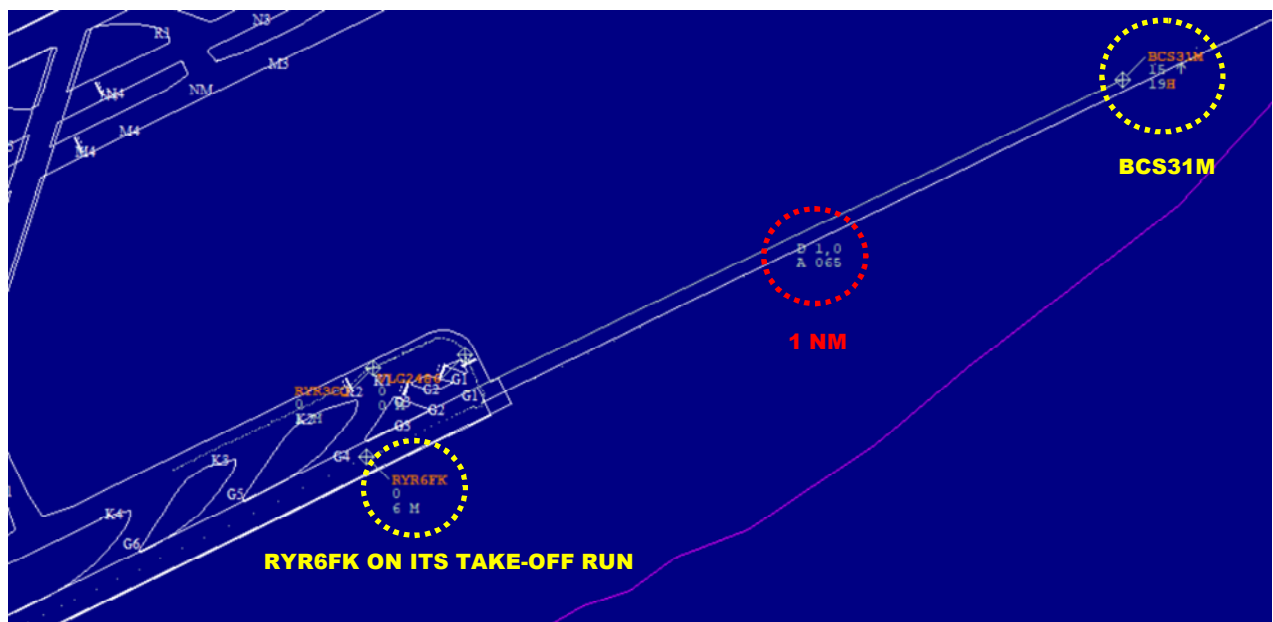
Figure 5. Positions of the aircraft at 6:32:06 h

At 6:32:06 h, the RADAR trace shows the BCS31M aircraft reaching 1,500 ft at 1 NM from the end of runway 24L, which is the standard altitude in this missed approach zone.

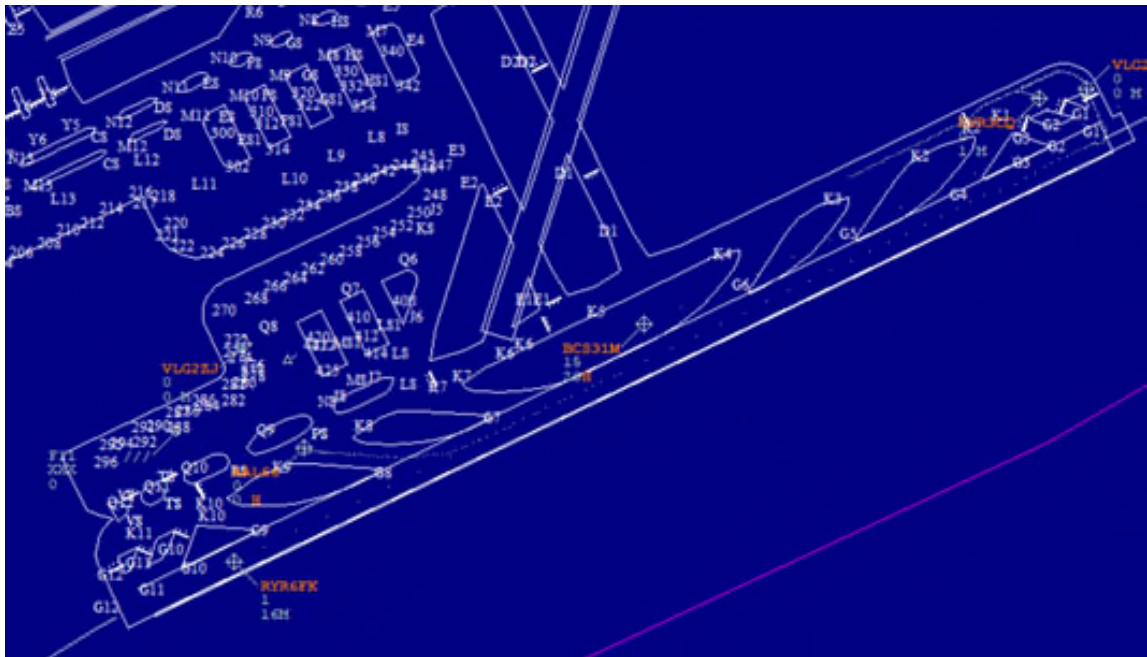
Figure 6. Positions of the aircraft at 6:32:36 h

At 6:32:36 h, the RADAR trace shows the aircraft with call sign RYR6FK climbing through 100 ft and the aircraft with call sign BCS31M flying over runway 24L, maintaining 1,500 ft.

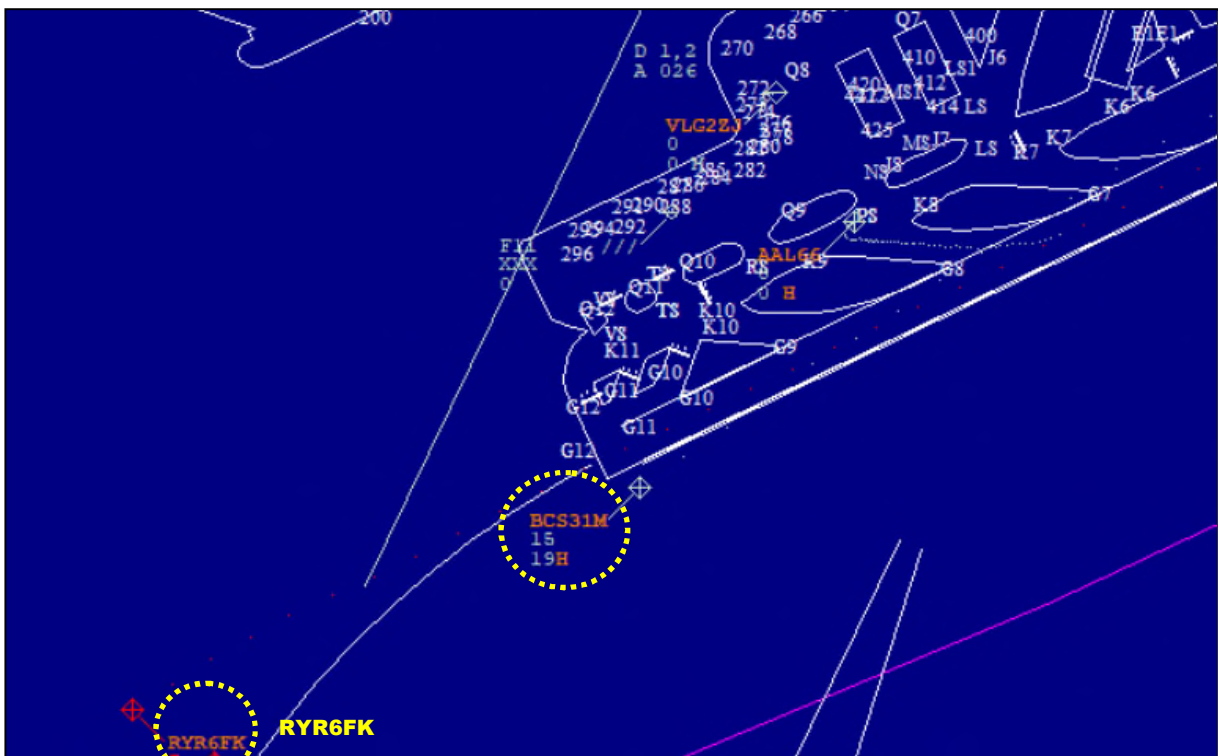
Figure 7. Positions of the aircraft at 6:32:51 h

At 6:32:51 h, the RADAR trace shows the RYR6FK aircraft climbing through 700 ft and the BCS31M aircraft behind it maintaining 1,500 ft.

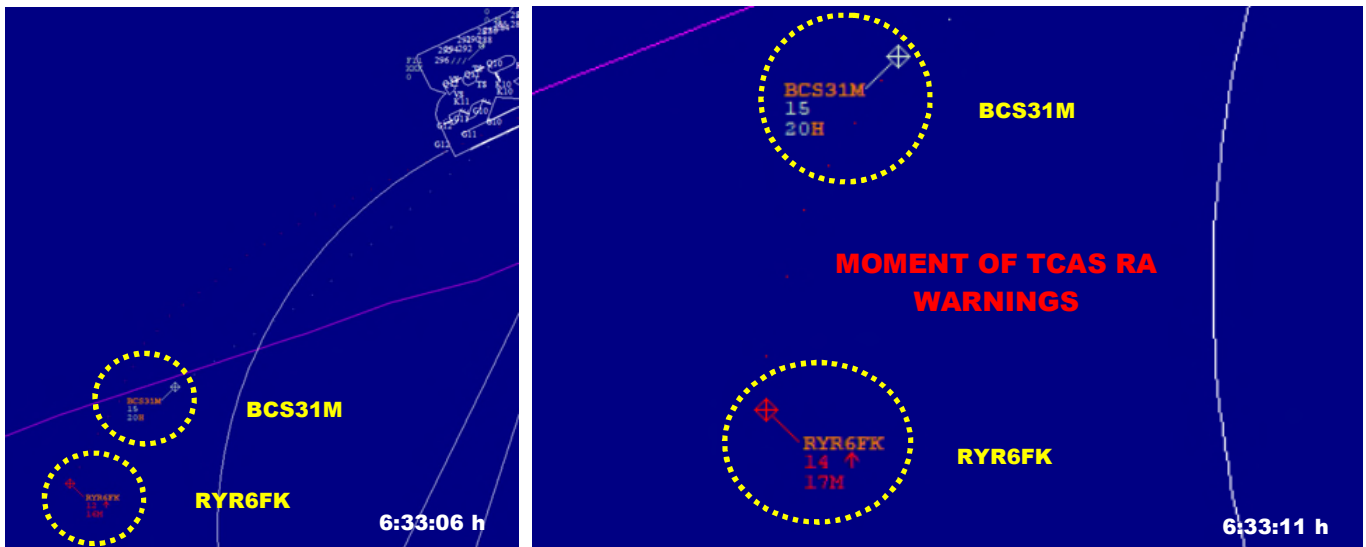
Figure 8. Positions of the aircraft at 6:33:06 h and 6:33:11 h

At 6:33:06 h, the controller on the local frequency (TWR LCL 24L) transferred the aircraft with call sign RYR6FK to the approach controller (APP LECB), and the RADAR trace shows it climbing through 1,200 ft cleared to 2,000 ft. The BCS21M aircraft is shown maintaining 1,500 ft. Five (5) s later (6:33:11 h), the aircraft with call sign RYR6FK was climbing through 1,400 ft and cleared to 2,000 ft, and the aircraft with call sign BCS31M was still holding at 1,500 ft. This was when the two aircraft were closest, separated by 0.3 NM horizontally and 200 ft vertically, triggering their TCAS RA warnings.

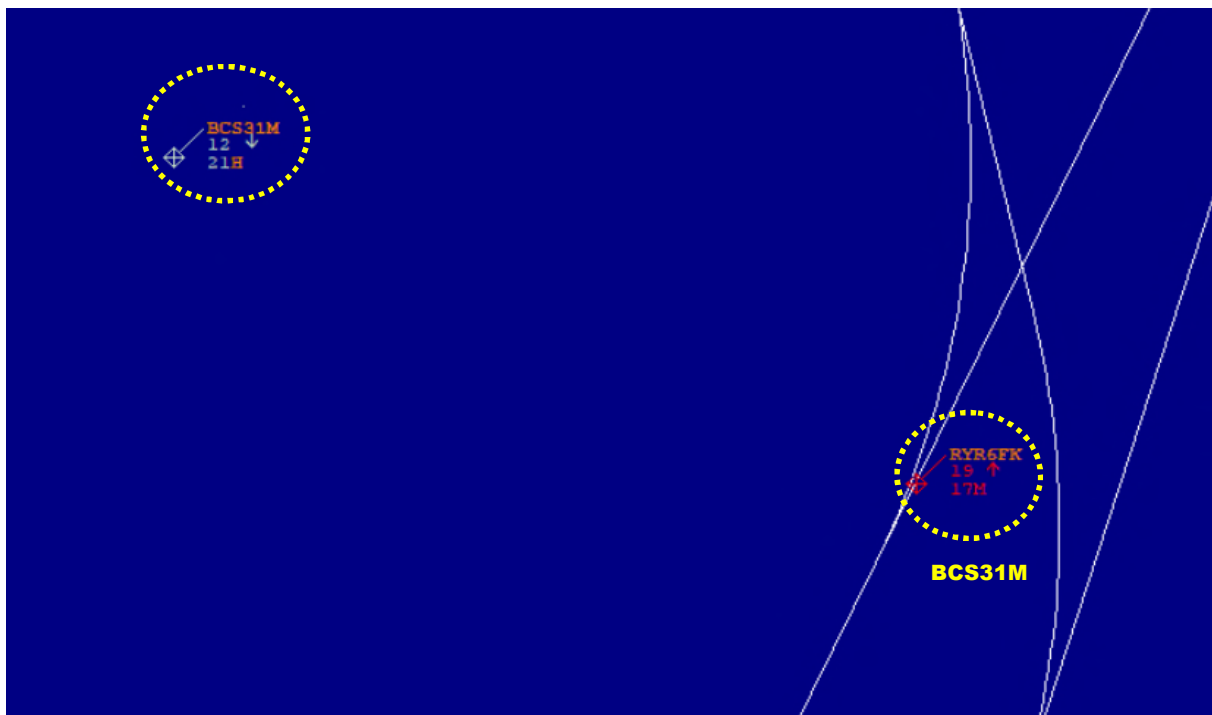
Figure 9. Positions of the aircraft at 06:33:30 h

At 6:33:30 h, the aircraft with call sign BCS31M notified TWR LCL 24L that it had received a TCAS RA warning, and after a request for confirmation by TWR LCL 24L, that they were climbing to 3,000 ft flying the standard missed approach procedure. The RADAR trace shows the aircraft with call sign RYR6FK climbing through 1,500 ft and the aircraft with call sign BCS31M descending through 1,200 ft.

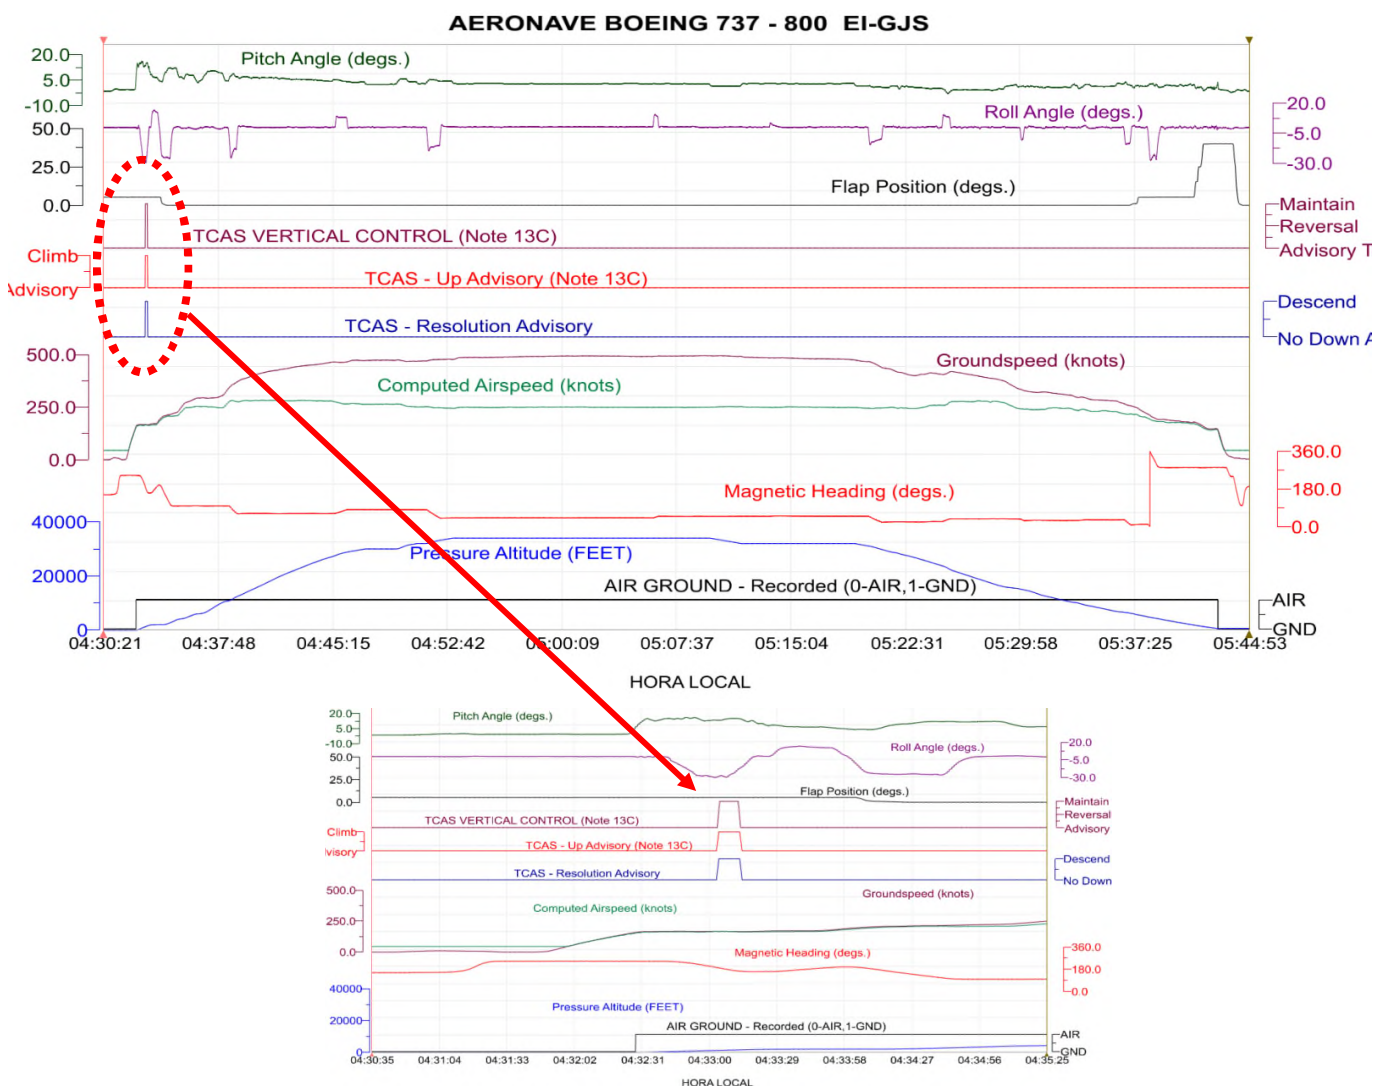
**Figure 12. Flight parameters recorded on the BOEING 737- 800 aircraft**

It was on a magnetic heading of 190.9 °, which varied to 164.85 ° during the 9 s that the warning remained in force.

The flaps were deployed at an angle of 5.3 °, varying the pitch angle between 13 ° and 14.5 °, while the roll angle ranged between -26.5 ° and -16 ° (to the left).

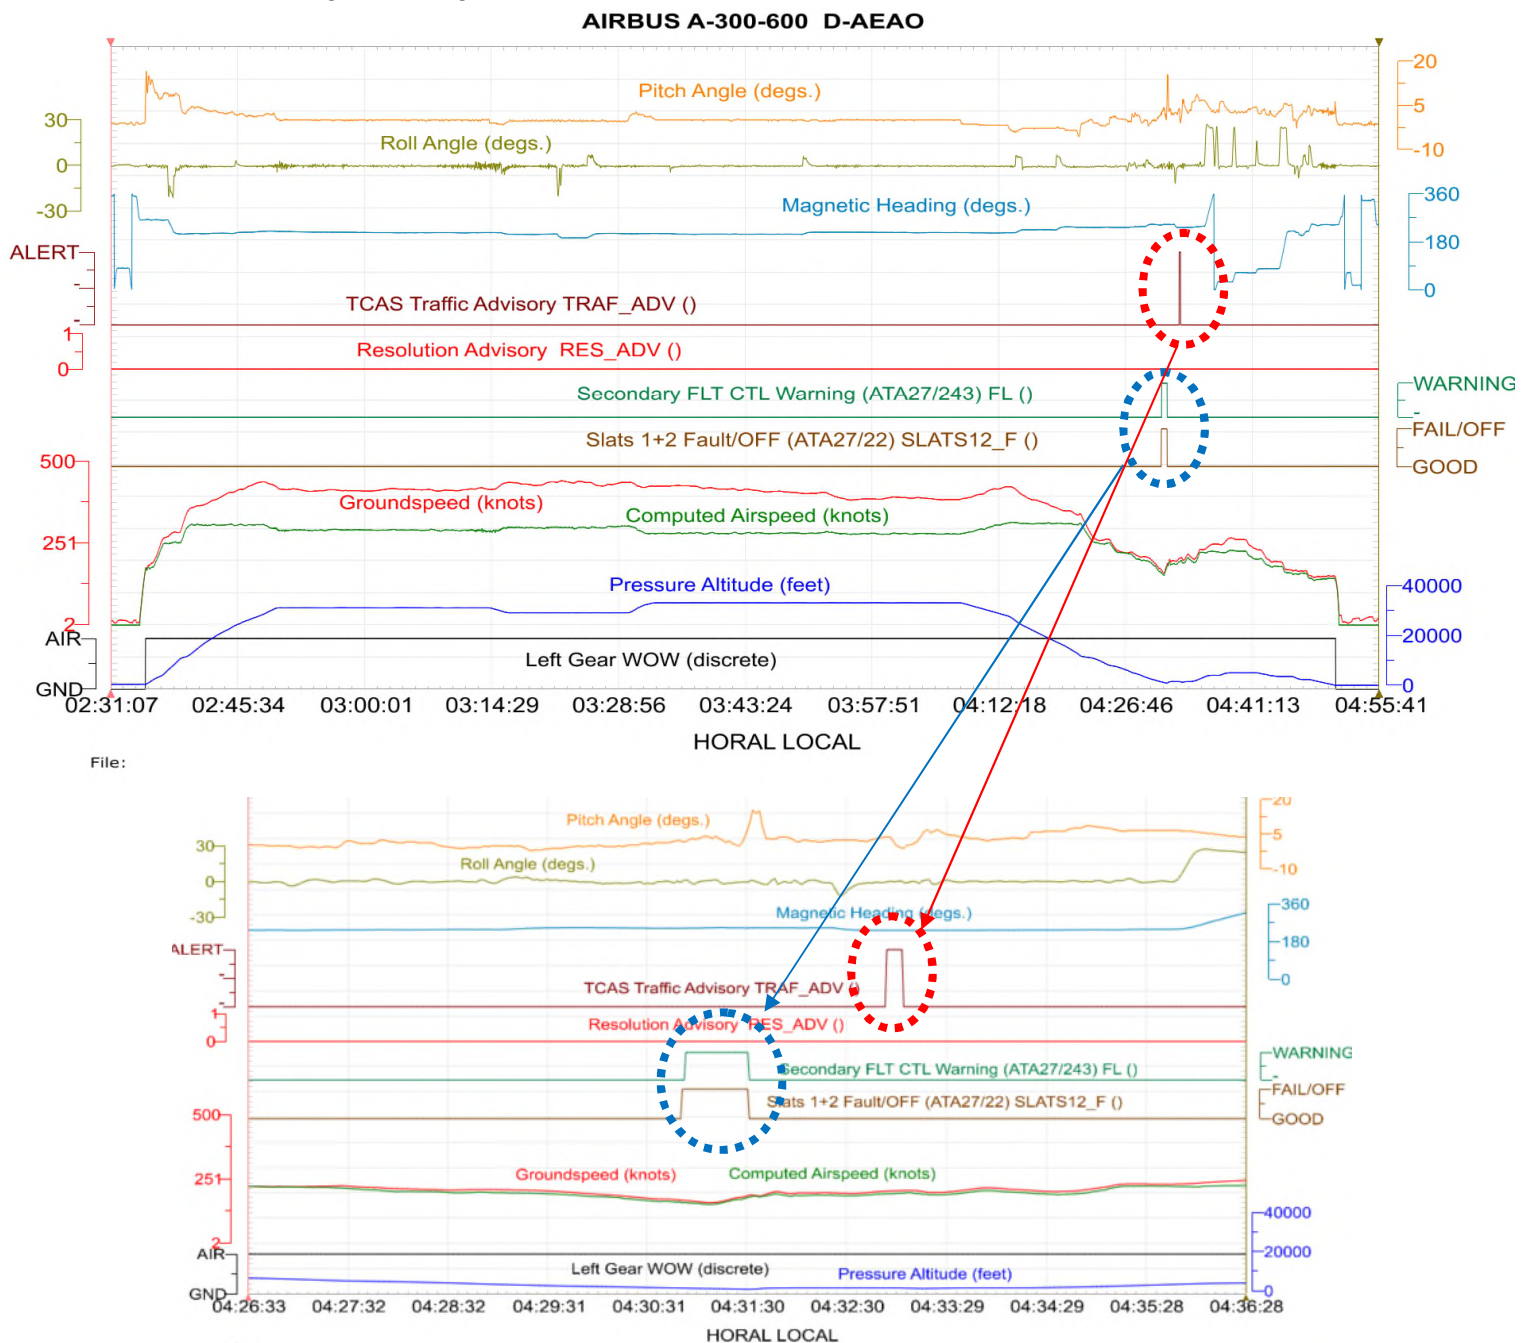
**Figure 13. Flight parameters recorded on the AIRBUS A 300-600 aircraft**

It was on a magnetic heading of 233 °, which it maintained for the duration of the warning, and the flaps were not deployed. The pitch angle was 4 °, and it was level, i.e. not rolling.

The aircraft maintained an altitude of 1,500 ft along the length of the runway centreline and began turning left.

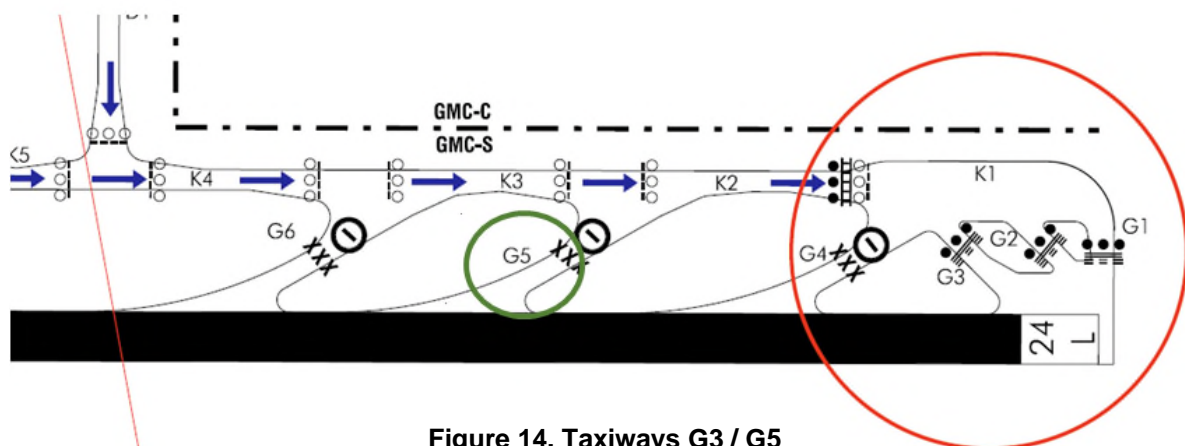
Figure 14. Taxiways G3 / G5

- The airport was operating in phase 2 of the reduced visibility procedure (cloud base 500 ft and 7,000 m visibility), and the crew of the BOEING 737-800 (RYP61FK) were cleared for take-off between two heavy turbulent wake aircraft (one had just landed and the other was at 2.4 NM). When the AIRBUS A 300-600 (BCS31M) reached 1.9 NM on final, its crew were instructed to wait for a late clearance, and it was during this communication that the controller was advised the aircraft was executing a missed approach. At that point, the BOEING 737-800 (RYP61FK) had yet to cross G3 and was taxiing at just 20 kt. It took a few moments to request confirmation of the missed approach from the AIRBUS A 300-600 (BCS31M). When their reply was received, the BOEING 737-800 (RYP61FK) was passing G5 at a speed of 60 kt, and its take-off was allowed to proceed. Given the unusual situation, this was not an appropriate decision; therefore, the planning is considered to have been inadequate.
