Air Accident Investigation Unit Ireland

SYNOPTIC REPORT

Cessna 182L, EI-CDP

6 October 2018

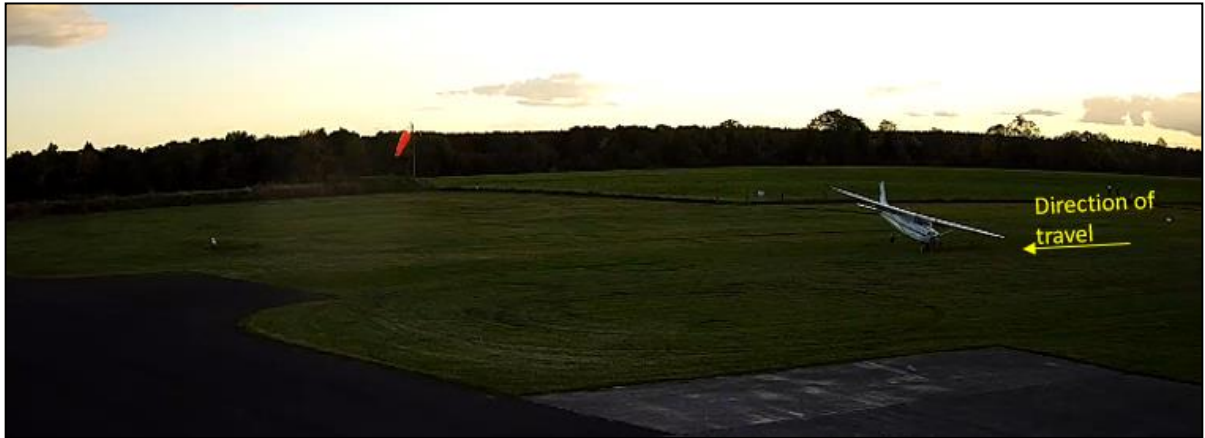
The Pilot informed the Investigation he was aware that due to the rate of descent and speed of the aircraft, it would overshoot the runway. Therefore, he opted to put the aircraft down onto RWY 09 as soon as possible. Due to the speed of the aircraft and the prospect of colliding with the boundary hedge and fence beyond the end of the runway, the Pilot said he applied full left rudder and aileron to turn the aircraft and it skidded sideways along the grass runway (**Figure No. 1**).

Figure No. 1: Sideways skid of aircraft coming to the end of grass surface

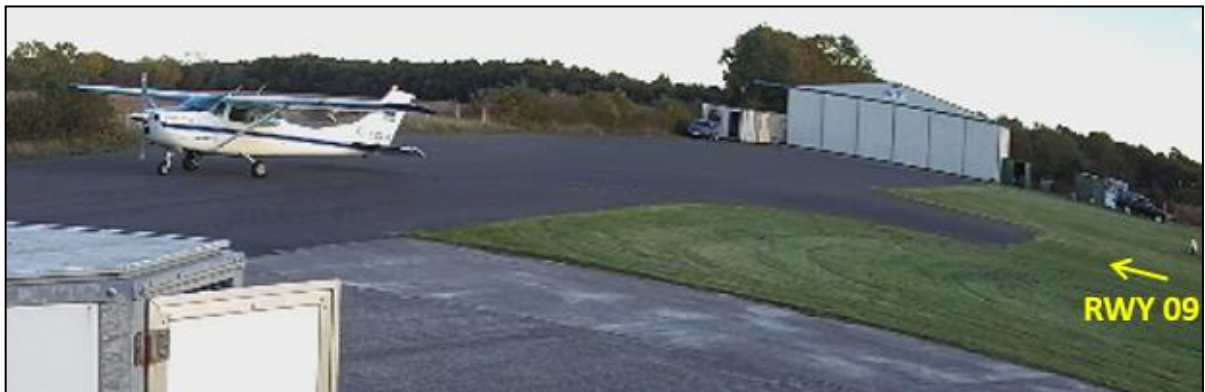
Video evidence and ground scarring show that as the aircraft skidded sideways, the left wing pitched down and the right wheel lifted off the ground. The tail struck the ground as the nose wheel lifted. The aircraft, still moving in a sideways motion, departed the grass surface onto a tarmac area beyond the end of the runway. The aircraft came to a stop on the tarmac on a heading of 020 degrees magnetic, approximately 7 metres (m) from the airfield's eastern boundary hedge and fence (**Figure No. 2**). The Pilot and Skydivers evacuated the aircraft. No injuries were reported to the Investigation. There was no fire.

Figure No. 2: Resting position of EI-CDP

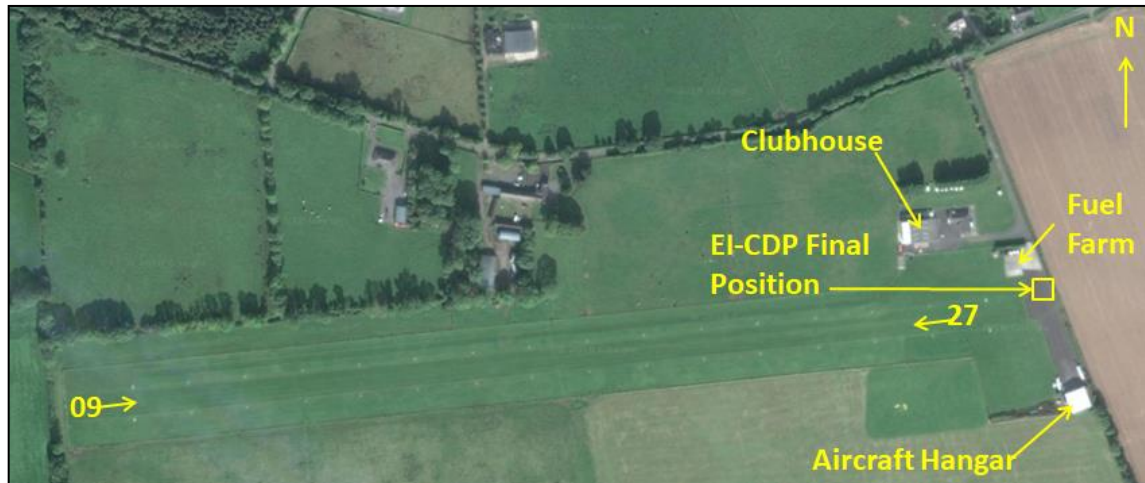
Figure No. 3: Aerial view of EI-CDP (Google Earth)

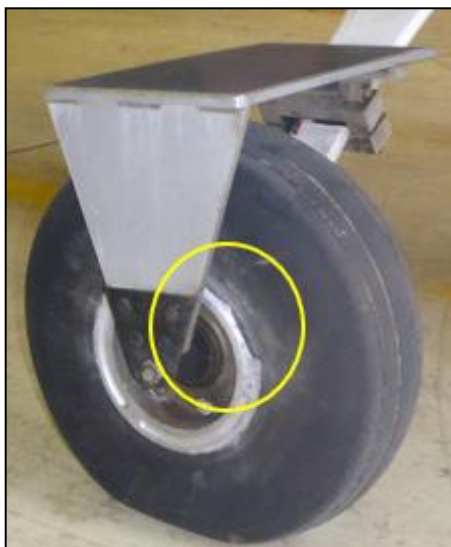
The hub of the right main landing gear wheel was broken along its outer circumference and is indicated by the yellow circle in **Photo No. 1** adjacent to a step modification fitted to the landing gear strut. The tie-down point under the tail of the aircraft was distorted to the left (yellow circle in **Photo No. 2**).

Photo No. 1: Right main landing gear wheel

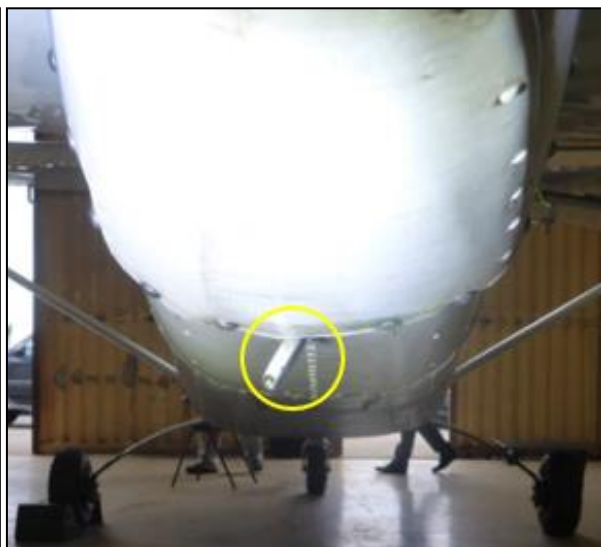
Photo No. 2: Tie-down point

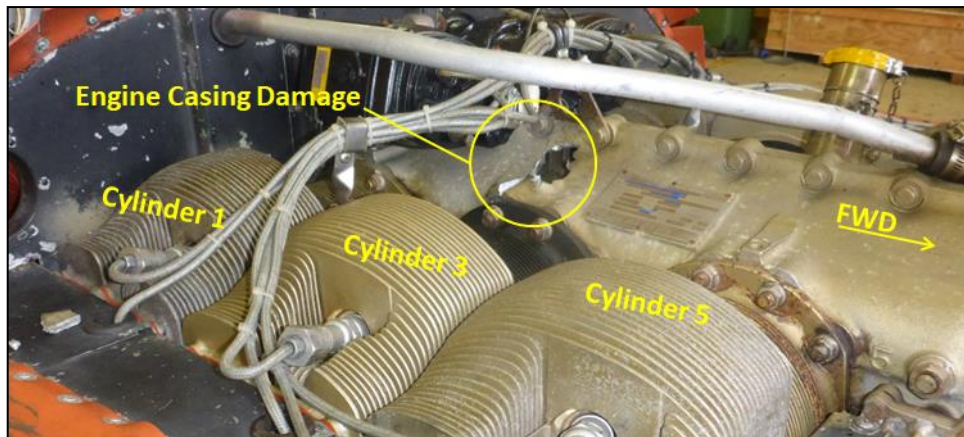
The aircraft engine exhibited significant damage. On initial visual inspection a hole was evident in the engine crankcase adjacent to the No. 3 cylinder (**Photo No. 3**). The engine was subsequently removed from the aircraft under AAIU supervision and sent to an approved engine maintenance facility for further investigation, also under AAIU supervision (**Section 1.12**).

Photo No. 3: Engine damage

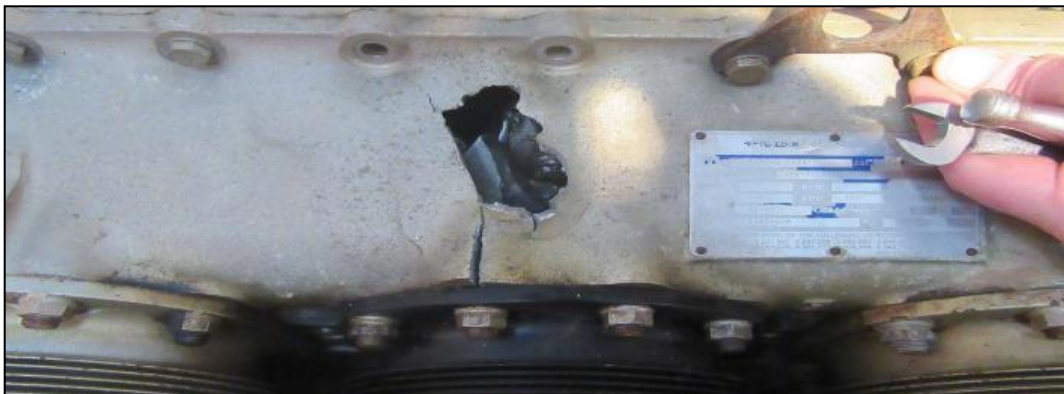
On initial inspection at the engine overhaul facility, it was observed that the engine was partially seized and would not fully rotate. The crankcase situated on the upper right-hand side of the engine exhibited significant damage and was punctured from the inside out. The exact nature of the internal failure was not evident. It was notable at this point that the external paint finish and external condition of Cylinders No. 3 and No. 4 were different to that of the remaining four cylinders. **Photo No. 5** shows Cylinder No. 3 adjacent to the damaged crankcase.

Photo No. 5: L to R – Cylinders No. 1, No. 3 and No. 5

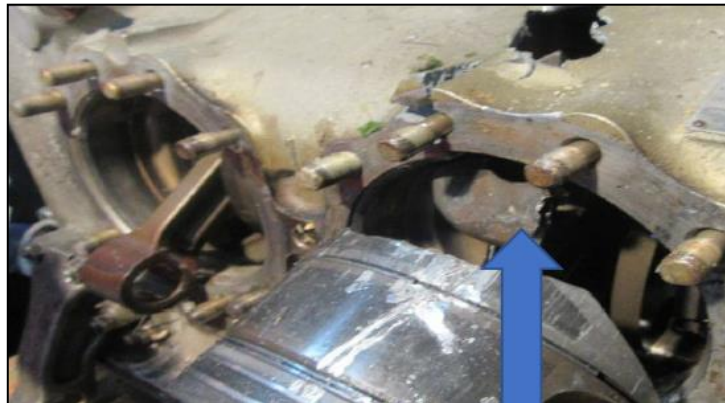
With all cylinders removed it was apparent that the crankshaft had broken into three distinct pieces and had caused a significant amount of secondary damage to the crankcase, connecting rods and cylinders. A large, detached section of crankshaft could be observed wedged just below the fractured crankcase (**Photo No. 6**).

Photo No. 6: Detached section of crankshaft

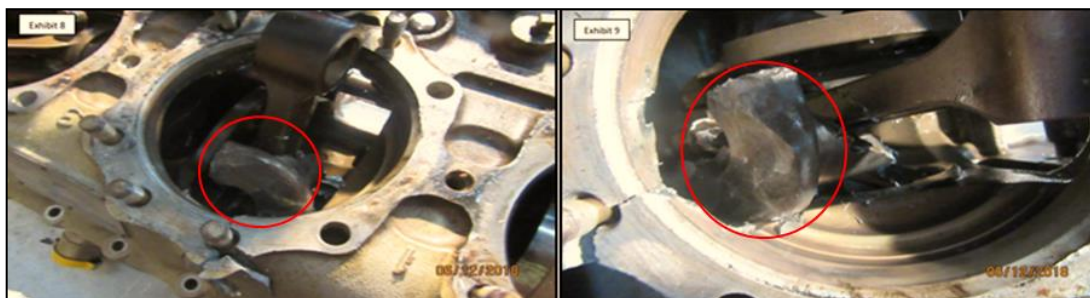
With the cylinders and pistons removed, a large, detached piece of the crankshaft and associated damage was evident in the No. 3 cylinder area as shown circled in **Photo No. 7** and **Photo No. 8**.

Photo No. 7 (left) and **Photo No. 8** (right): Detached section of crankshaft

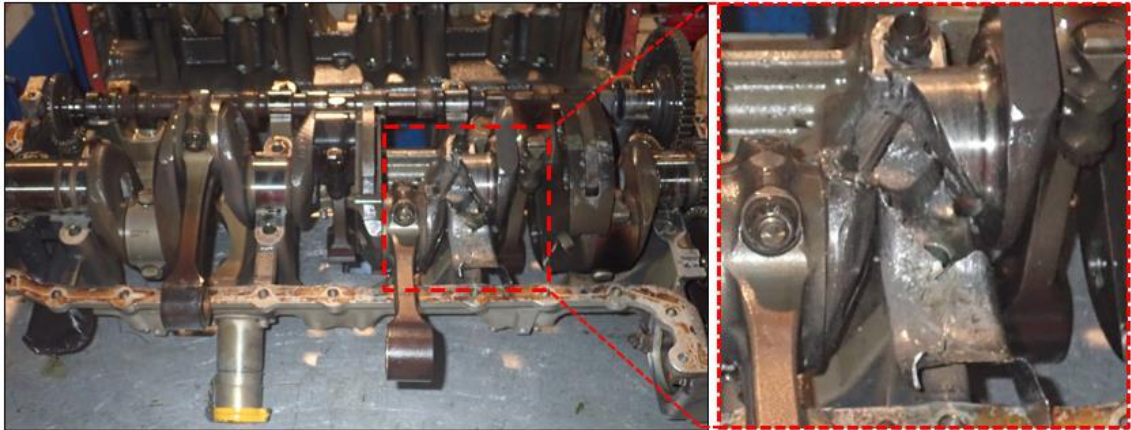
The crankcase halves were separated, and it was observed that the damage to the crankshaft was largely confined to the No. 2 main journal and bearing location. The crankshaft was found in three distinct pieces, with each piece displaying a number of fracture surfaces as shown in **Photo No. 9**. In addition, some smaller fragments of the crankshaft had broken away and had been damaged beyond visual recognition.

Photo No. 9: Damaged crankshaft sitting in the L/H crankcase

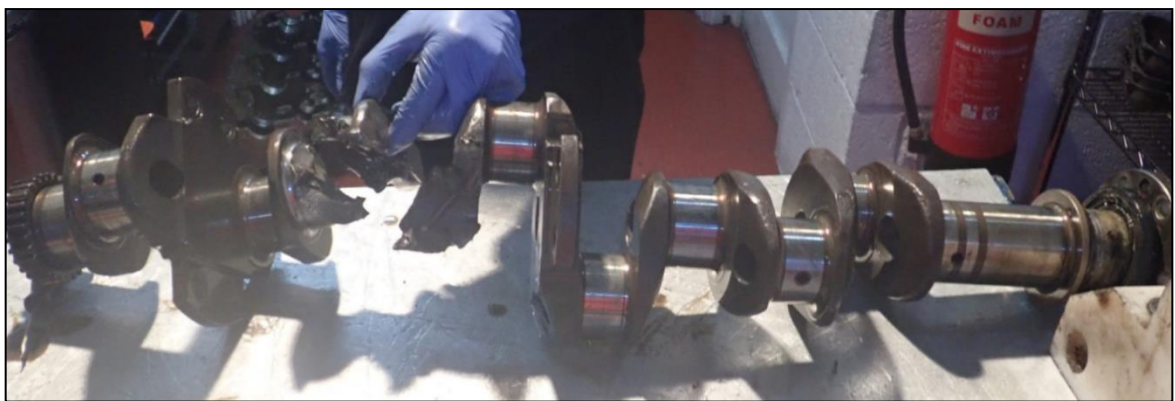
The crankshaft was removed from its case and laid out as shown in **Photo No. 10**. The damage to the crankshaft was found to be centred on a fracture in the No. 2 main journal area (refer to **Figure No. 6**).

Photo No. 10: Damaged crankshaft as removed from the crankcase

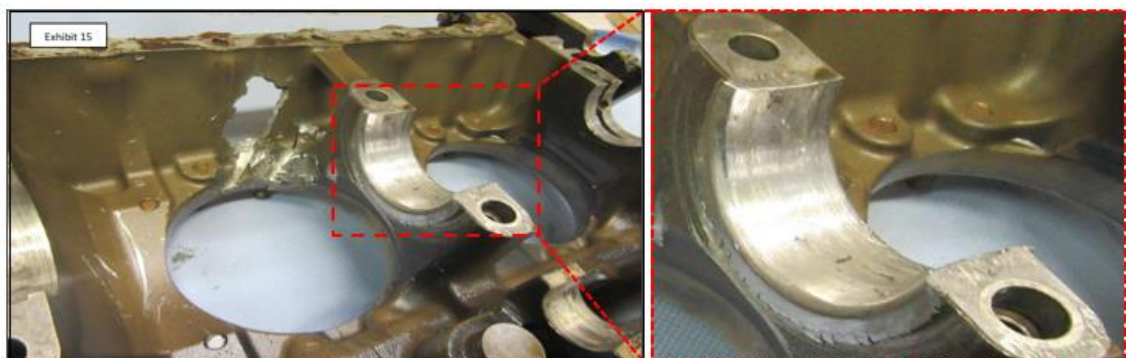
With the crankshaft removed from the engine casing, the full extent of the damage to the crankcase and the internals of the engine could be observed. The No. 2 main bearing shell as fitted on the right-hand crankcase half, suffered significant distress and distortion as shown in **Photo No. 11**.

Photo No. 11: No. 2 main bearing shell damage (R/H crankcase)

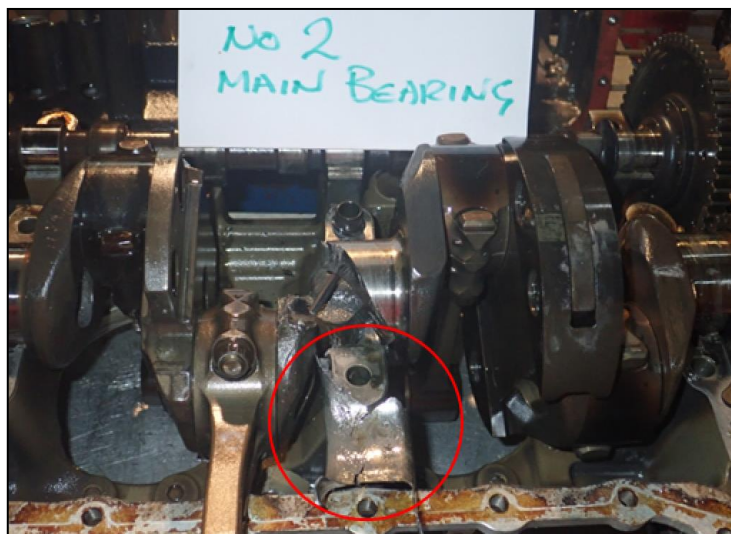
The No. 2 bearing shell on the L/H crankcase also suffered significant distress and distortion as shown circled in red in **Photo No. 12**. Remnants of the aluminium bearing shell were retrieved from the engine sump and from within the oil cooler.

Photo No. 12: No. 2 main bearing shell damage (L/H crankcase)

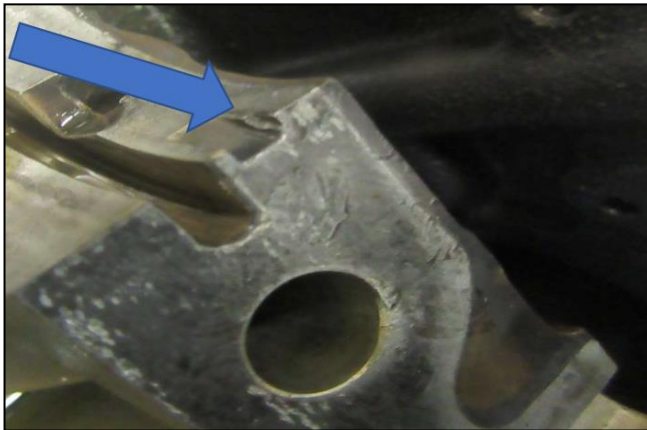
The workshop report detailed evidence of normal wear in most locations on the crankcase halves. Evidence of fretting and tang slot wear of the No. 1 bearing crankcase saddle from the L/H crankcase half is shown in **Photo No. 13** (blue arrow). Mild fretting of the No. 2 main bearing crankcase saddle from the L/H crankcase half in combination with heavy wear to the bearing bore material can be observed in **Photo No. 14**. Fretting to the No. 1 and No. 2 camshaft bearing saddle areas is indicated by the blue arrow in **Photo No. 15** and **Photo No. 16**.

'... the fretting¹⁰ and tang mark wear observed in the number 1 + 2 main crankshaft bearing saddle locations, and number 1 + 2 camshaft bearing and saddle locations, is a lot more severe than you would expect to find in an engine that has reached TBO¹¹'.

'The fretting observed in these areas, has been manifesting for a period of time due to the movement of the crankcase halves as a result of an underlying issue. The root cause could possibly be attributed to loss of torque to crankcase thru studs'.

Photo No. 13: Fretting and tang slot wear to the No. 1 main bearing crankcase saddle

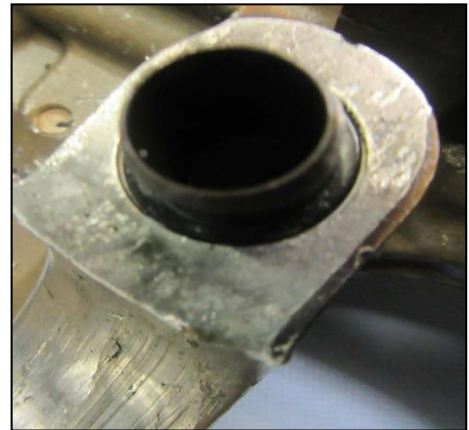
Photo No. 14: Fretting of the No. 2 main bearing crankcase saddle and heavy wear to the bearing bore material

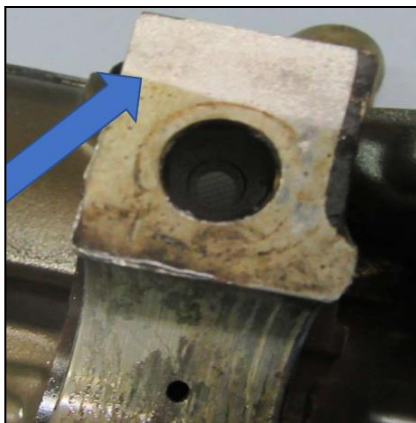
Photo No. 15: Fretting of the No. 1 camshaft bearing saddle

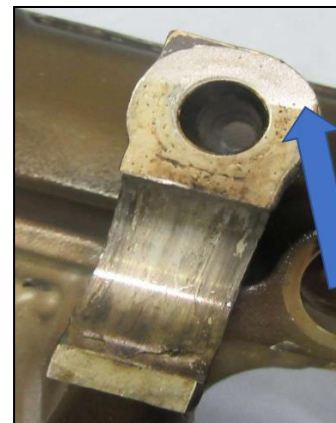
Photo No. 16: Fretting to the No. 2 camshaft bearing saddle

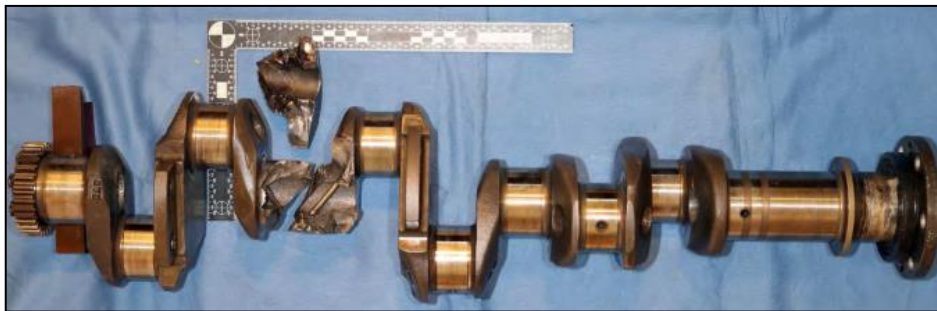
The three main crankshaft sections (**Photo No. 17**) were sent to a specialist laboratory for detailed metallurgical analysis to ascertain the cause and mode of failure. The analysis performed included macroscopic examination, magnetic particle testing, energy dispersive x-ray spectroscopy, microhardness testing and detailed examination using a Scanning Electron Microscope (SEM). A detailed report on the analysis and findings was provided to the Investigation. No anomalies were noted in the crankshaft's base material.

Photo No. 17: General view of crankshaft

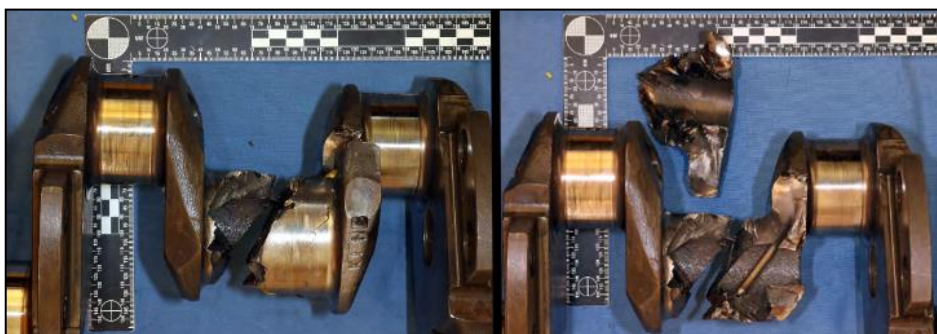
The report identified that the crankshaft had fractured through MJ #2 (**Photo No. 18**). The fracture planes were complex and had resulted in separation of the journal into three pieces. The outer diameter of MJ #2 showed evidence of scuffing wear and material transferred from the plain bearing. The remainder of the journals showed some oil discolouration but no significant signs of distress.

Photo No. 18: General views of failed crankshaft

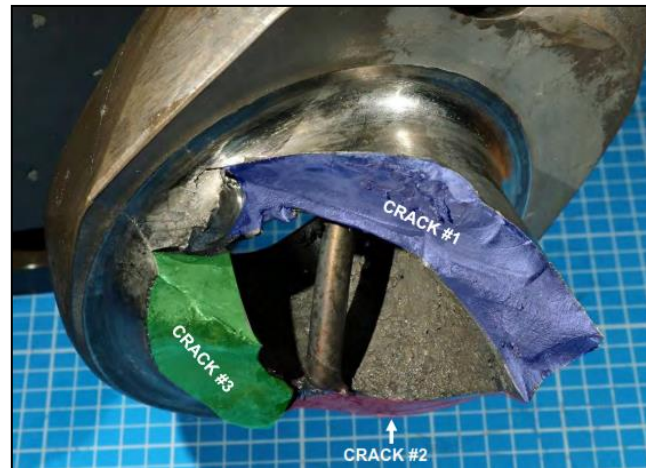
Examination of radial and conchoidal¹² markings on the fracture surfaces indicated that the failure had occurred by the coalescence of three separate major fatigue cracks, each of which had initiated on the outer diameter of MJ #2. These cracks for ease of reference are arbitrarily identified as Crack #1, #2 and #3 (**Figure No. 7**). There was no evidence of cracking on the outer diameters of any of the journals, other than on MJ #2.

Figure No. 7: Views of the aft portion of MJ #2

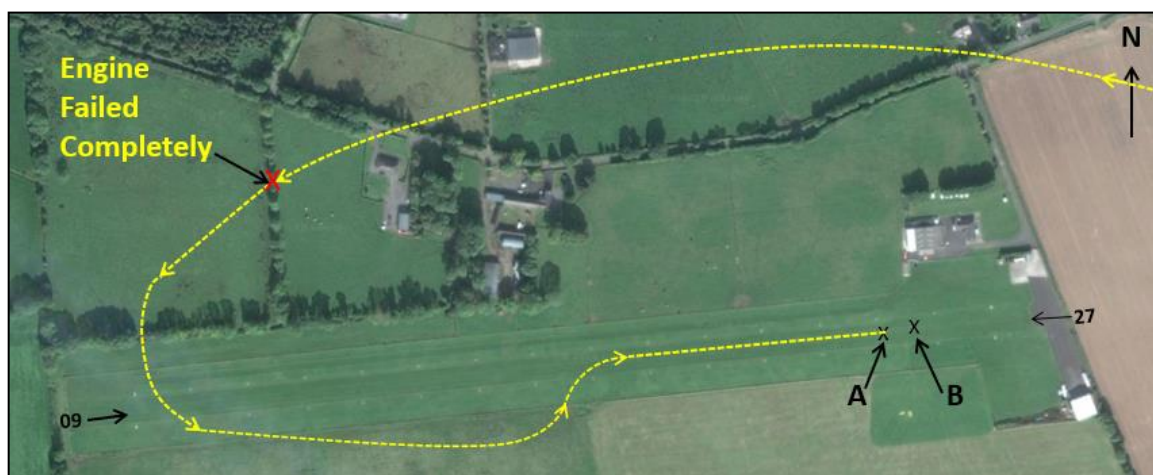
The aircraft crossed the centreline for RWY 09 and passed over a field to the right of RWY 09 before finally aligning with the runway. At this point, the aircraft had approximately 360 m of grass runway remaining. According to the Pilot, the aircraft was travelling at an airspeed of approximately 60 kt and based on the meteorological aftercast, which indicated a north-westerly wind of 5 kt, there was a potential tailwind component.

Figure No. 13: Approximate emergency landing route (Google Earth)

Points A and B on **Figure No. 13** indicate the initial and second points of contact respectively of the aircraft with the runway. Point A is 125 m and Point B is 102.5 m from the tarmac at the end of the runway.

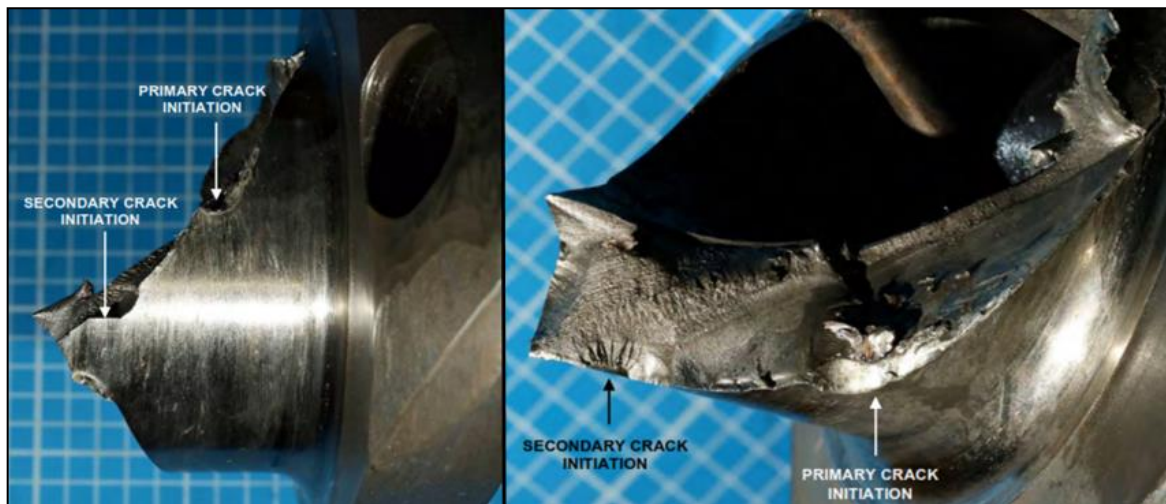
The nature of the markings on the crack surfaces indicated that Crack #1 was a fatigue crack, which had initiated from two locations, on the outer diameter of MJ #2 (**Figure No. A1**). The features of the primary initiation site had been destroyed by post-fracture damage. At the secondary initiation site, there was a heat-induced longitudinal crack in the outer diameter, approximately 3mm long by 0.45mm deep (**Figure No. A2** and **Figure No. A3**).

Figure No. A1: Crack #1 initiation site on MJ #2

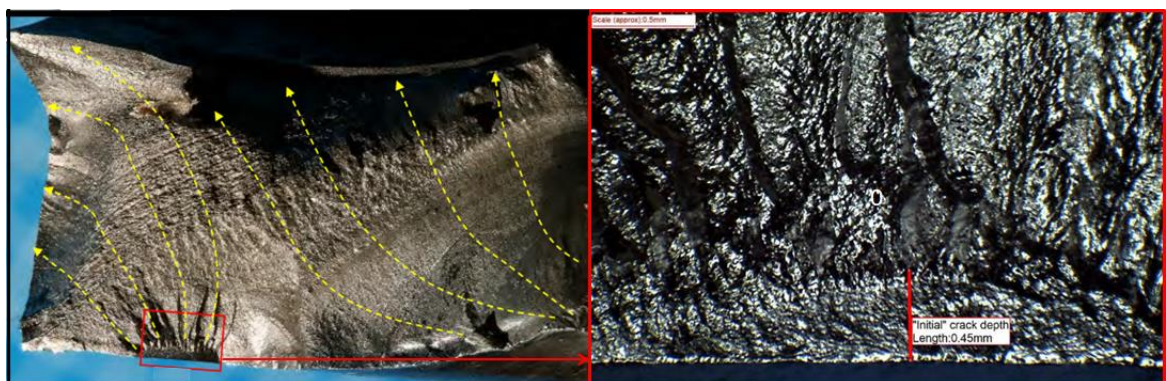
The metallurgist considered that the appearance of the heat-induced crack, at the secondary initiation site, was consistent with having been caused by thermal distress locally, resulting from frictional overheating of the outer diameter (**Figure No. A2**). There was another, similar crack immediately adjacent and running parallel to it (**Figure No. A3**).

Figure No. A2: Close-up of Crack #1 secondary initiation site on MJ #2

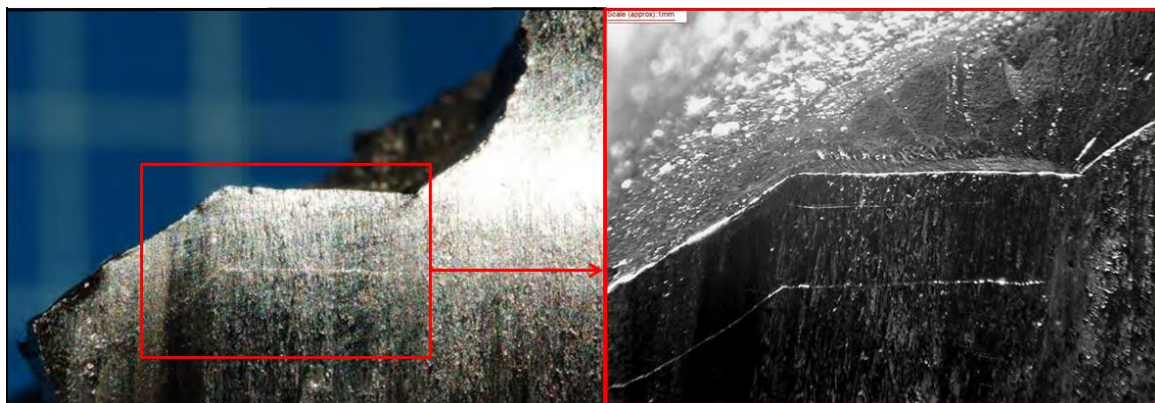
Figure No. A3: Crack #1 Secondary initiation site close-up of MJ #2

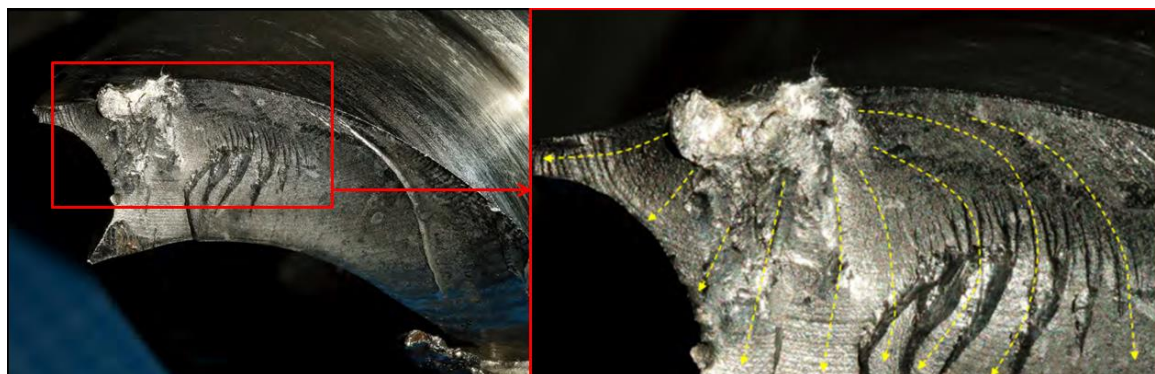
The nature of the markings on the crack surfaces indicated that Crack #2 was a fatigue crack, which had initiated from a single location on the outer diameter of MJ #2 (**Figure No. A4**). The features of the initiation site had been destroyed by post-fracture damage. The profile of the fracture plane, in the vicinity of the initiation site, was similar to that of Crack #1, in the vicinity of its secondary initiation site. This suggested that Crack #2 had initiated from a heat-induced longitudinal crack, similar to that described for Crack #1 in **Section A1.1**.

Figure No. A4: Close-up of Crack #2 initiation site on MJ #2

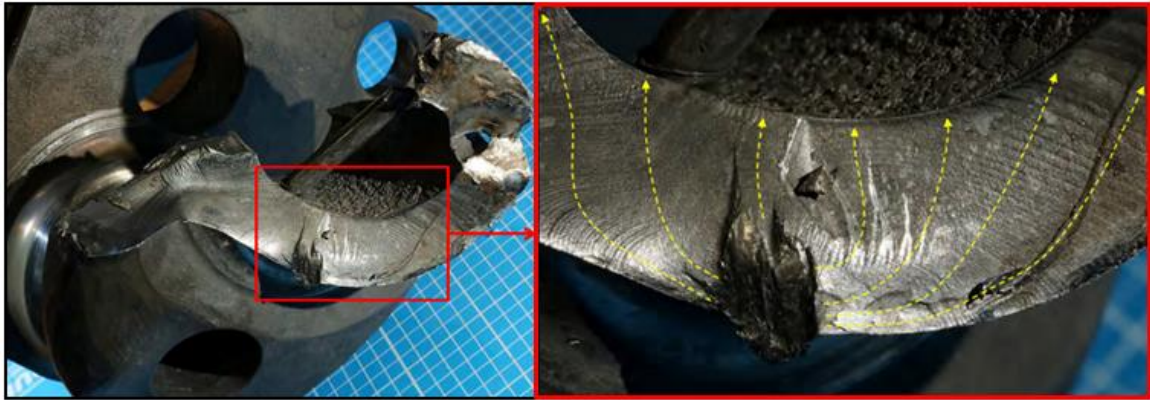
The nature of the markings on the crack surfaces indicated that Crack #3 was a fatigue crack which had initiated from a single location on the outer diameter of MJ #2 (**Figure No. A5**). The features of the initiation site had been destroyed by post-fracture damage. The profile of the fracture plane, in the vicinity of the initiation site, was similar to that of Crack #1 in the vicinity of its secondary initiation site. This suggested that Crack #3 had initiated from a heat-induced longitudinal crack, similar to that described for Crack #1 in **Section A1.1**.

Figure No. A5: Close-up of Crack #3 initiation site on MJ #2

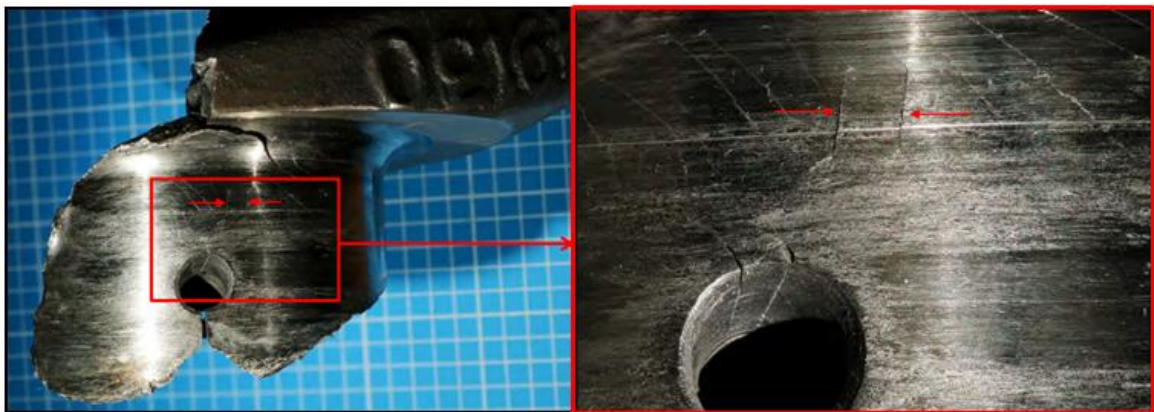
Several other longitudinal cracks (**Figure No. A6**) were evident on the outer diameter of MJ #2, which were similar in appearance to those described at **Section A1.1** but were remote from the fracture planes. Their appearance suggested that they were also the result of thermal distress, caused by frictional overheating of the outer diameter of MJ #2.

Figure No. A6: Close-up of longitudinal cracks on surface of MJ #2

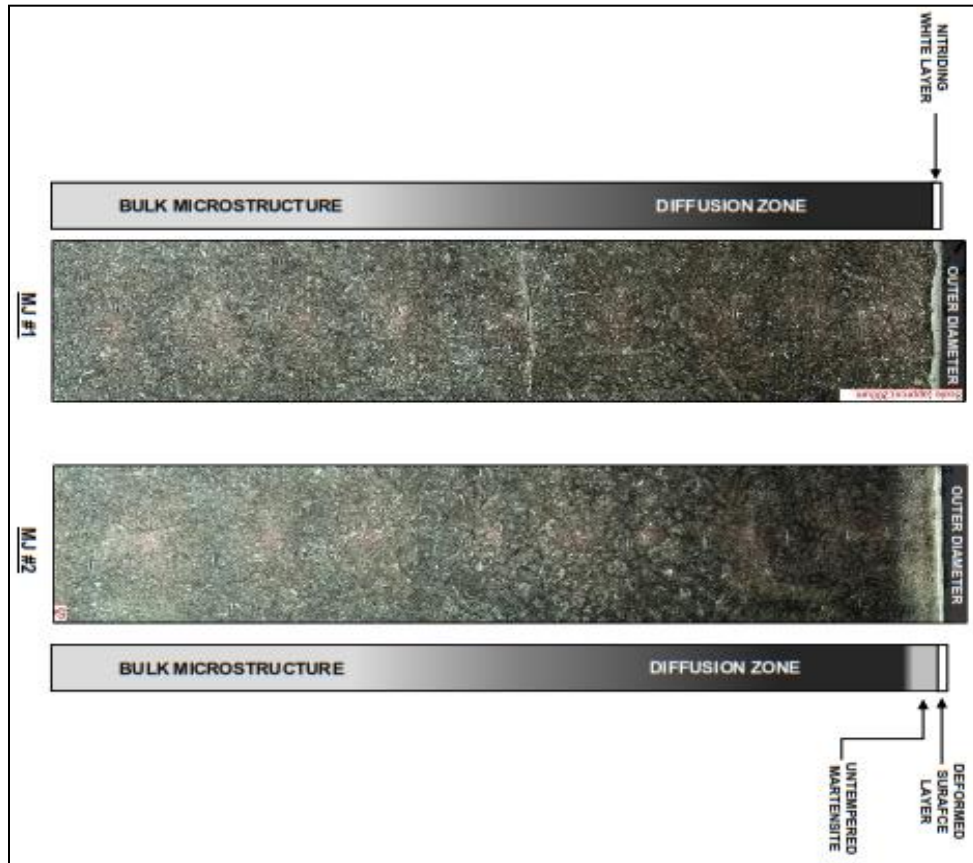
Figure No. A7: Etched metallographic sections through MJ #1 and MJ #2

MJ #1 showed a well-defined white layer at the surface, formed during nitriding. There was also a white etched layer at the surface of MJ #2, but it was identified as not being a nitride white layer but rather as a layer of deformed material, caused by frictional wear on the outer diameter. Beneath it, there was a light etched layer of untempered martensite. This indicated that the frictional wear had generated sufficient heat (temperatures typically above 816 °C²⁰) to locally transform the alloy microstructure. High temperature gradients that occurred during the formation of untempered martensite resulted in high levels of residual stress within the affected area.
