Air Accident Investigation Unit Ireland

FORMAL REPORT

**Rollason D.62B Condor, EI-BDX
Gibletstown, Duncormick, Co. Wexford**

6 October 2019

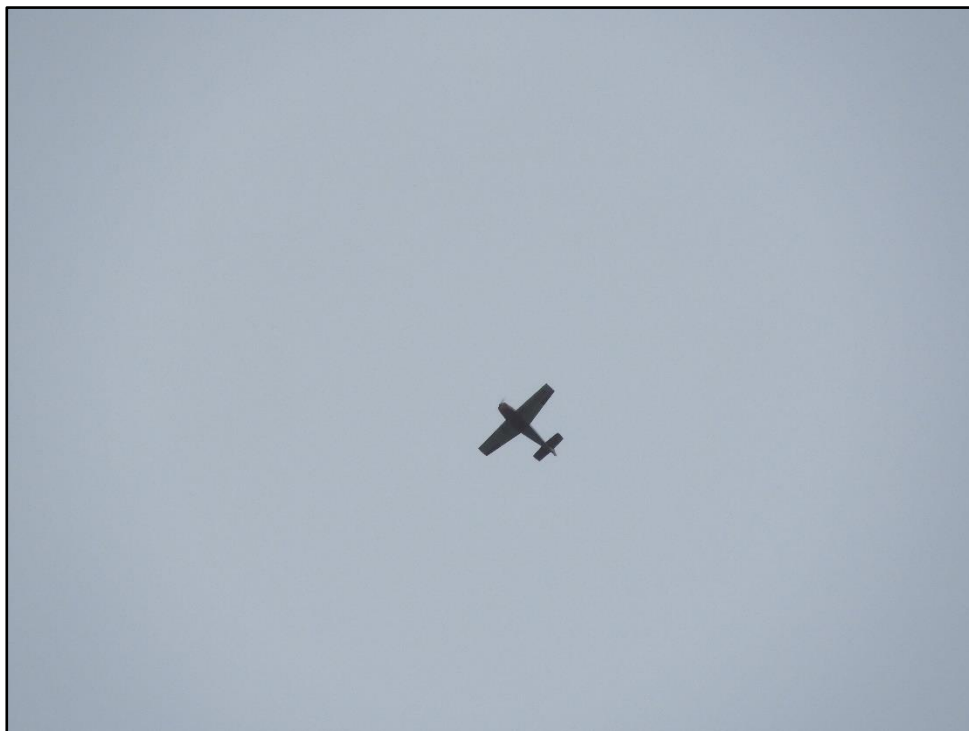
Photo No. 1: Photograph of EI-BDX during the accident flight (*provided by witness*)

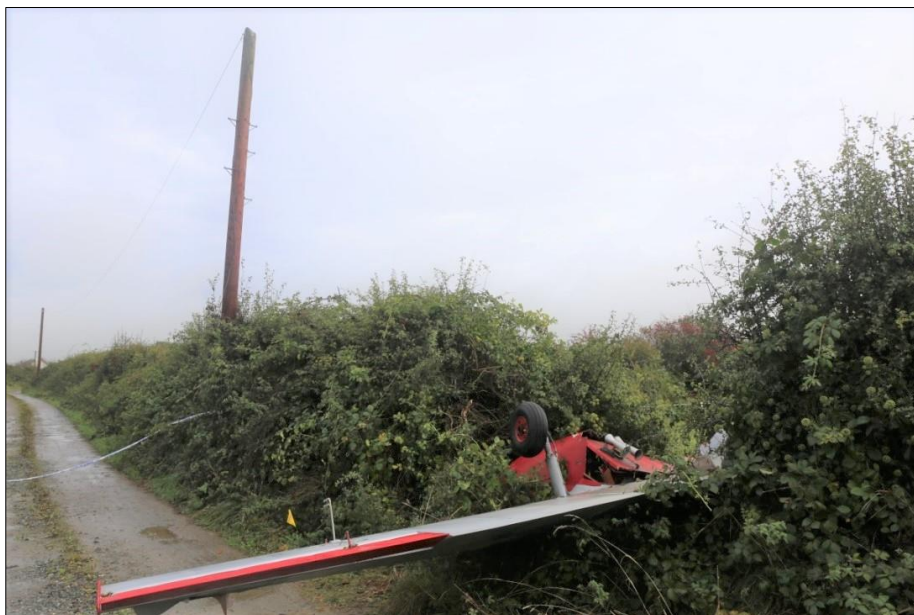
The wreckage from the aircraft was spread over a wide area spanning four agricultural fields. The largest section of wreckage comprised the instrument panel forward to the propeller; the entire right wing complete with main undercarriage leg (**Photo No. 3**); and the inboard section of the left wing including the main undercarriage leg (**Photo No. 4**). This section of wreckage came to rest, inverted, in the boundary hedgerow of an agricultural field.

Photo No. 3: Right wing and main wreckage

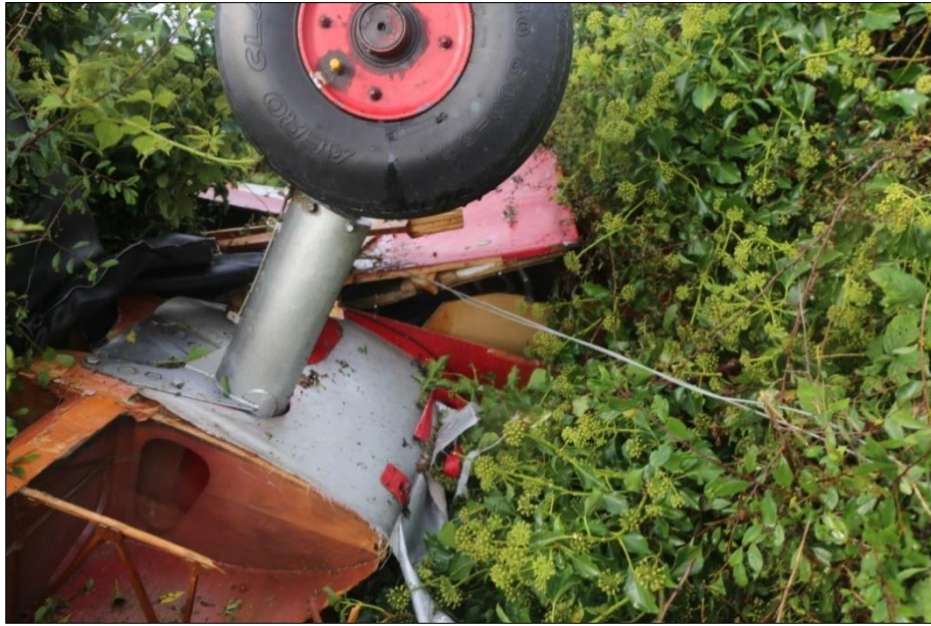
Photo No. 4: Inboard section of left wing (inverted) that remained attached

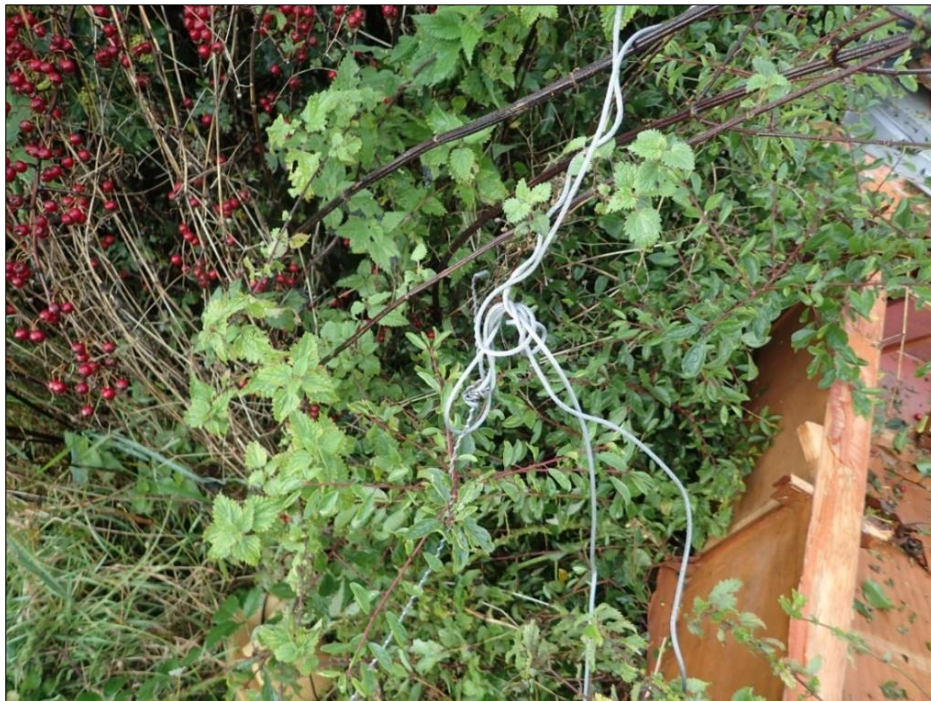
Control cables remained attached to the main wreckage (**Photo No. 5**) and were stretched to a length of approximately 28 m.

Photo No. 5: Entangled and damaged control cables attached to main wreckage

The cables exhibited significant distress including severed strands, hockles¹³ (with open and closed patterns) and bird-caging¹⁴.

The cables exhibited significant distress including severed strands, hockles (with open and closed patterns) and bird-caging. The extent of the cable damage was consistent with the attached tail section being subject to complex, varying, aerodynamic loading as the damaged aircraft rotated rapidly and descended. The varying aerodynamic loads would also have resulted in the cables applying significant mechanical loads to the wood and fabric aircraft fuselage and cockpit area, and likely contributed to the rapid disintegration of the aircraft which was described by the witnesses.

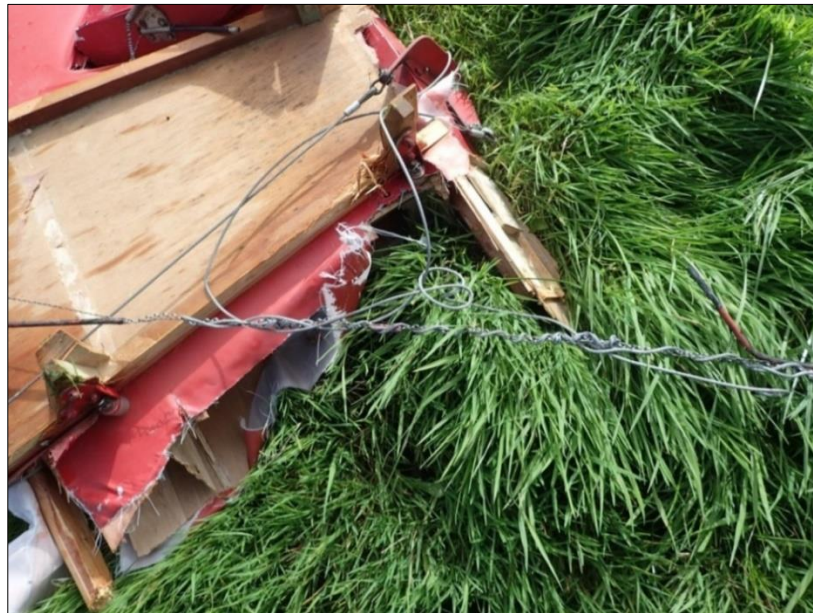
The other end of the cables remained attached to the left, and centre sections of the horizontal stabiliser (**Photo No. 6**).

Photo No. 6: Control cables from the aircraft tail still attached to the main wreckage

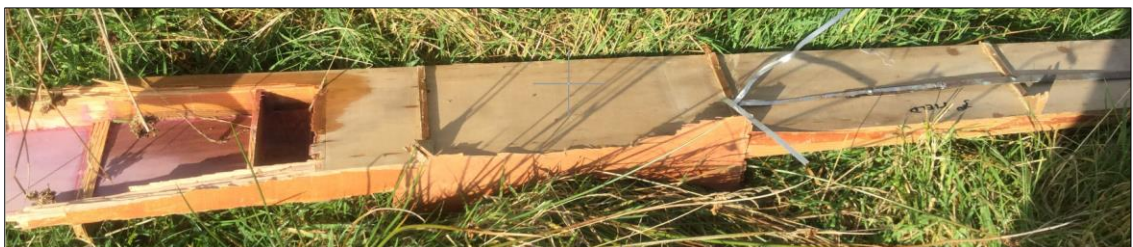
The outboard section of the left wing had broken up and various pieces were scattered throughout the debris field. The longest wreckage sections of the left wing were segments of the front wing spar (**Photo No. 7**) and rear wing spar.

Photo No. 7: Separated front spar from the left wing

It was noted that the upper and lower booms of the left wing front spar had both fractured; the fracture on the lower boom extended over approximately 40 cm, whereas the fracture on the upper boom was concentrated over approximately 25 cm. Examination of the fractures revealed a predominant presence of pulled fibres at the fracture of the lower boom and a significant incidence of buckled fibres at the fracture of the upper boom.

In timber spar boom fractures, pulled fibres are typical of a tension failure while buckled fibres are typical of a compression failure. The presence of predominantly pulled fibres on the fracture surfaces of the lower member with buckled fibres on the fracture surfaces of the upper member, combined with the greater length of the lower boom fracture versus the upper boom fracture, is consistent with a bending failure due to a combination of tension below the neutral axis and compression above it, and indicates a failure of the wing in positive g loading.

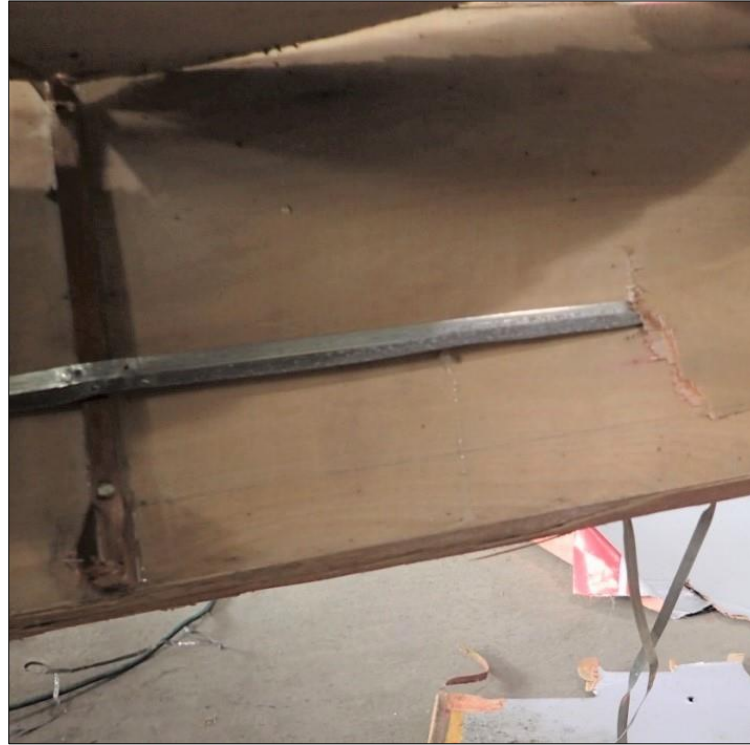
Two metal bonding straps, which were part of the aircraft's lightning protection system, were routed along the forward face of the front spar web and were fractured after being pulled through the plywood surface, outboard of the left wing root section (**Photo No. 8**).

Photo No. 8: Bonding straps pulled through front spar web (viewed from front)

Once the left main spar failed, the aileron control cables would have torn through the wood and fabric of the left wing. The bonding straps on the forward face of the main spar had torn through to the back of the spar, indicating that the failed section of the spar moved rearwards relative to the remaining root section. It is likely that parts of the failed wing section, most probably the fractured main spar and/or the wing end-cap (which incorporated part of the aileron mechanism), impacted the top of the rudder, fracturing it, and compromising the structure in the vicinity of the rudder's upper hinge attachment point. With the rudder hinge attachment structure compromised, its hinge separated, triggering the disintegration of the empennage and the fuselage.

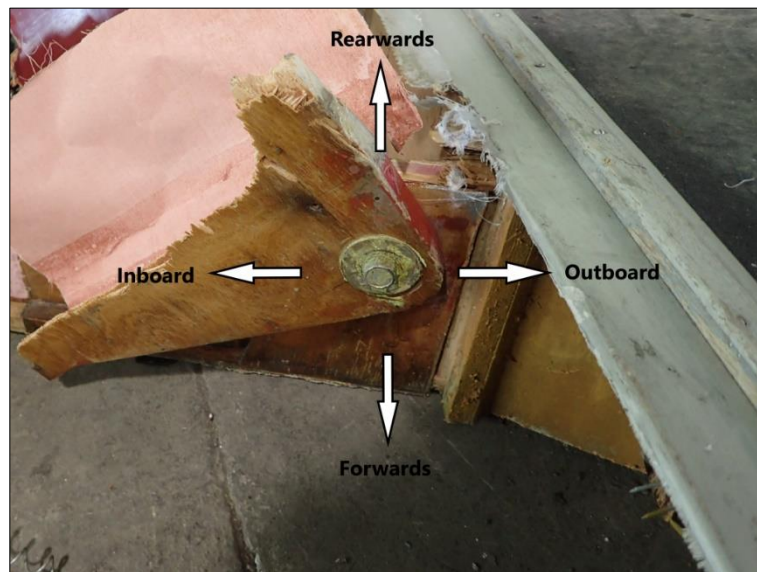
Bolted joints located just inboard of the wing walkways attach the rear wing spars to the centre spar section (which runs through the fuselage). The Investigation noted that a short section of the centre spar section remained attached to the left rear spar at the bolted joint just inboard of the left wing walkway (**Photo No. 9**). There was a pronounced angle between the two components at the bolted joint. It was noted that this joint remained tightly fastened at the bolt and that even when significant force was applied, it was not possible to change the angle between the short section of the centre spar section and the left rear spar at the bolted joint just inboard of the left wing walkway.

Photo No. 9: Bolted joint between rear spar and centre spar

Further evidence that the left wing failed in positive loading can be found in **Photo No. 9**, which shows that the rear spar at the bolted joint (just inboard of the left wing walkway) had rotated upwards relative to the inboard centre spar section. The Investigation noted that this bolted joint remained tightly fastened and resisted movement even when significant force was applied, which indicated that the relative movement was not as a result of post-accident wreckage distribution or handling.

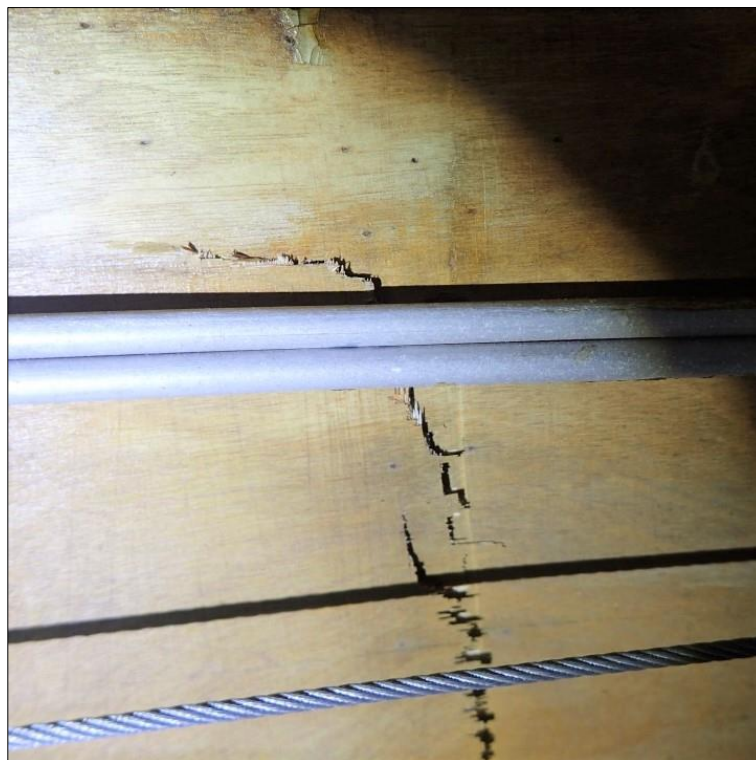
Removal of the covering material and examination of the (still-attached) right wing revealed that the webs of the main spar exhibited fracture damage (**Photo No. 10**). Also, two of the wing ribs had suffered fracture damage in the vicinity of the area where load was transferred from the upper wing fabric surface, via stitched Dacron¹⁵ to the lower surface of the ribs (**Photo No. 11**).

Photo No. 10: Fracture damage on the webs of the main spar of the right wing

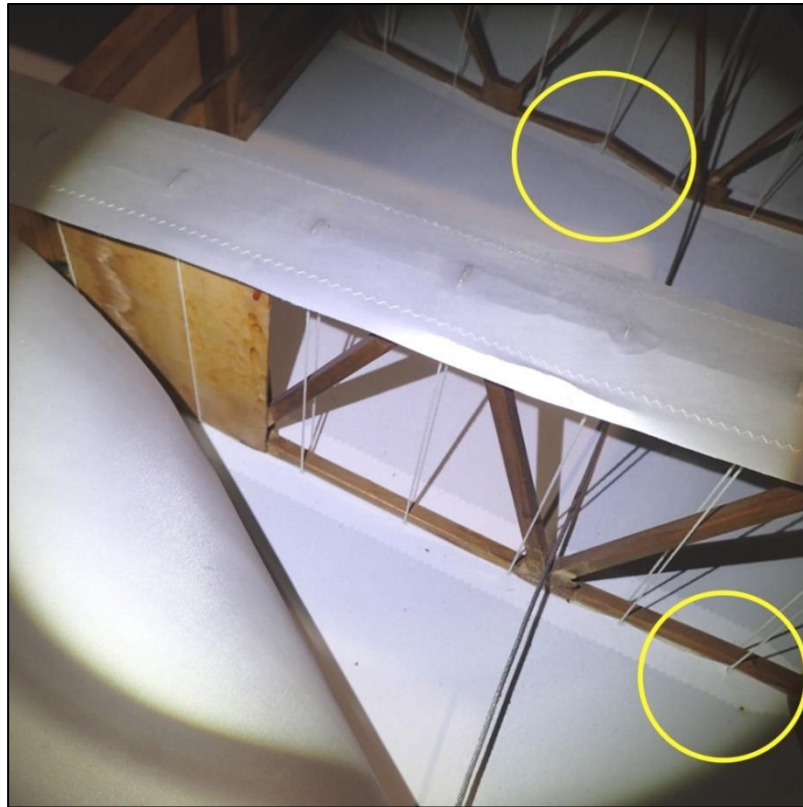
Photo No. 11: Damage to ribs of the right wing (circled in yellow)

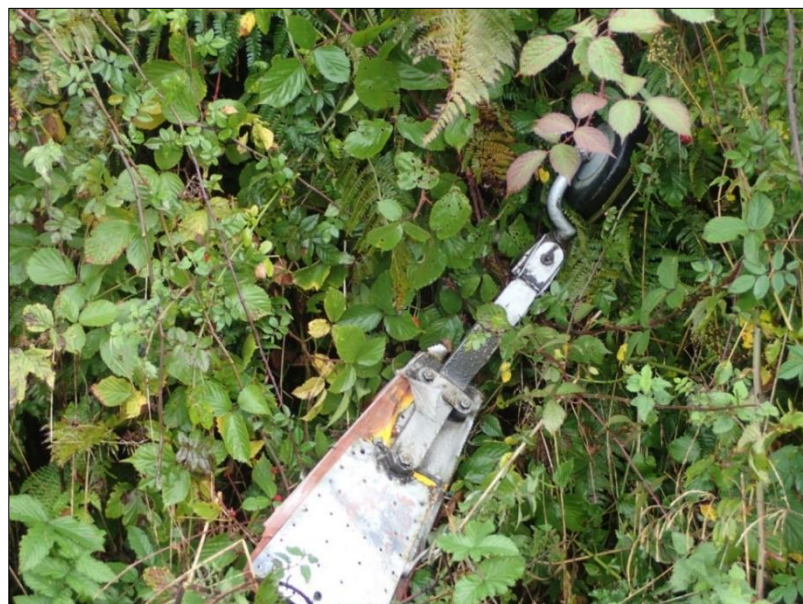
The tail wheel had separated completely from the aircraft and the majority of its securing screws had pulled out of their retaining structure. The component was located in a hedgerow, a few metres away from the main wreckage (**Photo No. 12**).

Photo No. 12: Tailwheel assembly as located within the hedgerow

The tail wheel assembly had separated completely from the aircraft and exhibited damage consistent with being subjected to a significant downwards force which caused the majority of its securing screws to pull out of their retaining structure; it was located in a hedgerow, a few metres away from the main wreckage, suggesting that it separated from the aircraft early in the accident sequence.

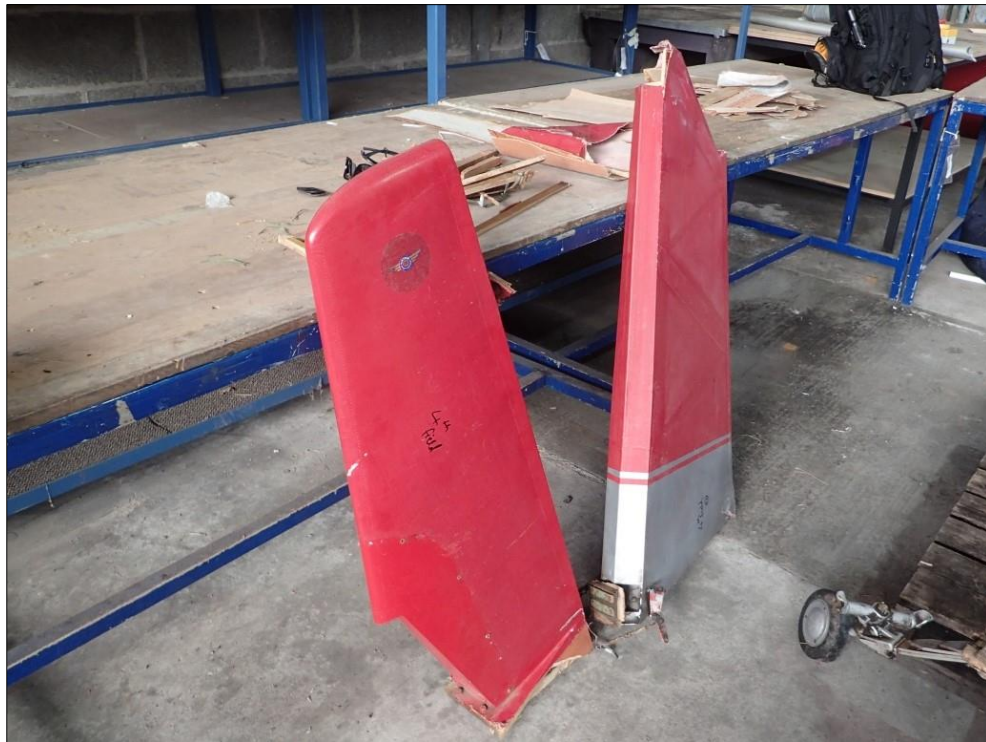
Examination of the vertical stabiliser and rudder revealed that the rudder had separated from the vertical stabiliser at its upper hinge point and from the empennage at its lower hinge point (below the tailplane/elevator structure and above the tailwheel); each of these separations involved the attachment structure for each hinge separating from the vertical stabiliser and the empennage (respectively). Furthermore, the vertical stabiliser had separated (at its root) from the horizontal stabiliser (**Photo No. 14**). The rudder control cable attachment horns were bent downwards from their normal orientations.

Photo No. 14: Vertical stabiliser (red) and rudder (red/silver)

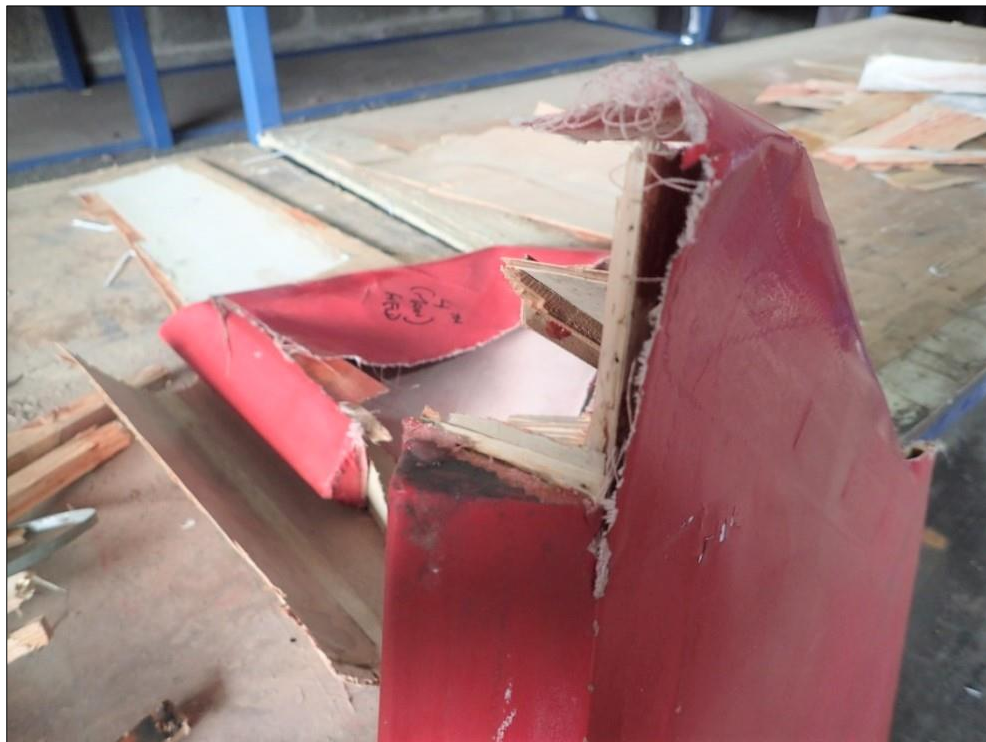
Examination of the rudder revealed that the section above the upper hinge had fractured and remained attached to the lower part only by the fabric (**Photo No. 15**).

Photo No. 15: Fractured and separated upper portion of the rudder

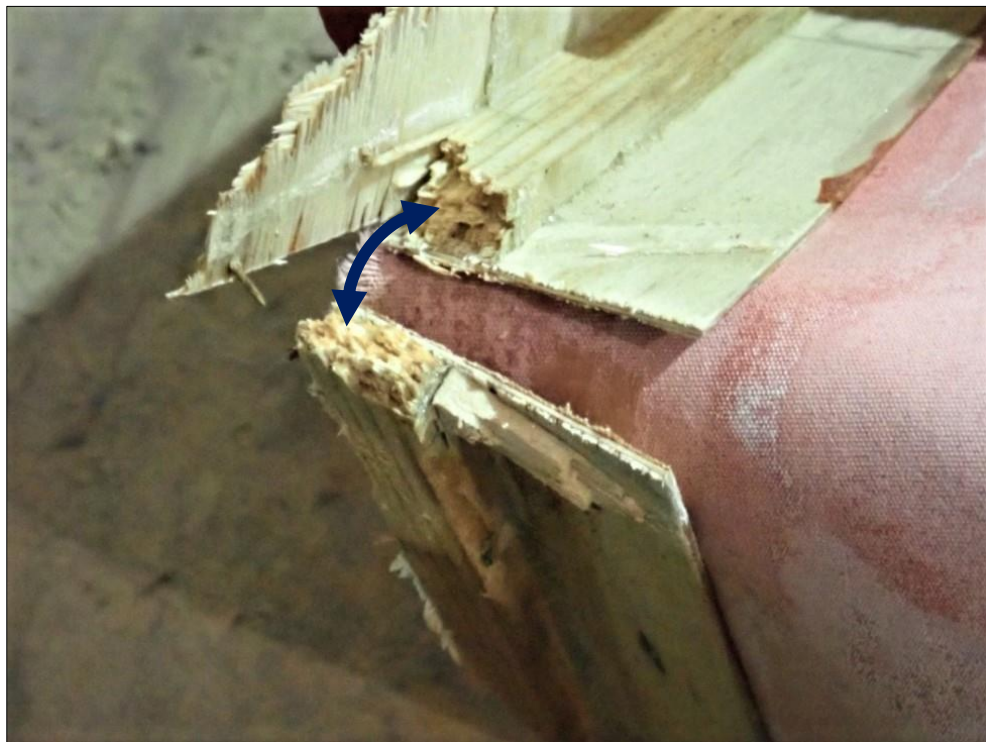
The upper part of the rudder was fractured in a left to right direction (when viewed from behind) (**Photo No. 16**).

Photo No. 16: Fractured surfaces of the separated upper portion of the rudder

11. *The separated rudder was noted to have a fracture that was caused by a force being applied to its top from the left side, as viewed from behind the aircraft*

Examination of the fractured portion of the upper section of the rudder indicated that the fracture was caused by a force applied to the left side of the rudder (**Photo No. 16**). The downward bending of the rudder's control-cable attachment horns suggests that the rudder's upper hinge had separated, allowing the rudder to rotate backwards and downwards. Given the fracture of the rudder was above its upper hinge point, it is likely that part of the failed left wing struck the upper portion of the rudder on its left side, fracturing the upper portion and initiating the separation of the upper hinge from the aircraft's vertical stabiliser structure. The downwards rotation of the rudder, and the associated pulling of its control cables would have compromised the structure at the rear of the empennage.
