## INCIDENT

<b>Aircraft Type and Registration:</b>	ATR42-300, EI-SLD	
<b>No &amp; Type of Engines:</b>	2 Pratt and Whitney PW120 turboprop engines	
<b>Year of Manufacture:</b>	1985	
<b>Date &amp; Time (UTC):</b>	18 January 2007 at 2225 hrs	
<b>Location:</b>	London Stansted Airport	
<b>Type of Flight:</b>	Commercial Air Transport (Cargo)	
<b>Persons on Board:</b>	Crew - 2	Passengers - None
<b>Injuries:</b>	Crew - None	Passengers N/A
<b>Nature of Damage:</b>	None	
<b>Commander's Licence:</b>	Airline Transport Pilot's Licence	
<b>Commander's Age:</b>	41 years	
<b>Commander's Flying Experience:</b>	2,732 hours (of which 2,144 were on type) Last 90 days - 147 hours Last 28 days - 35 hours	
<b>Information Source:</b>	AAIB Field Investigation

## Synopsis

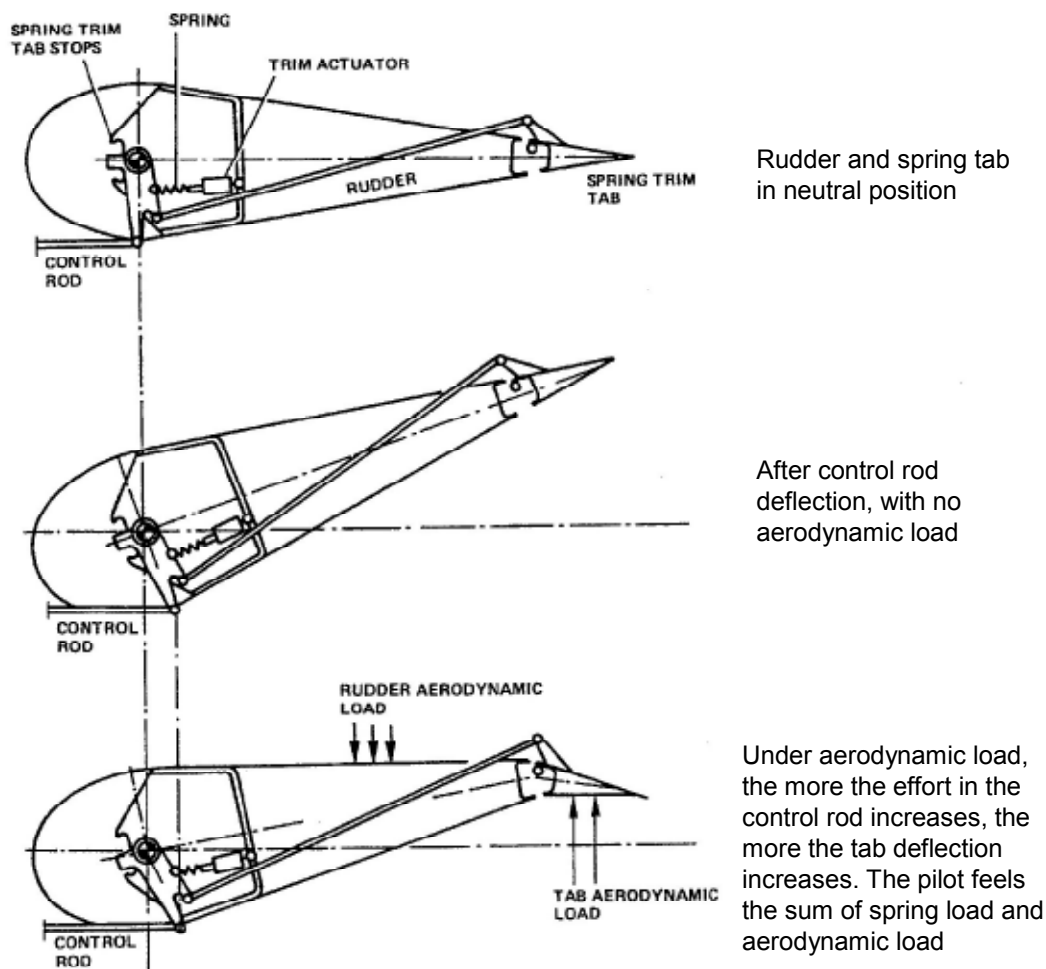
**Figure 2**

The ATR 42 is equipped with a manually operated primary flight control system, which is augmented in the roll axis by hydraulically operated spoilers. The pilots' rudder pedals are connected, via cables, to a spring-loaded servo tab on the rudder trailing edge. The principle of operation is shown in Figure 2. The rudder itself is connected to a Releasable Centring Unit (RCU, also referred to as the 'rudder cam'), the internal springs of which maintain a centring force (approximately 10 kg force at the rudder pedals) towards the trimmed

Schematic representation of rudder and spring tab operation

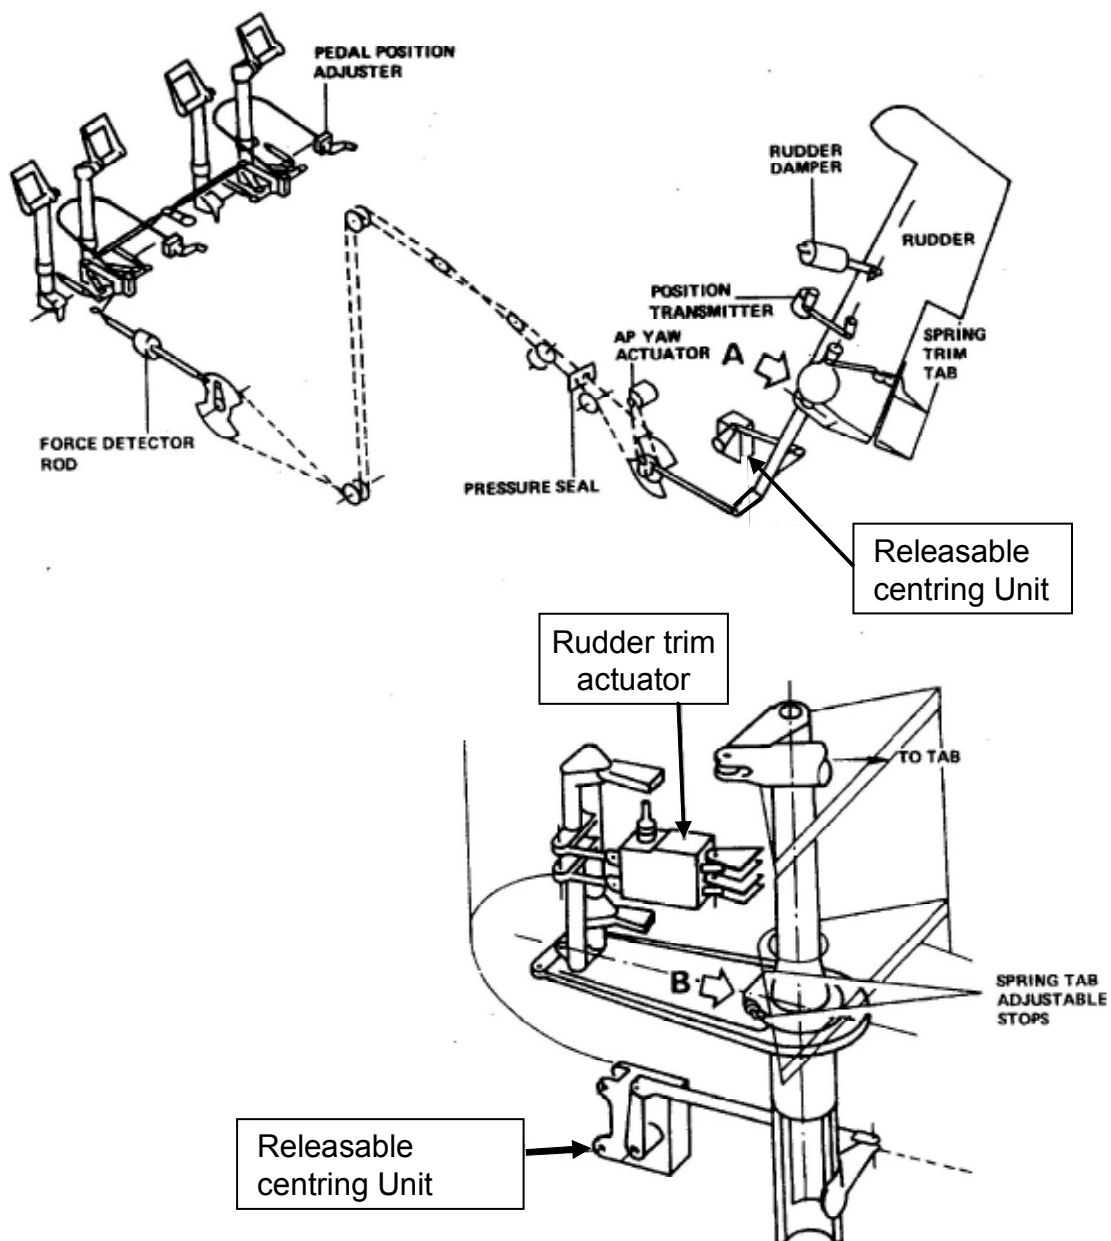
**Figure 3**

An electrically operated trim actuator acts on the same linkage and is controlled from the flight deck pedestal (Figure 3). The design of the rudder trim switch in the flight deck is such that a left or right trim demand also makes an electrical connection to an electromagnetic clutch within the RCU, causing it to release the rudder linkage, thus allowing it to centre on the new trimmed

Rudder system layout
