SERIOUS INCIDENT

Aircraft Type and Registration:	1) Boeing 737-800, EI-FJW 2) Airbus A320-214, OE-IVC
No & Type of Engines:	1) 2 CFM56-7B26E turbofan engines 2) 2 CFM56-5B4/3 turbofan engines
Year of Manufacture:	1) 2016 2) 2016
Date & Time (UTC):	13 August 2018 at 0948 hrs
Location:	Runway 06 at Edinburgh Airport
Type of Flight:	1) Commercial Air Transport (Passenger) 2) Commercial Air Transport (Passenger)
Persons on Board:	1) Crew - 7 Passengers - 159 2) Crew - 6 Passengers - 180
Injuries:	1) Crew - None Passengers - None 2) Crew - None Passengers - None
Nature of Damage:	1) None 2) None
Commander's Licence:	1) Airline Transport Pilots Licence 2) Airline Transport Pilots Licence
Commander's Age:	1) 42 years 2) 37 years
Commander's Flying Experience:	1) 6,800 hours (of which 6,650 were on type) Last 90 days - 160 hours Last 28 days - 30 hours 2) 10,000 hours (of which 9,000 were on type) Last 90 days - 200 hours Last 28 days - 70 hours

Synopsis

A landing Boeing 737 closed to within 875 m of a departing Airbus A320 when landing at Edinburgh Airport. The airport air traffic control service provider defined this as a runway incursion as the 737 was over the runway surface when th

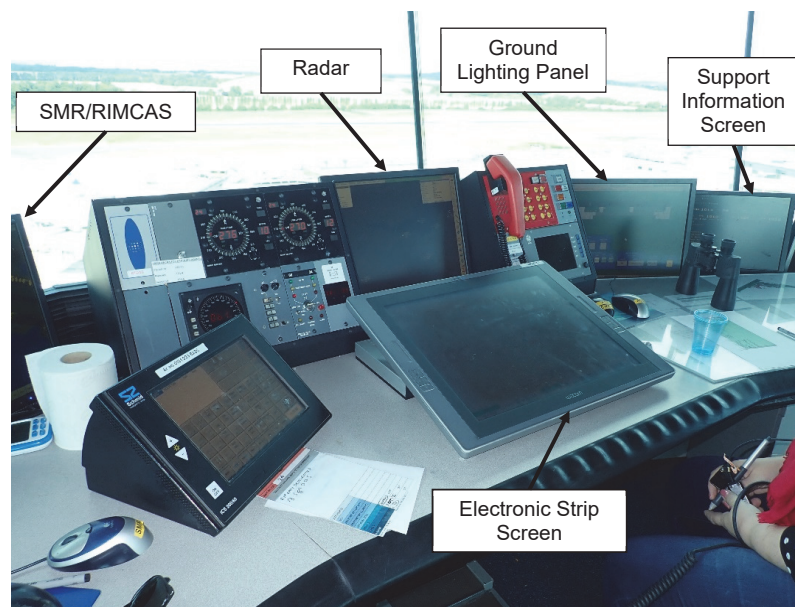
Tower controller's workstation at Edinburgh as viewed from the OJTI's approximate position

On a day with poor visibility and/or low cloud, less information is available out of the window and both the OJTI and the controller need to rely more on information presented on the screens. The design of the screens is such that there is not a good view of them from any position other than the controller's position. Therefore, the OJTI may need to be more active in changing positions to see the information they need to effectively monitor the trainee controller. Figure 8 illustrates the difficulty of seeing the information on the screens if not seated in the controller's position.

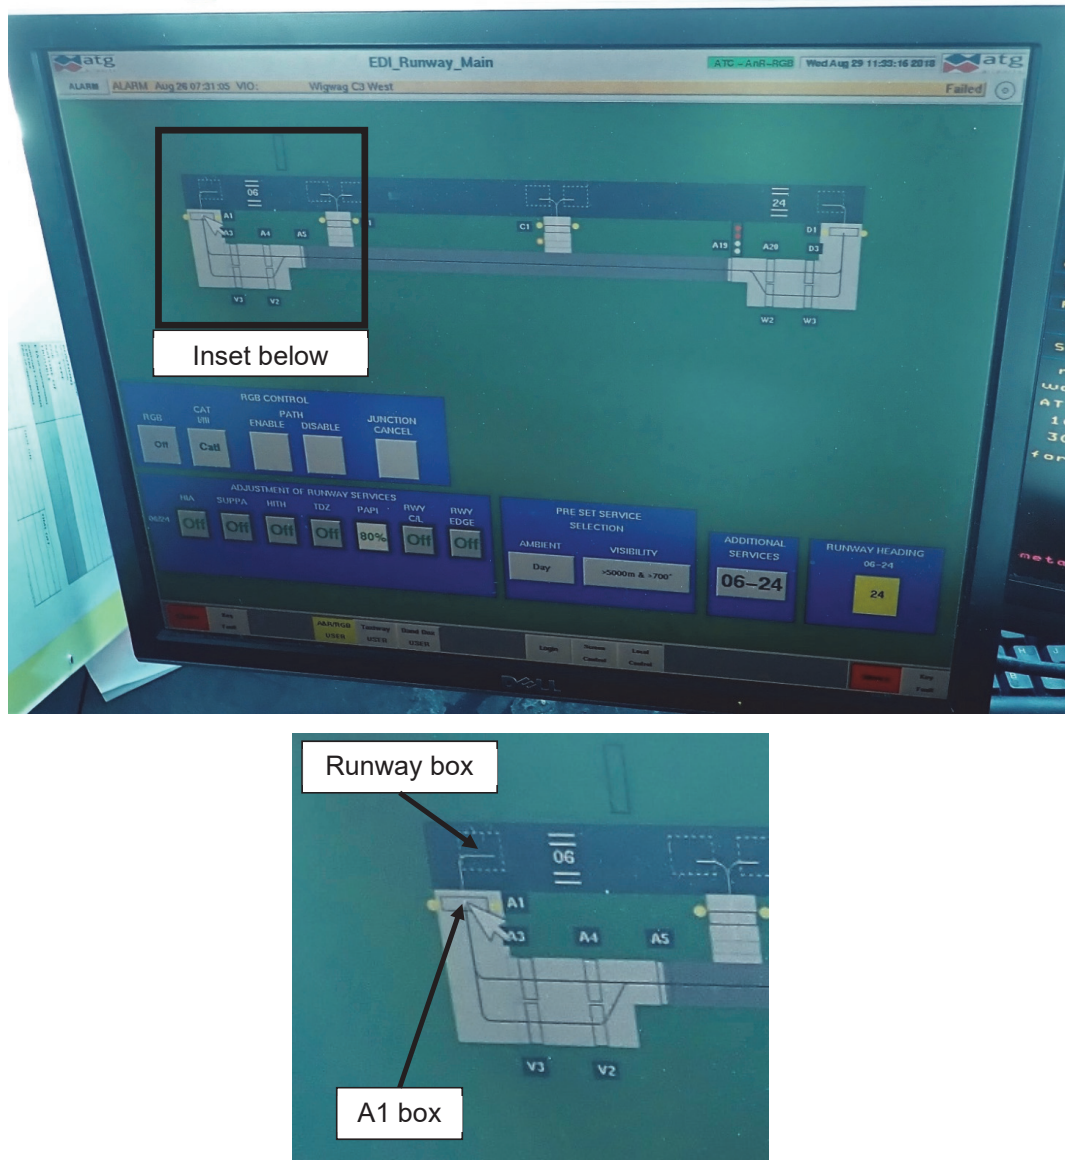
**Figure 11**

The lighting control panel is interactive. The controller selects different boxes on the screen using a mouse to turn on and off lights and change the intensity of some. Turning off the Stop Bar for the holding point A1 for Runway 06 requires the controller to click accurately inside the A1 box followed by a click in the box at the start of the runway.

Lighting control panel
