Final Report

IN-063/2019

Incident involving an AIRBUS A320-214, registration EI-IKL, operated by ALITALIA, and a BOEING B737-8AS, registration EI-ENN, operated by RYANAIR, 58 NM east-southeast (ESE) of the Madrid-Barajas Airport (SPAIN) on 7 September 2019

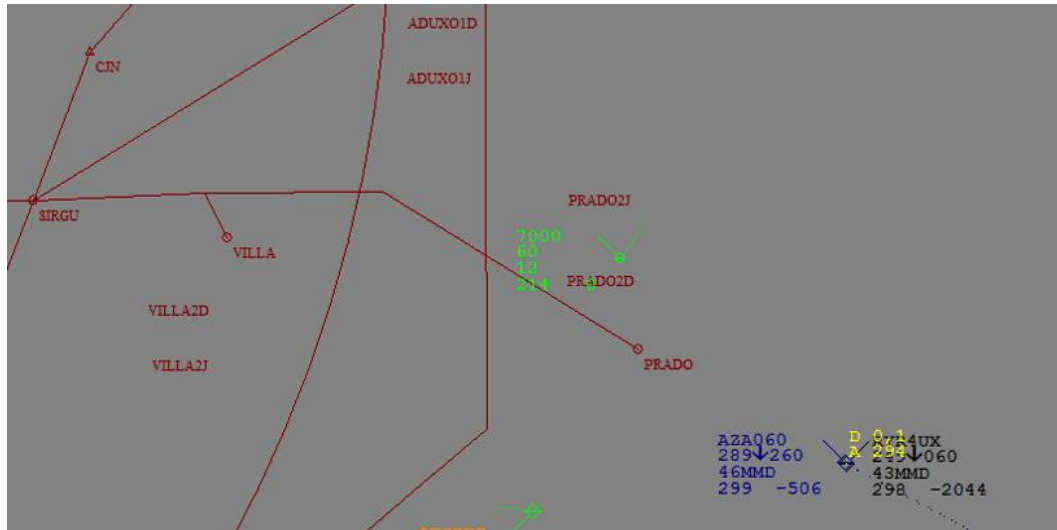
Fig. 3 Palestra image for 13:56:31

At this same time, AZA060 was on course to ASBIN point (IAF), descending through FL289 to FL260 at a rate of descent of -506 fpm. RYR4UX was 0.1 NM away, on course to PRADO point and descending through FL249 to 6000 ft at a rate of descent of -2044 fpm.

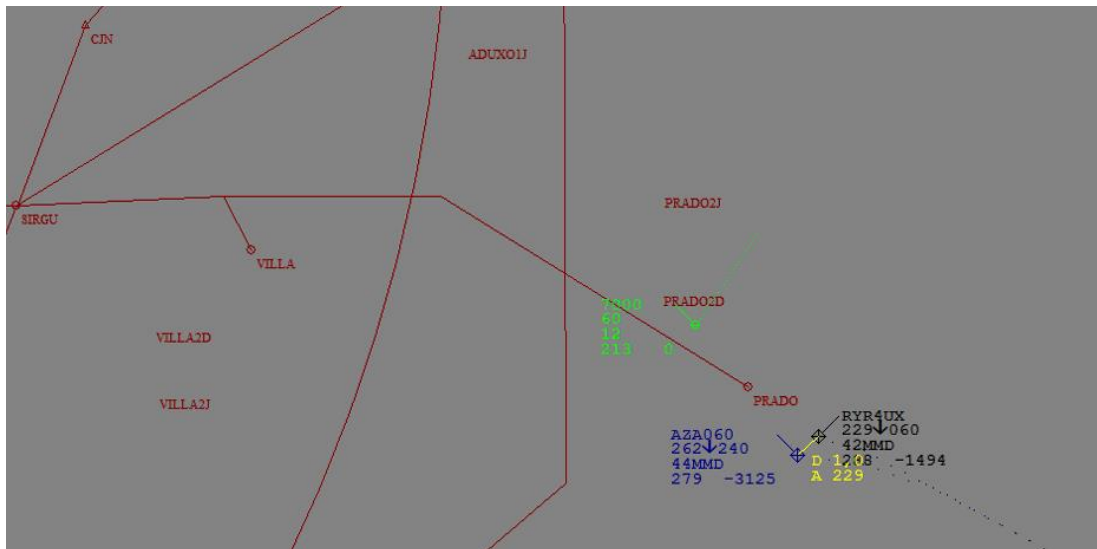
Fig. 4 Palestra image for 13:57:36

At the same time, AZA060 was on course to ASBIN point (IAF) at FL262 and descending to FL240 at a rate of descent of -3125 fpm. RYR4UX was 1.0 NM away, on course to the same point at FL229 and descending to 6000 ft at a rate of descent of -1494 fpm.

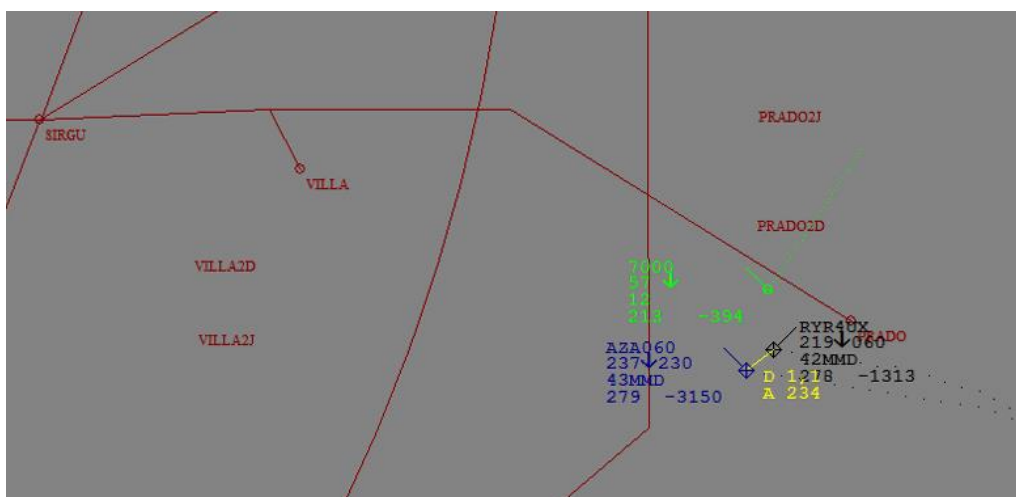
Fig. 5 Palestra image for 13:58:22

At 13:58:22, AZA060 was on course to ASBIN point (IAF) at FL237 and descending to FL230 at a rate of descent of -3150 fpm. RYR4UX was 1.1 NM away, on course to the same point at FL219 and descending to 6000 ft at a rate of descent of -1313 fpm.

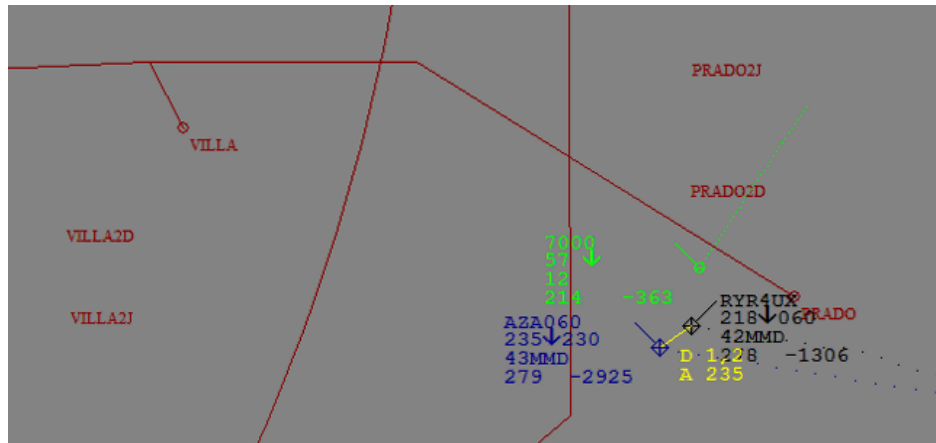
Fig. 6 Palestra image for 13:58:28

At 13:58:28, AZA060 was on course to ASBIN point (IAF) at FL235 and descending to FL230 at a rate of descent of -2925 fpm. RYR4UX was 1.2 NM away, on course to the same point at FL218 and descending to 6000 ft at a rate of descent of -1306 fpm.

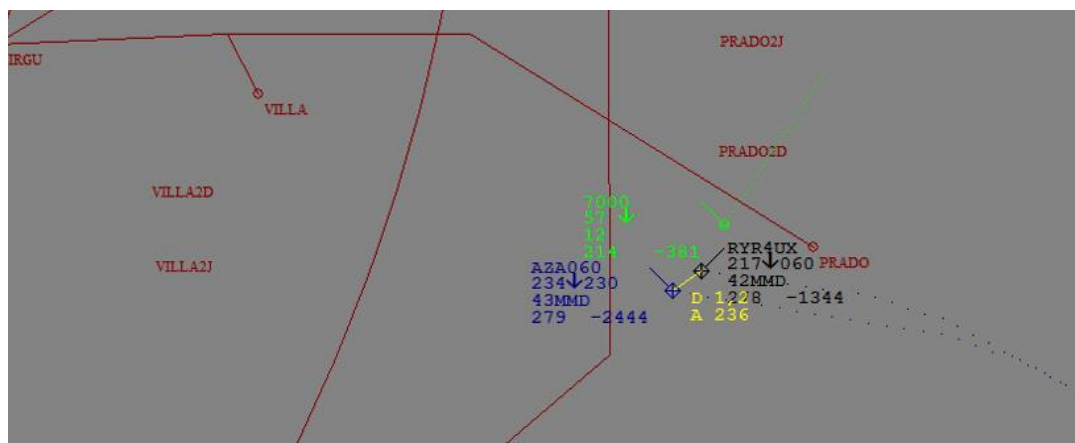
Fig. 7 Palestra image for 13:58:33

At the same time, AZA060 was en route to ASBIN point (IAF) at FL234 and descending to FL230 (note that the controller issued the instruction at this time, which is why CFL 140 had not yet been entered on the label) at a rate of descent of -2444 fpm. RYR4UX was 1.2 NM away, en route to the same point at FL217 and descending to 6000 ft at a rate of descent of -1344 fpm.

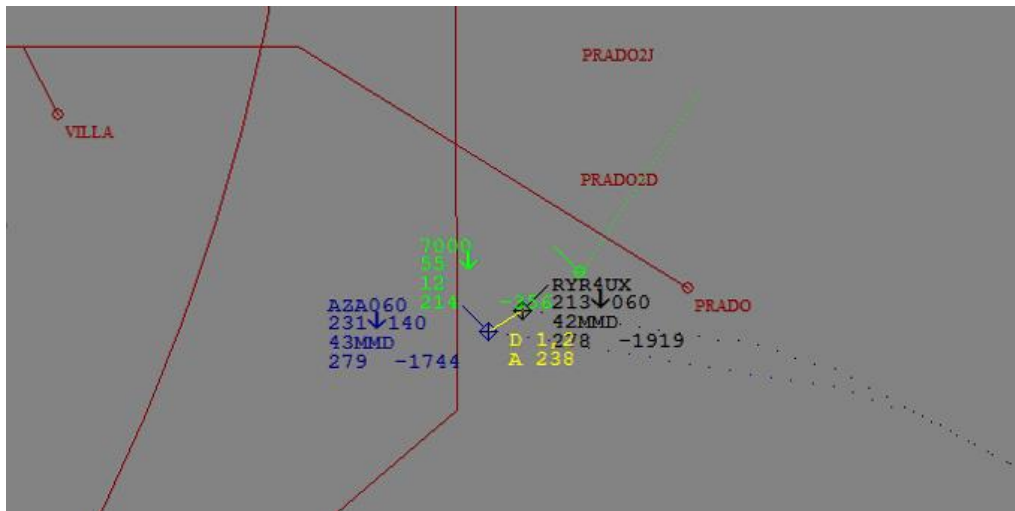
Fig. 8 Palestra image for 13:58:39

At 13:58:39, AZA060 was en route to ASBIN point (IAF) at FL231 and descending to FL140 at a rate of descent of -1744 fpm. RYR4UX was 1.2 NM away, en route to the same point at FL213 and descending to 6000 ft at a rate of descent of -1919 fpm.

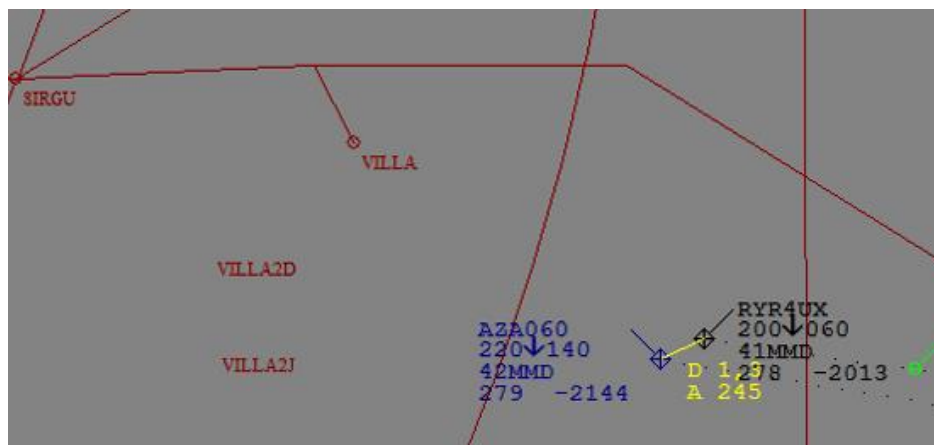
Fig. 9 Palestra image for 13:59:19

At the same time, AZA060 was en route to ASBIN point (IAF) at FL220 and descending to FL140 at a rate of descent of -2144 fpm. RYR4UX was 1.3 NM away, en route to the same point at FL200 and descending to 6000 ft at a rate of descent of -2013 fpm.

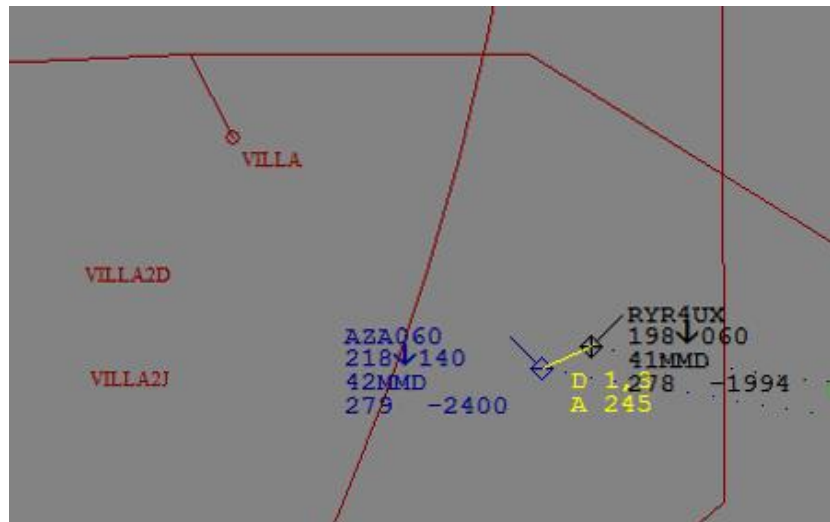
Fig. 10 Palestra image for 13:59:27

At the same time, AZA060 was en route to ASBIN point (IAF) at FL218 and descending to FL140 at a rate of descent of -2400 fpm. RYR4UX was 1.3 NM away, en route to the same point at FL198 and descending to 6000 ft at a rate of descent of -1994 fpm.

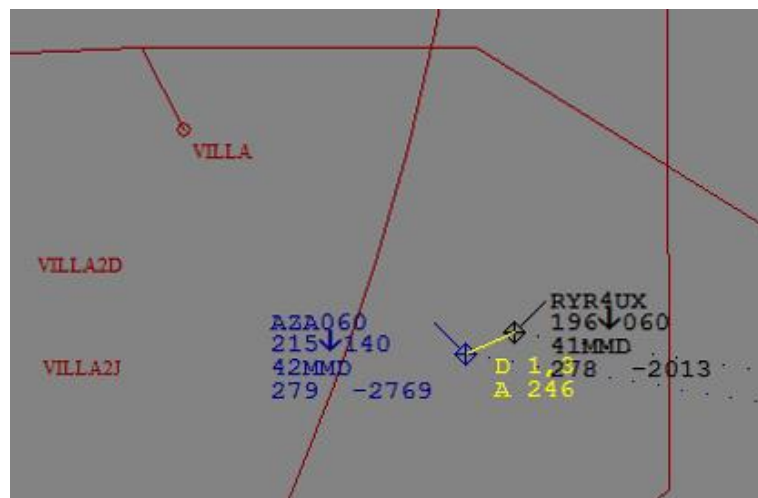
Fig. 11 Palestra image for 13:59:33

At the same time, AZA060 was en route to ASBIN point (IAF) at FL215 and descending to FL140 at a rate of descent of -2769 fpm. RYR4UX was 1.3 NM away, en route to the same point at FL196 and descending to 6000 ft at a rate of descent of -2013 fpm.

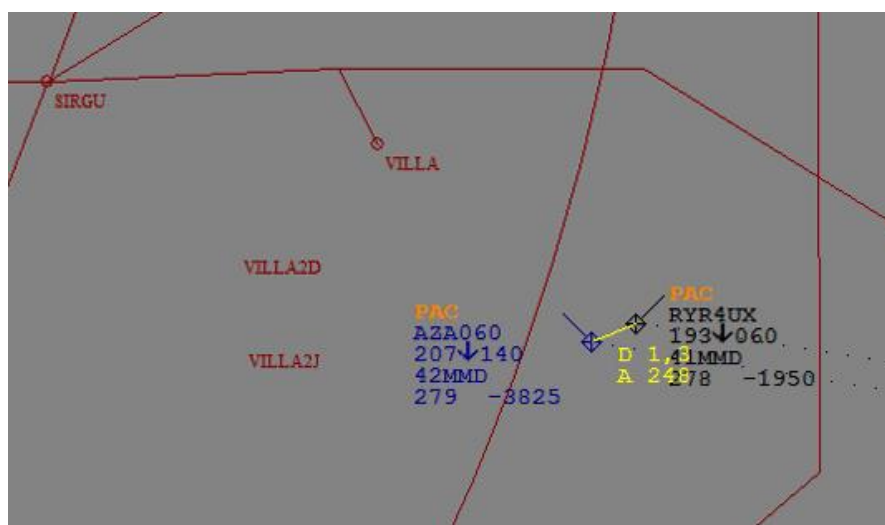
Fig. 13 Palestra image for 13:59:39

At 13:59:39, AZA060 was en route to ASBIN point (IAF) at FL207 and descending to FL140 at a rate of descent of -3825 fpm. RYR4UX was en route to the same point at FL193 and descending to 6000 ft at a rate of descent of -1950 fpm. The two aircraft were 1.3 NM and 1400 ft apart.

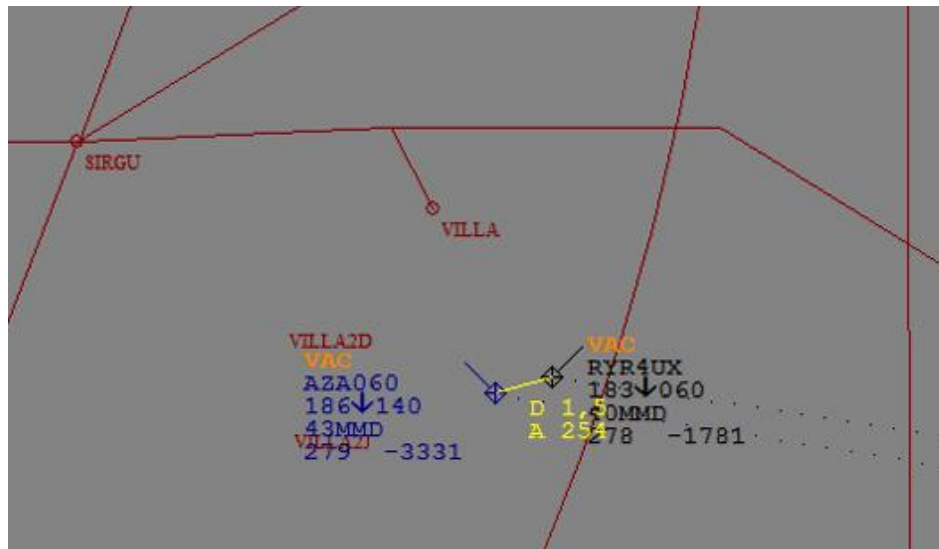
Fig. 16 Palestra image for 14:00:16

At 14:00:16, AZA060 was on course to ASBIN point (IAF) at FL186 and descending to FL140 at a rate of descent of -3331 fpm. RYR4UX was en route to the same point at FL183 and descending to 6000 ft at a rate of descent of -1781 fpm. At this time, the aircraft were 1.5 NM and 300 ft apart. The STCA-VAC alert remained active.

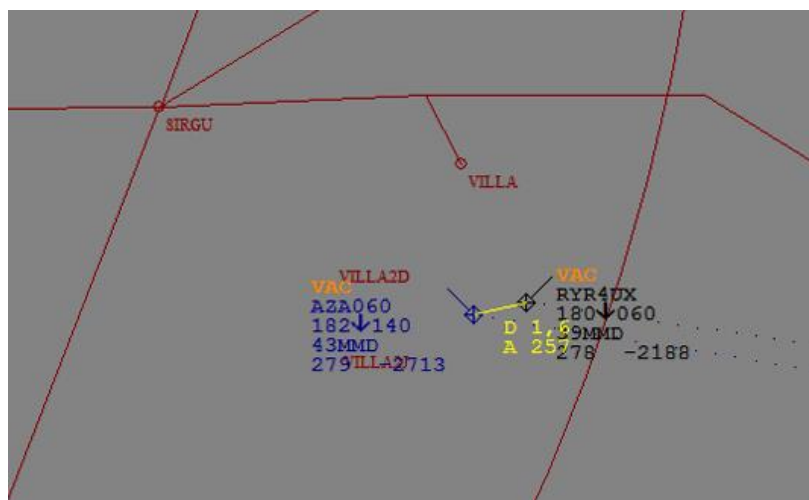
Fig. 17 Palestra image for 14:00:25

At 14:00:25, AZA060 was on course to ASBIN point (IAF) at FL182 and descending to FL140 at a rate of descent of -2713 fpm. RYR4UX was en route to the same point at FL180 and descending to 6000 ft at a rate of descent of -2188 fpm. At this time, the aircraft were 1.6 NM and 200 ft apart. The STCA-VAC alert remained active.

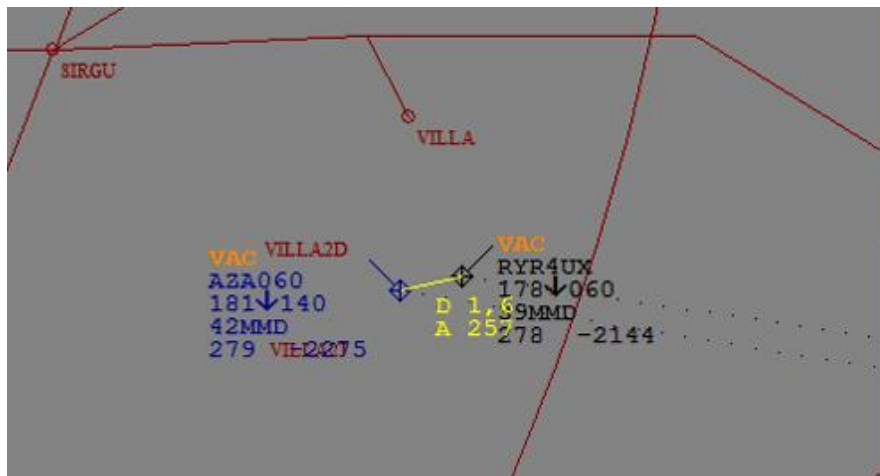
Fig. 18 Palestra image for 14:00:30

At the same time, AZA060 was en route to ASBIN point (IAF) at FL181 and descending to FL140 at a rate of descent of -2275 fpm. RYR4UX was en route to the same point at FL178

and descending to 6000 ft at a rate of descent of -2144 fpm. At this time, the aircraft were 1.6 NM and 300 ft apart. The STCA-VAC alert remained active.

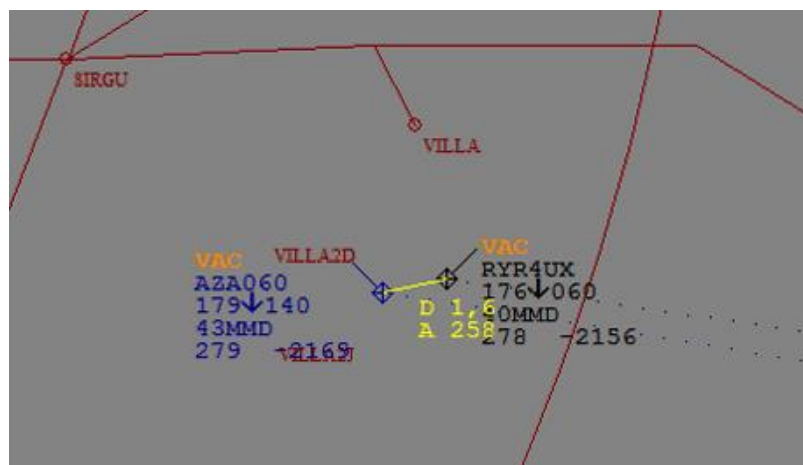
Fig. 19 Palestra image for 14:00:35

At the same time, AZA060 was en route to ASBIN point (IAF) at FL179 and descending to FL140 (note that the CFL had not been entered yet into the label) at a rate of descent of -2169 fpm. RYR4UX was en route to the same point at FL176 and descending to 6000 ft at a rate of descent of -2156 fpm. At this time, the aircraft were 1.6 NM and 300 ft apart. The STCA-VAC alert remained active.

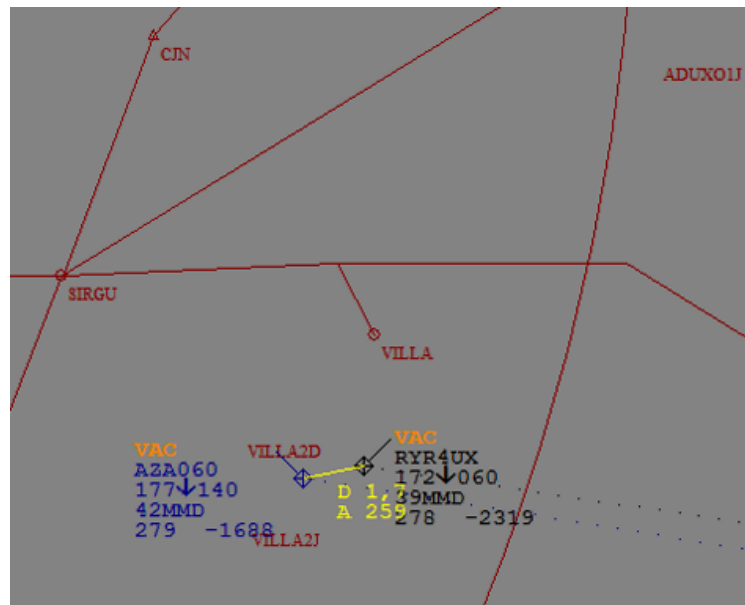
Fig. 20 Palestra image for 14:00:45

At 14:00:45, AZA060 was en route to ASBIN point (IAF) at FL177 and descending to FL140 (note that the controller had started issuing the clearance one second earlier, which is why CFL 170 had not yet been entered into the label) at a rate of descent of -1688 fpm. RYR4UX was en route to the same point at FL172 and descending to 6000 ft at a rate of descent of

-2319 fpm. At this time, the aircraft were 1.7 NM and 500 ft apart. The STCA-VAC alert remained active.

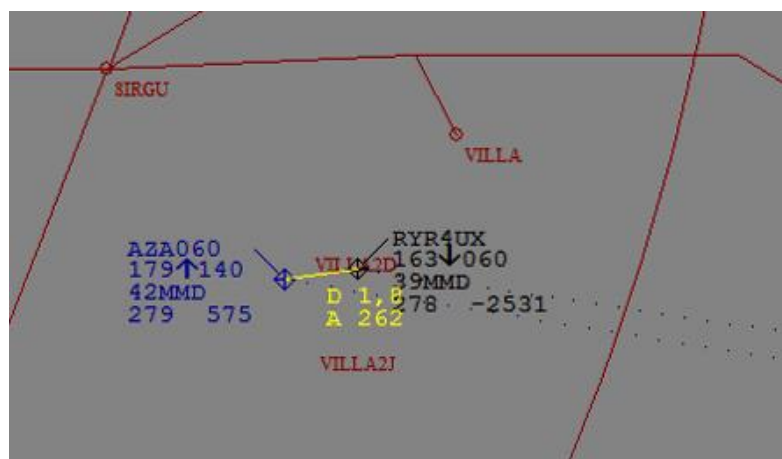
Fig. 21 Palestra image for 14:01:05

At 14:01:05, AZA060 was on course to ASBIN point (IAF) and cleared to descend to FL170 (note that CFL 170 had not yet been entered into the label). It began climbing through FL179 at a rate of climb of +575 fpm. RJR4UX was en route to the same point at FL163 and descending to 6000 ft at a rate of descent of -2531 fpm.

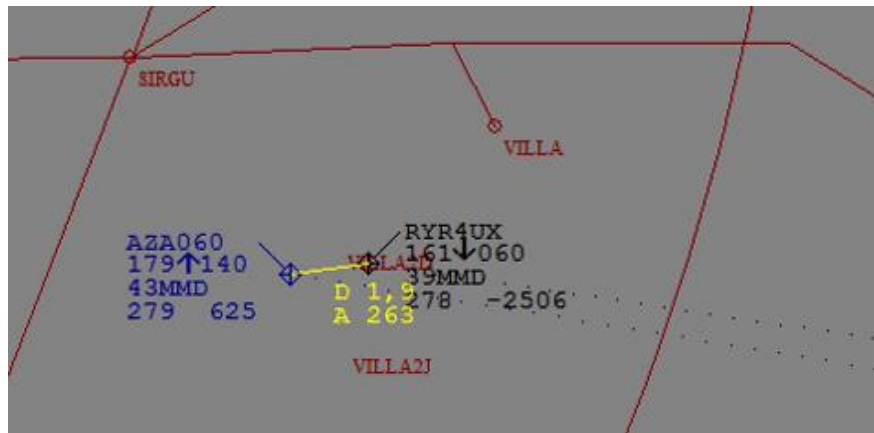
Fig. 22 Palestra image for 14:01:10

At the same time, AZA060 was en route to ASBIN point (IAF) still at FL179 and cleared to descend to FL170 (note that CFL 170 had not been entered yet into the label) at a rate of

climb of +625 fpm. RYR4UX was en route to the same point at FL161 and descending to 6000 ft at a rate of descent of -2506 fpm.

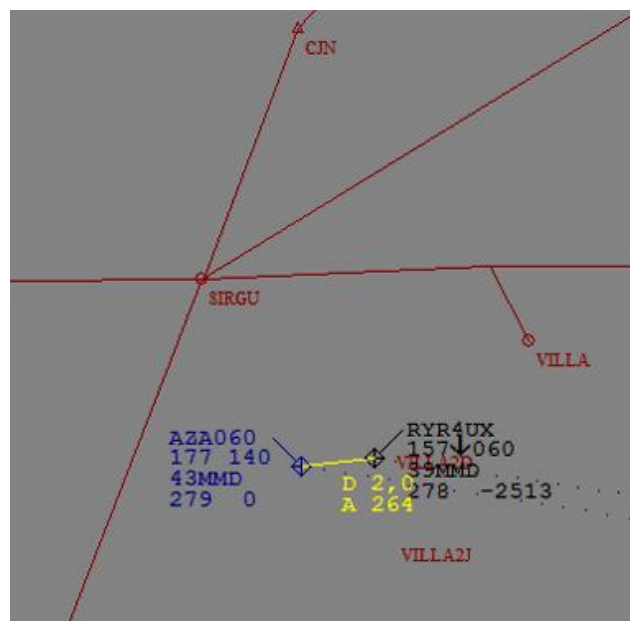
Fig. 23 Palestra image for 14:01:22

At the same time, AZA060 was en route to ASBIN point (IAF) again descending through FL177 at a zero rate of descent and cleared to descend to FL170 (note that CFL 170 had not yet been entered into the label). RYR4UX was en route to the same point at FL157 and descending to 6000 ft at a rate of descent of -2513 fpm.

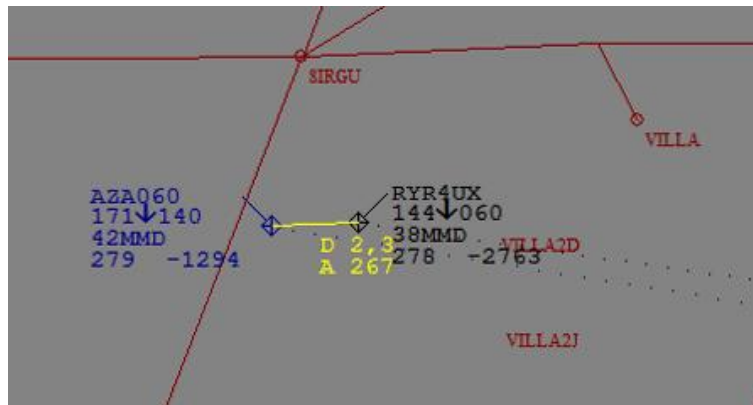
Fig. 24 Palestra image for 14:01:54

At the same time, AZA060 was on course to ASBIN point (IAF) at FL171 and descending to FL140 at a rate of descent of -1294 fpm. RYR4UX was en route to the same point at FL144 and descending to 6000 ft at a rate of descent of -2763 fpm.

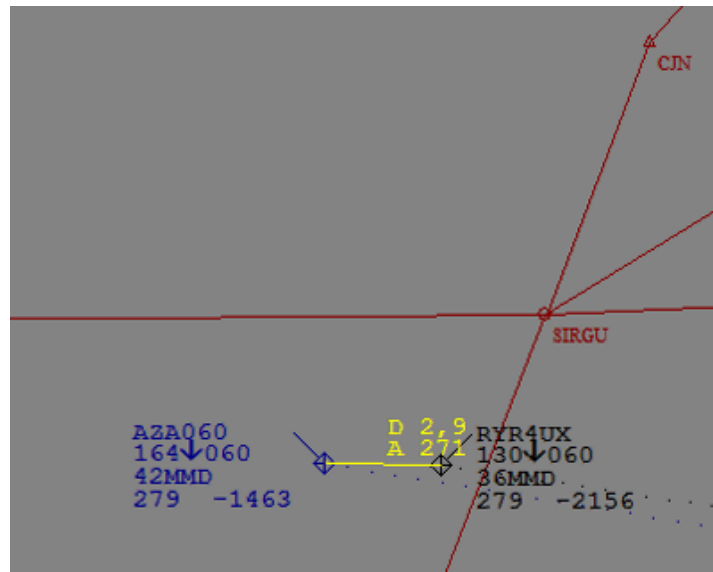
Fig. 25 Palestra image for 14:02:33

At 14:02:33, AZA060 was en route to ASBIN point (IAF) at FL164 and descending to 6000 ft at a rate of descent of -1463 fpm. RYR4UX was en route to the same point at FL130 and descending to 6000 ft at a rate of descent of -2156 fpm.
