*Accident
which occurred
on 30 January 2000
in the sea near Abidjan Airport
to the Airbus 310-304
registered 5Y-BEN
operated by Kenya Airways*

REPORT

This report presents the conclusions of the Commission of Inquiry on the circumstances and causes of the accident that occurred on 30 January 2000 in the sea near Abidjan airport to the Airbus 310-304 registered 5Y-BEN operated by KENYA AIRWAYS, which was undertaking the Abidjan - Lagos -Nairobi flight KQ 431.

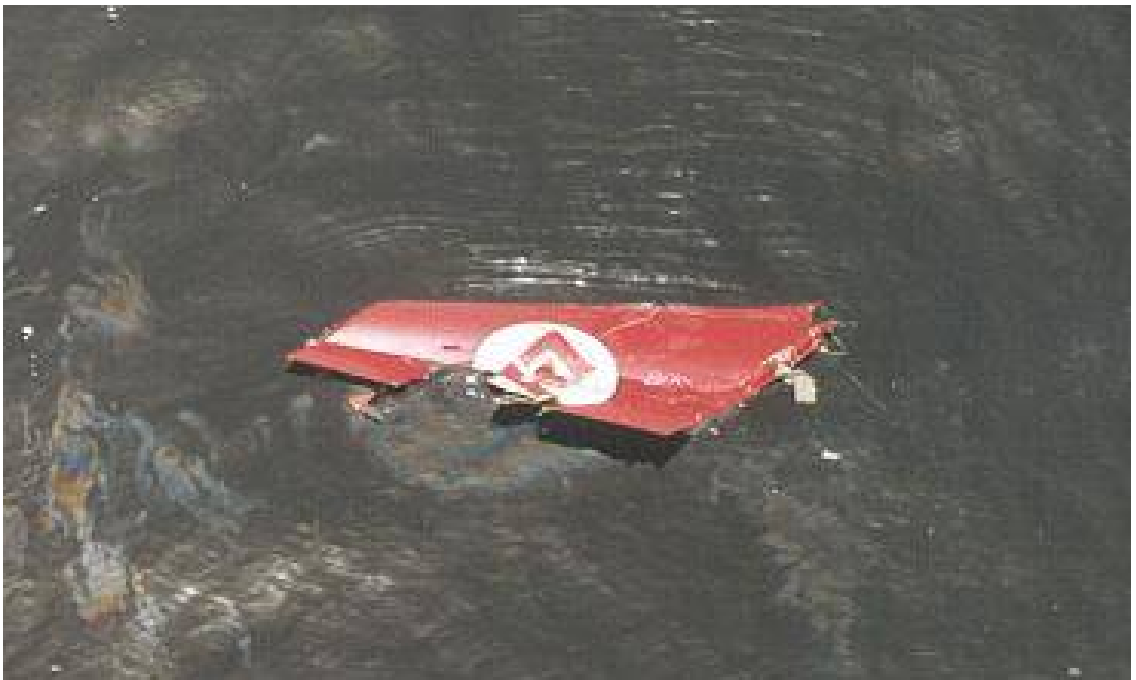
ANNEXE 9
PHOTOGRAPHIE DE QUELQUES DEBRIS RECUPERES EN SURFACE ET
SUR LA PLAGE OU OBSERVES SOUS LA MER

Dérive

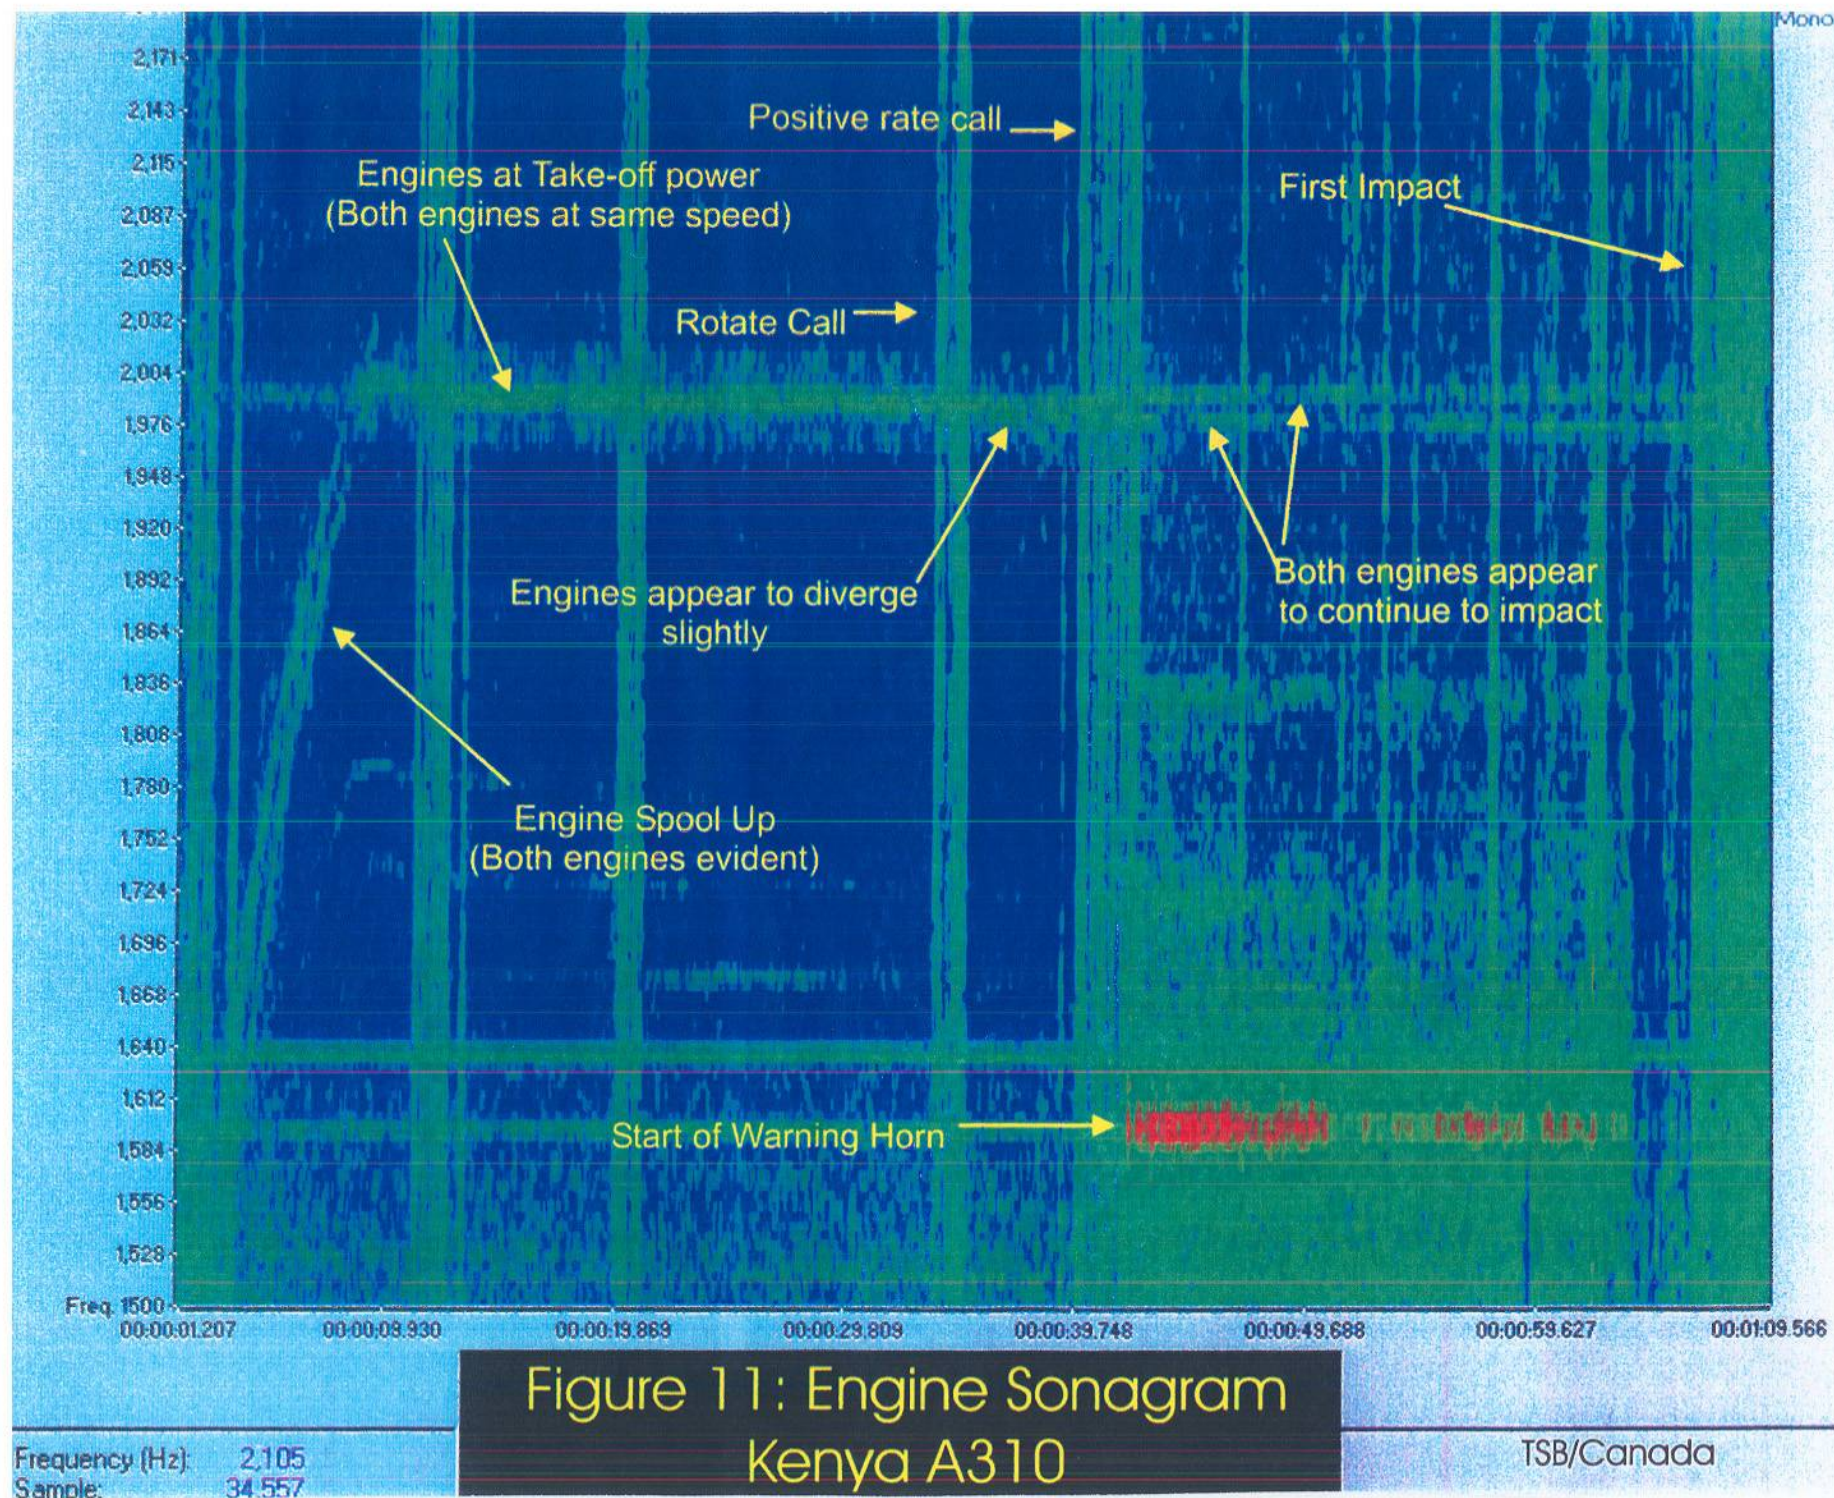
Figure 12: Auto Altitude Call Outs

The auto altitude call outs recorded during the final 16 seconds of the take-off were plotted as a function of time from the start of engine spool-up (Appendix C, Figure 12). A mathematical smoothing algorithm was applied to the data, which was then differentiated to provide an indication of the vertical rate of climb. The CVR recording indicated that there was a change from a positive to a negative rate of climb at some point following the stall warning activation. The derived vertical rate suggests that the rate of descent exceeded 1,000 feet/min, and that a recovery was possibly initiated, as suggested by an apparent reduction in the rate of descent, during the final 10 seconds of the flight.
