### Final report on aircraft serious incident

Case no.: **18-104F018**

Date: **16. June 2018**

Description: **Foreign Object Damage**

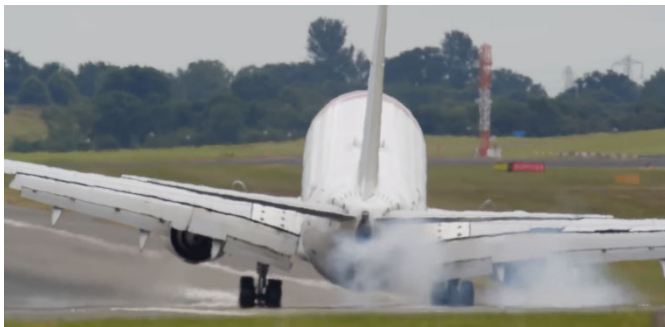
**Figure 2: The landing (RH MLG) at Birmingham Airport**

When the aircraft landed, it first landed on the RH MLG as the Commander had intended

before it also came down on the LH MLG followed by the NLG. During the landing, the left wing ground spoilers did not deploy. In addition tire debris was released from the LH MLG after it touched down on the runway.

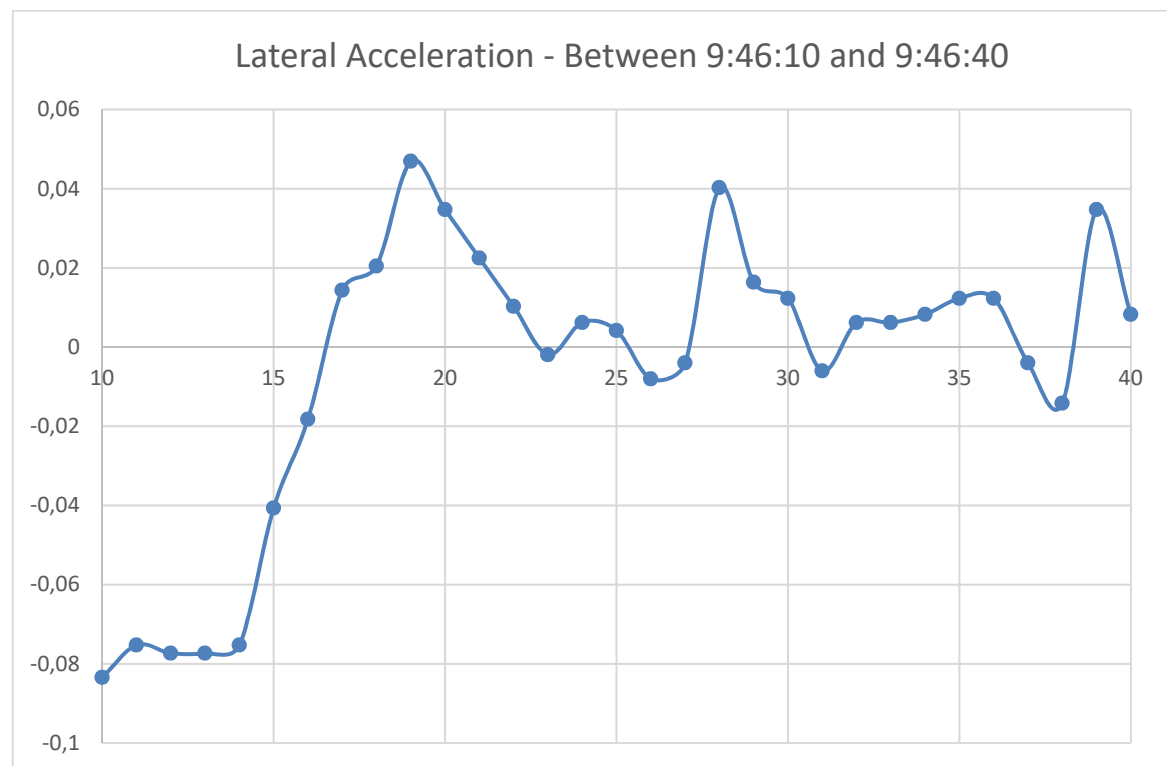
**Figure 12: The lateral acceleration of the aircraft during the takeoff run**

As the ITSB was interested in any unusual movement during the takeoff run the lateral acceleration of the aircraft was graphed over the takeoff run. Lateral acceleration peaks were noted as can be seen on the graph in Figure 12.

Weather data around the time of the takeoff period of the aircraft was investigated. The wind was very light (< 10 m/sec) in the area and it is unlikely to have caused the fluctuations in the lateral acceleration during the takeoff run of the aircraft.
