***Final report RL 2012:20e***

**Serious incident involving the aircraft EI-DAD  
at Skavsta Airport, Södermanland county,  
on 25 April 2011**

Case L-30/11

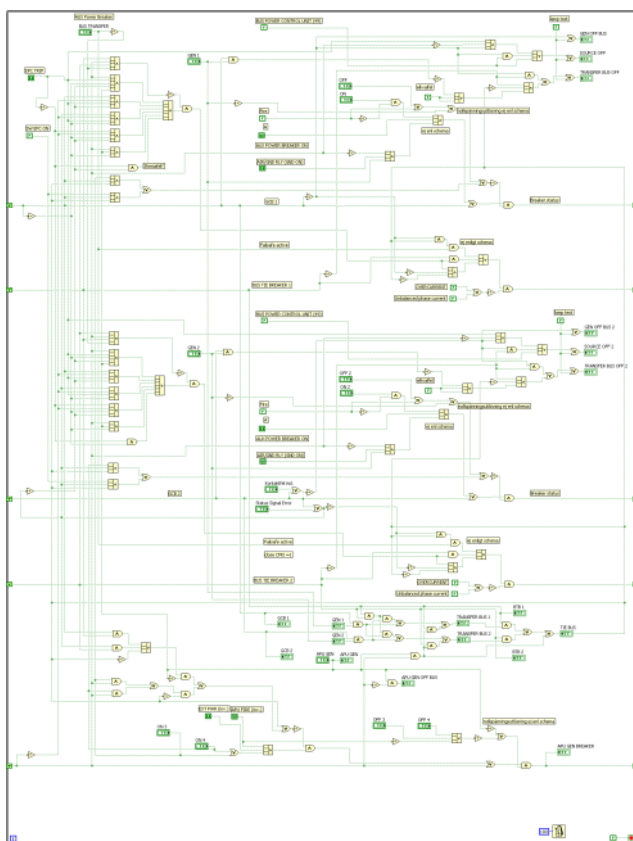
Fig. 18. Parts of code for the program for simulation of the electrical system.

The program was written in LabView, a graphical programming language that suits the purpose very well. All relevant components were programmed, where values of the inputs and outputs could be set arbitrarily. During the programming, WDM<sup>31</sup>, upon which the program was to a great extent based, was found to contain faults which meant that gates turned the wrong way. The function of the units with the gates turned the wrong way differed from what was described in AMM<sup>32</sup>. During a test run of the program, this did not work at all as it had been coded in exact accordance with WDM. When the gates were turned the “right” way, the program functioned correctly in accordance with the intended description in WDM and according to AMM. In order to provide an overview of parts of the program code, this is shown in Figure 18.

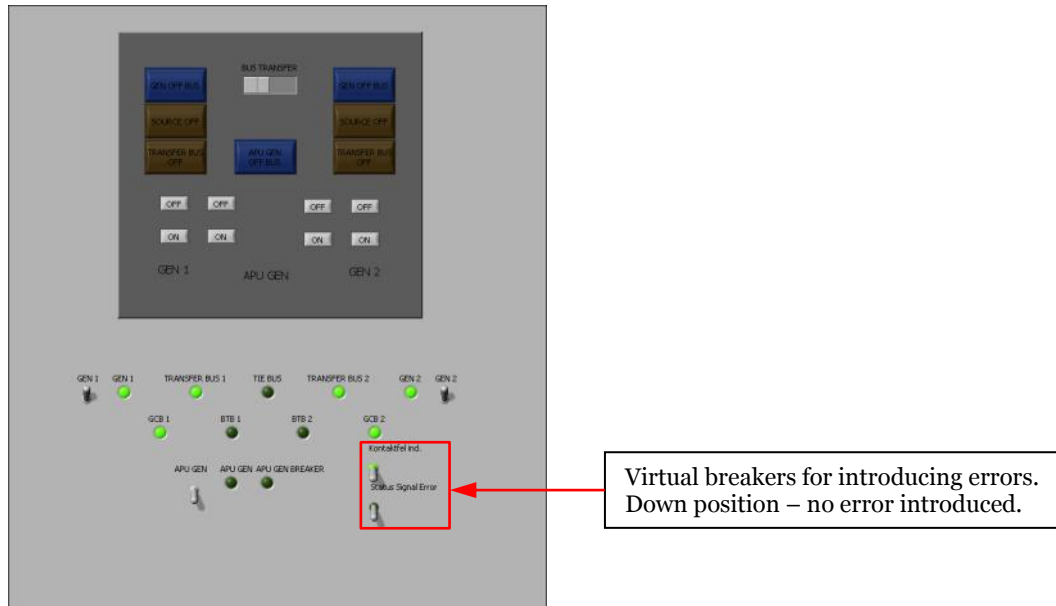
Fig. 19. GUI for the program for simulation of the electrical system of the Boeing 737-800

The GUI has a structure of virtual switches and indicator lamps – see Figure 19. On the GUI, it is also possible to introduce faults in status signals. Green indicator lights show parts powered by 115 V alternating current.

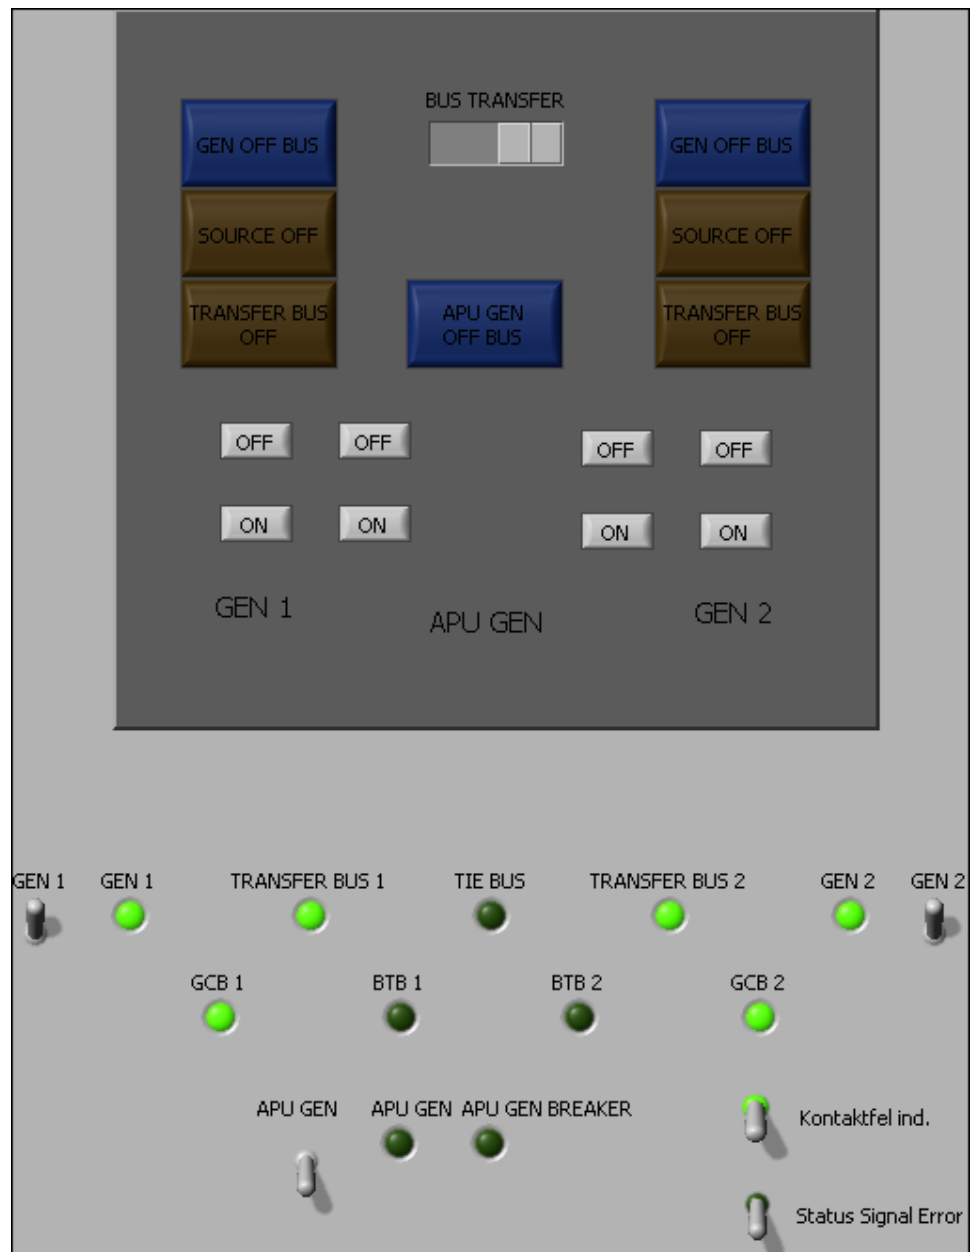
Fig. 21. GUI showing normal operating conditions.

Simulation of the incident with erroneous status signals from GCB2 is shown by means of FOI's program in Figures 21 – 25. The green “lights” indicate that 115 V alternating current is flowing through the unit. It is also shown here that APU too will not be able to be connected, and the symptoms are the same. It is also worth noting that this latent fault manifests when there is an initial “trigger-fault”.
