# **Air Accident Investigation Unit Ireland**

**FORMAL REPORT  
APPENDICES**

**ACCIDENT  
Sikorsky S-92A, EI-ICR  
Black Rock, Co. Mayo, Ireland  
14 March 2017**

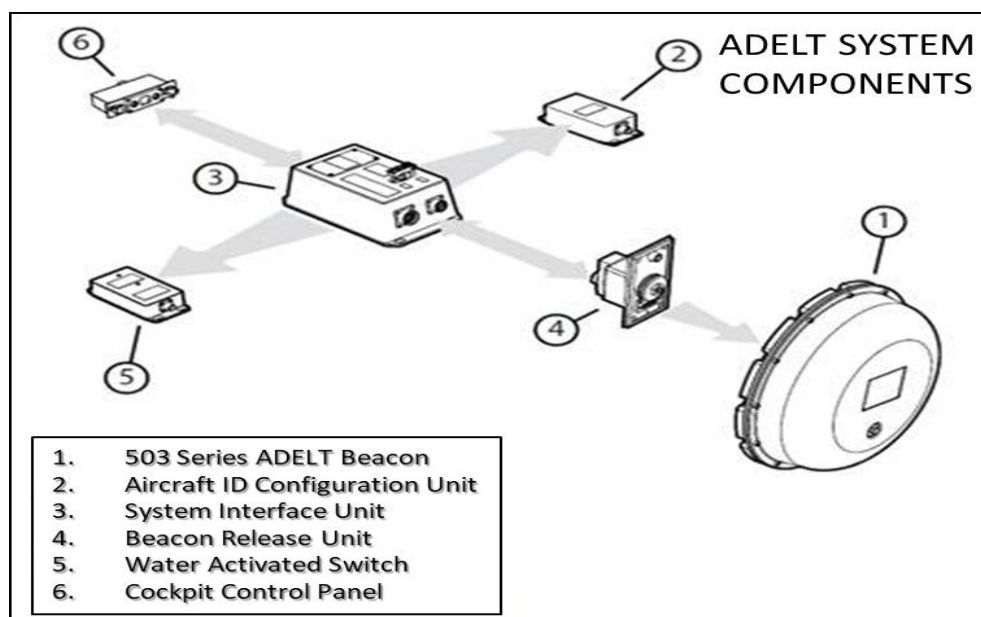
**Figure No. B1:** The main components of the ADELT System

The Manufacturer informed the Investigation that based on the damage to the ADEL baseplate shown in AAIU Preliminary Report 2017-006, *'The beacon itself would most certainly not continue to function in this condition.'*

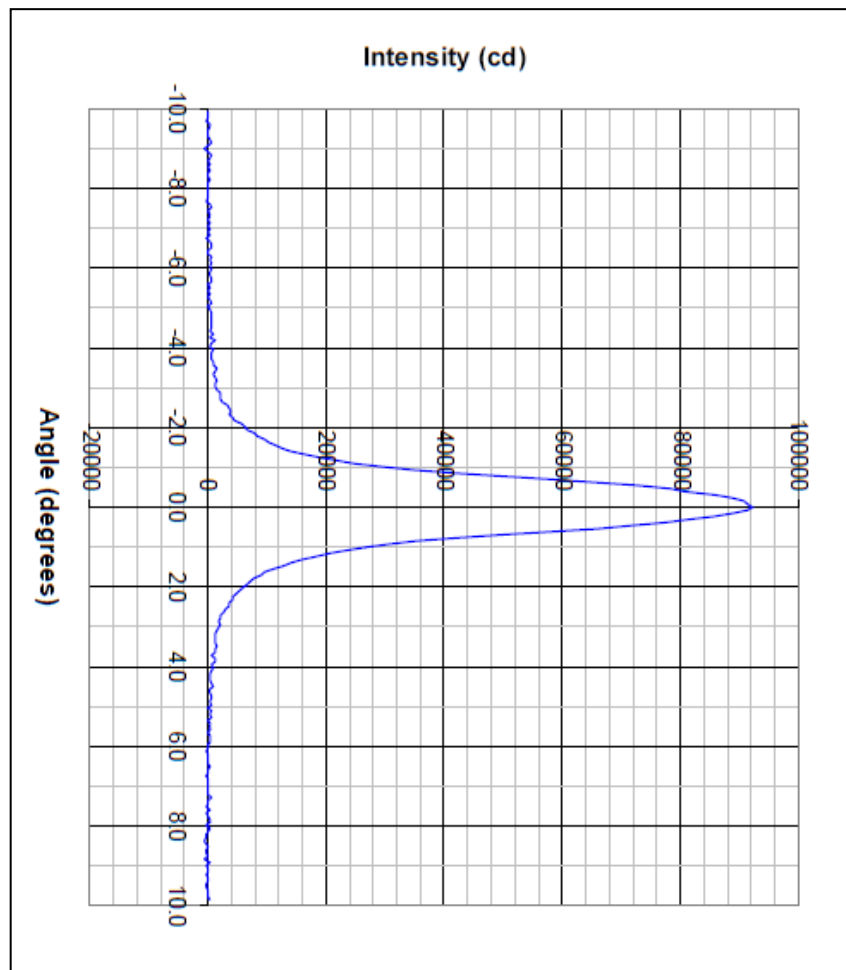
**Figure No. V2:** Vertical Beam Profile

Tests on the Vertical Beam Profile of a 35W lamp in the TRB-220 is shown in **Figure No. V2** below. The peak intensity of 92,000cd (candelas) calculates to an 'Effective Intensity' of 55,200cd at a flash length of 0.3 seconds, which is an 18 NM light according to IALA figures (49,000cd – 73,000cd = 18 NM range).

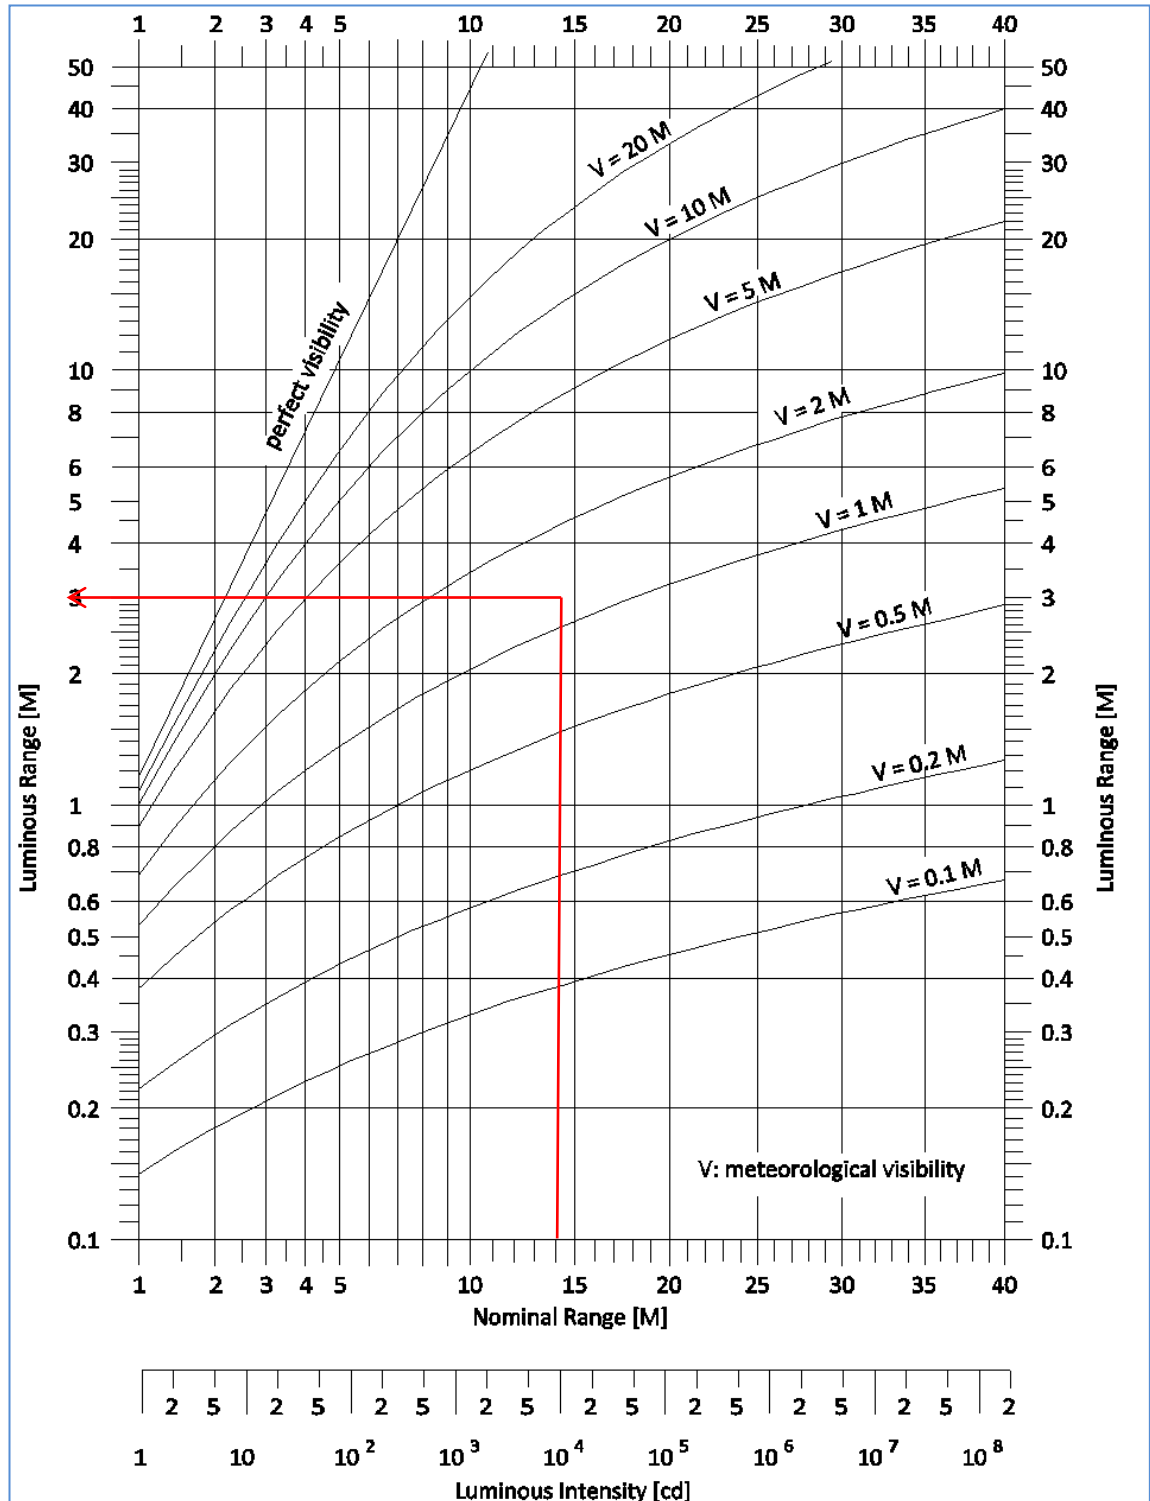
**Figure No. V3:** Luminous Range Diagram

The local visibility on 14 March 2017 @ 00.45 UTC is noted as being 2-3 km (1 – 1.6 NM) with mist and drizzle. **Figure No. V3:** shows that a light of 18 NM **nominal range** will only have **luminous range** of approximately 3 NM when the meteorological visibility is 1 NM (poor visibility).
