# **Air Accident Investigation Unit Ireland**

**FACTUAL REPORT**

**PESZKE S.C. GP-14-SE VELO, OM-M821  
Gowran Grange Airfield, Co. Kildare**

**27 March 2019**

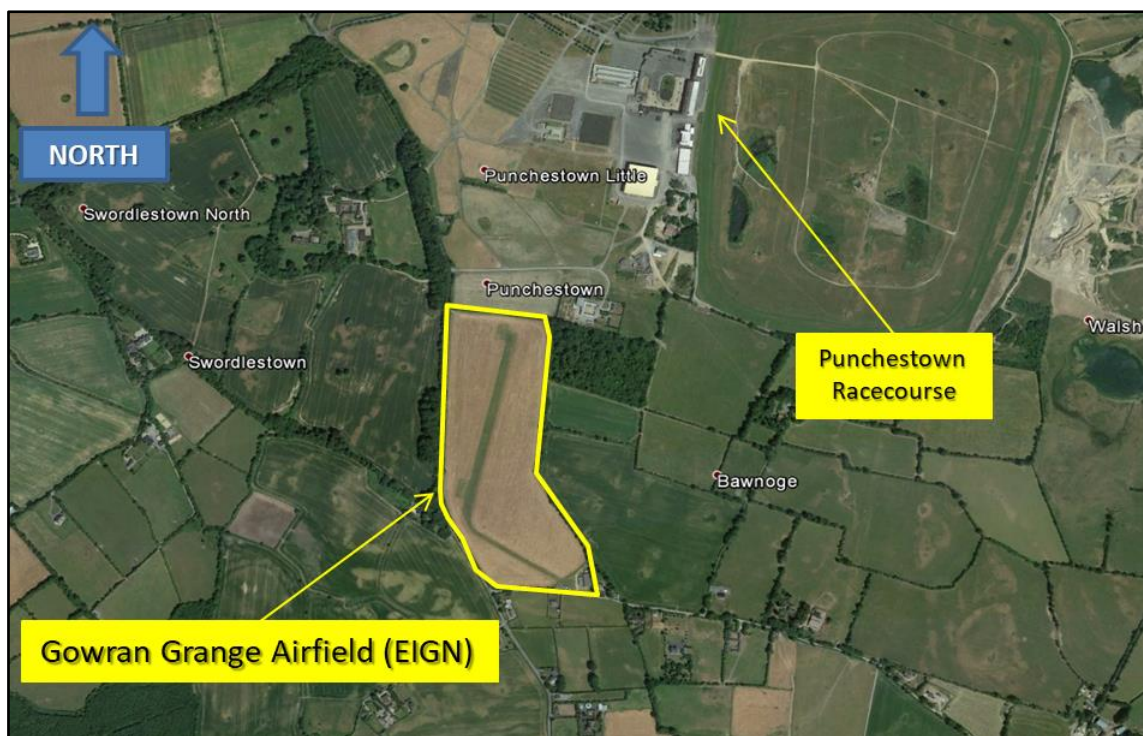
**Figure No. 1:** Aerial view of Gowran Grange Airfield (Google)

Gowran Grange Airfield (EIGN) is located one kilometre south-west of Punchestown Racecourse in County Kildare (**Figure No. 1**). The airfield is used exclusively by a local Gliding Club for both recreational and training flights in gliders. The main grass runway is orientated along a magnetic bearing of 030°/210° and is designated as RWY 03/21. RWY 03 is 475 metres (m) in length and has an uphill slope. The runway surface is uneven in areas along its length as illustrated in **Figure No. 2**.

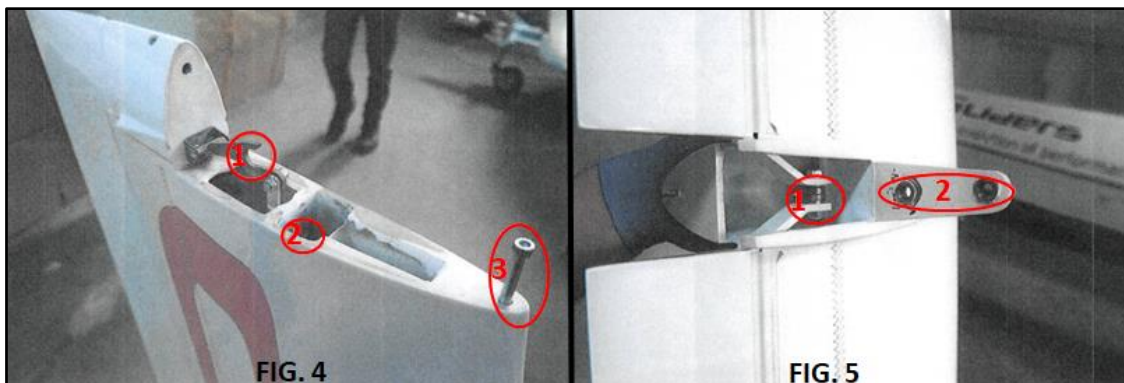
**Figure No. 3: 'Rigging Instructions and Tips'**  
(Source: Adapted from Glider Manufacturer's Document)

The glider was supplied to the Pilot by the Manufacturer with general documentation for operation. One such document was titled, '*Rigging<sup>5</sup> Instructions and Tips*'. The instructions contained a bulleted list of items to check during installation of the '*Wings*' and '*Horizontal Tailplane*'. Instructions referring to the assembly of the horizontal tailplane along with two related figures (FIG. 4 & FIG. 5) are presented in **Figure No. 3** below. For clarity, FIG. 5 -1 relates to item number 1 in the Glider Manufacturer's FIG 5 etc.

1. *Make sure the stick is in neutral position*
2. *Slide the bearing on elevator lever (FIG. 5 -1) into hook (FIG. 4 -1) and tongue with bushings (FIG. 5 – 2) onto positioning pins (FIG. 4 -2)*
3. *Make sure the stabilizer is in proper position and control system is correctly connected*
4. *Secure the stabilizer with tightening the bolt from the top (FIG. 4 -3)*
5. *Test the proper function of elevator and other control systems*

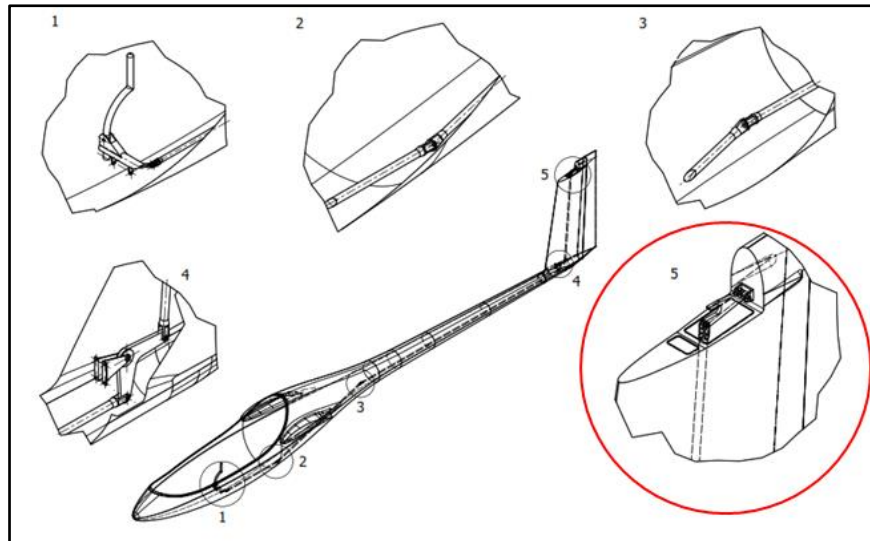
**Figure No. 4:** Elevator control system assembly  
(Source: Adapted from Glider Manufacturer's Construction Drawings)

The Glider Manufacturer informed the Investigation that the elevator control system assembly on the glider is operated ‘... via rigid carbon pull-push rods and levers. The carbon tubes are finished with duralumin<sup>6</sup> joints with steel swinging bearings and bolts’. **Figure No. 4** identifies the five main connection points along the elevator control run system.

Item 5, which is circled in **Figure No. 4**, identifies the mating area for the installation of the glider's detachable horizontal tailplane. This area is shown in more detail in **Figure No. 5** where the correct and incorrect installation of the horizontal tailplane, which incorporates the elevator (identified in red), is shown.

An elevator control rod (Refer to **Figure No.4**, Connection Points 1-2), which runs along the left side of the cockpit under some panelling, was found to be fractured at the carbon fibre torque tube attachment horn area. The point of failure was observed as the threaded portion of an eye-end, which connects the control rod to the carbon fibre attachment horn. In addition, the carbon fibre attachment horn itself was also found to have failed at its root area.
