DEPARTMENT OF TRANSPORT AND POWER

A.A.P. No. 4

**ACCIDENT TO  
VISCOUNT 803 AIRCRAFT EI-AOF  
NEAR ASHBOURNE, Co. MEATH.  
ON 22nd. JUNE, 1967**

REPORT ON AN INVESTIGATION  
MADE UNDER REGULATION 7 OF THE  
AIR NAVIGATION (INVESTIGATION OF ACCIDENTS)  
REGULATIONS, 1957 (S.I. No.19 of 1957)

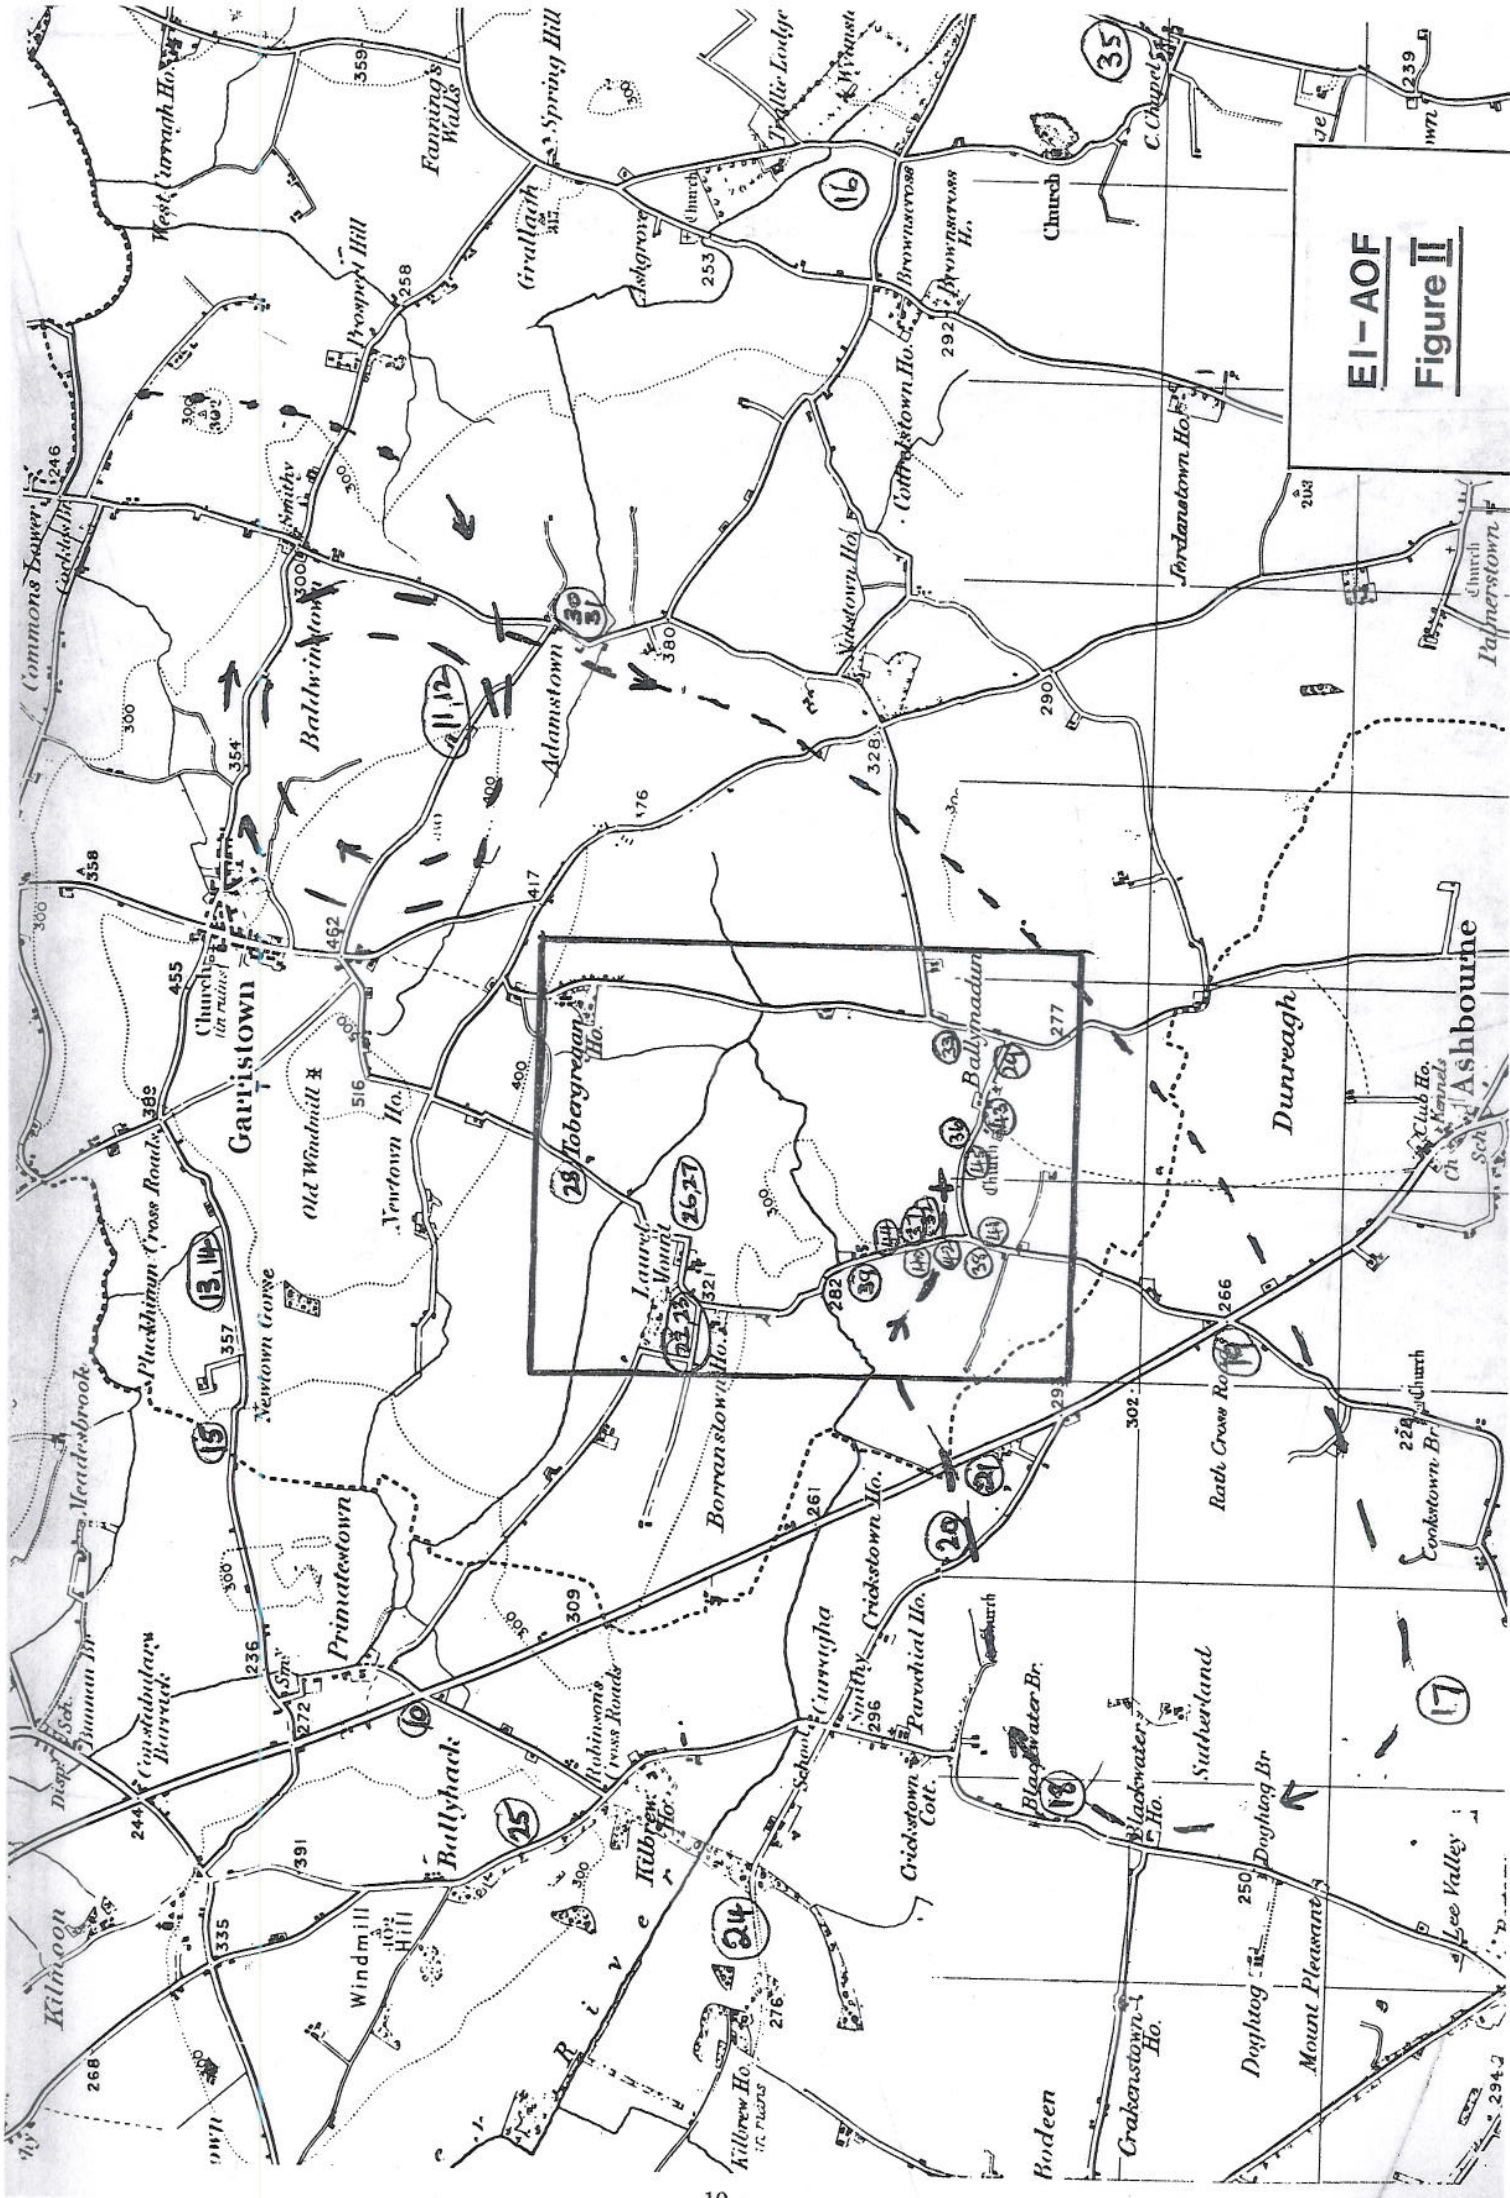
EI-AOF  
Figure II

A possible flight path of EI-AOF from the first point (1), at which it appears to have been flying an abnormally low altitude up to the point of impact is shown by means of the broken line on figures I and II.

Arrows indicate the probable flight direction; numbers indicate the position of witnesses, referred to in the report.

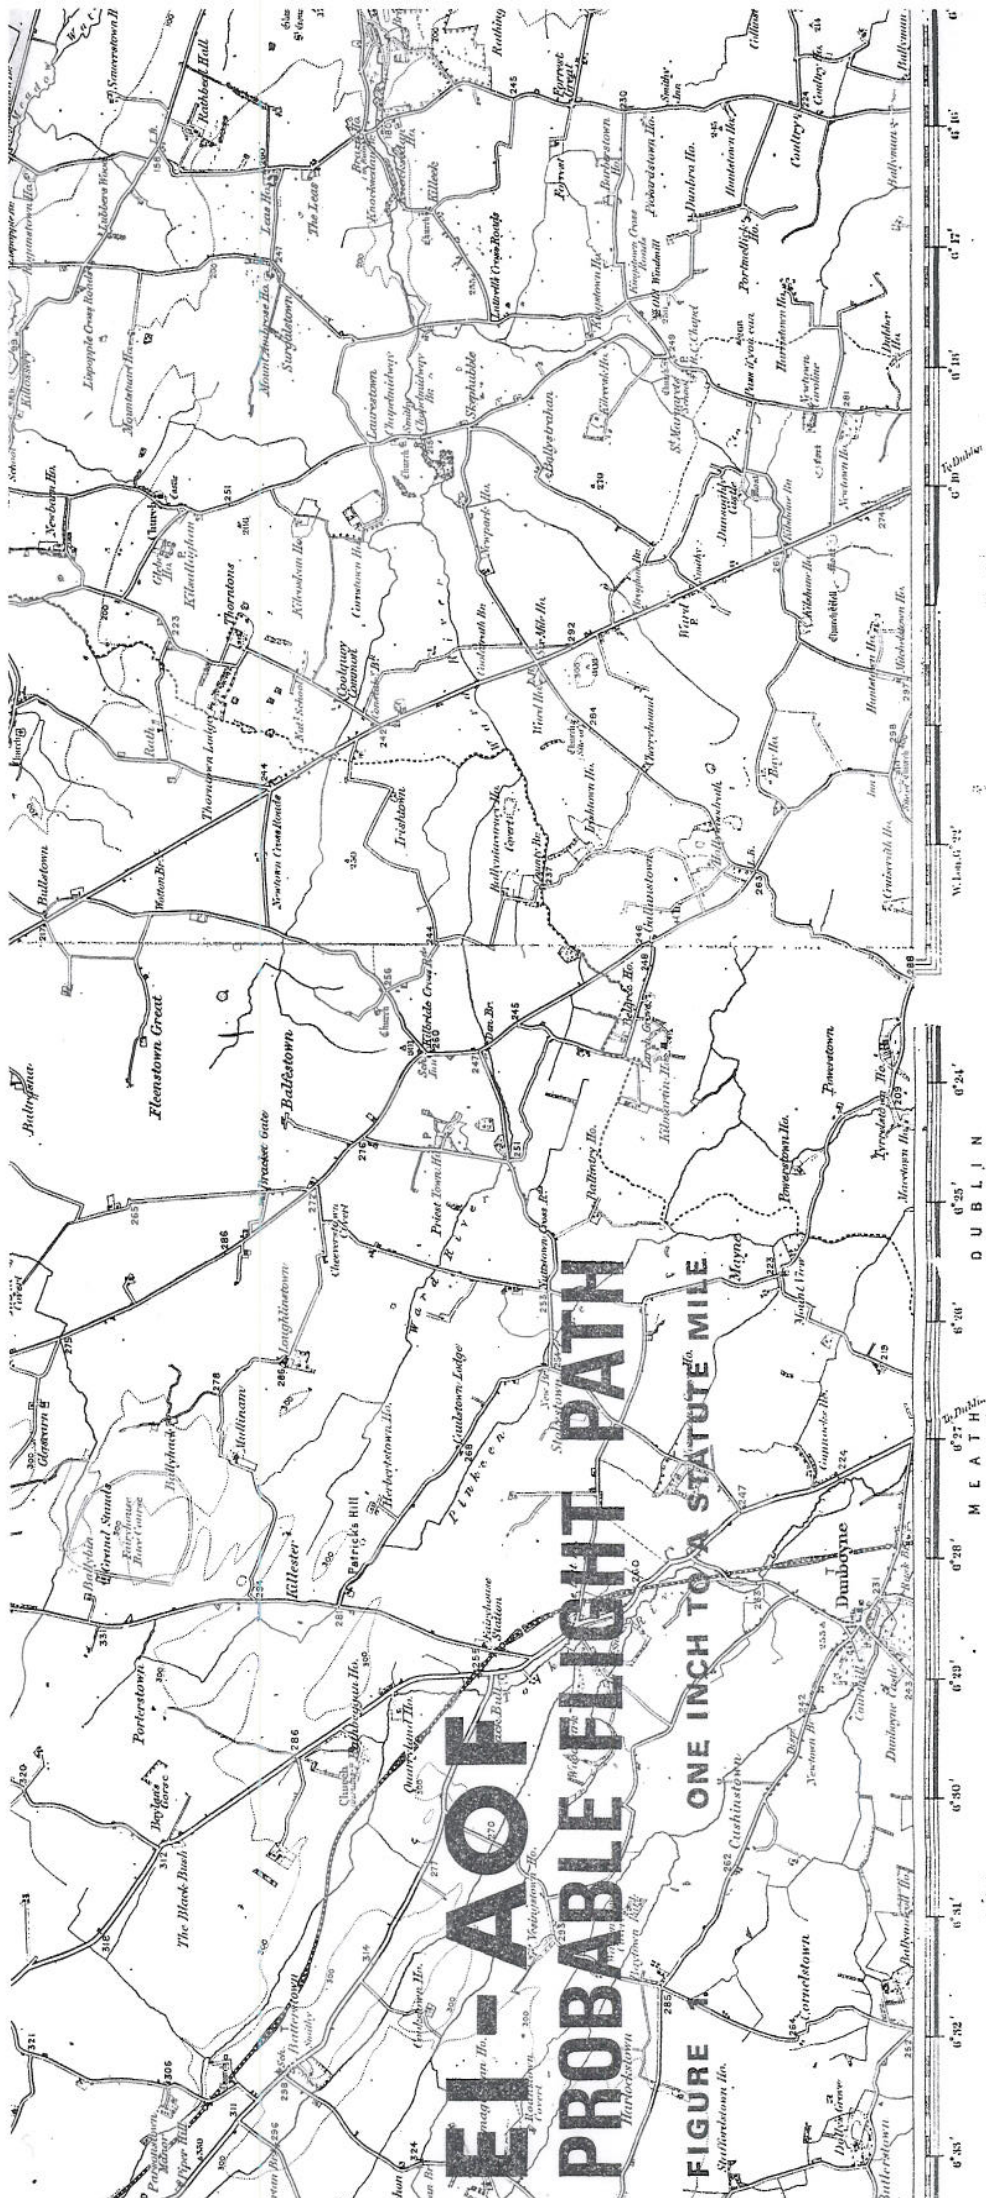
FIGURE 1

# EL-AOF- PROBABLE FLIGHT PATH

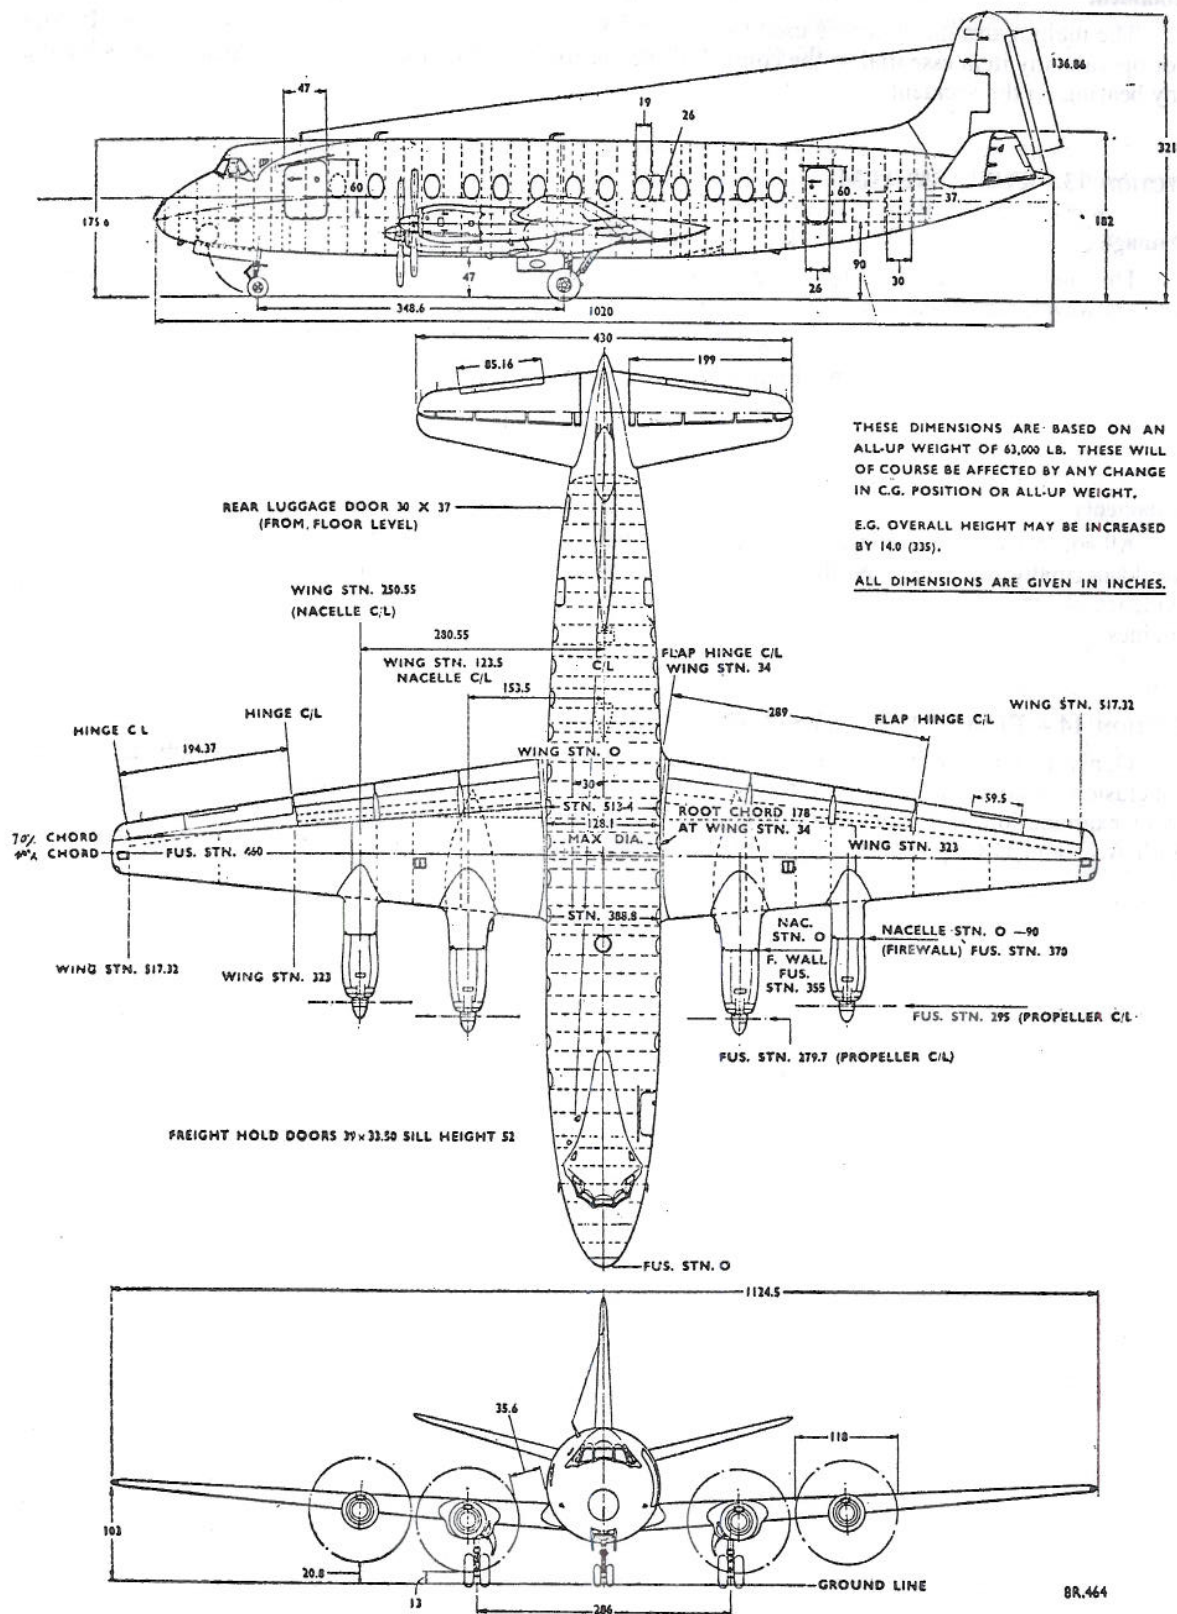
**Fig. 1 General Arrangement**

The main spar tip to tip was found in the correct spanwise position in the wreckage, thus eliminating any possibility of complete in-flight failure. Detailed examination of the fractures and general distortion revealed no evidence of fatigue or anything to suggest unusual in-flight wing distortion or overload condition prior to impact.

The wing root fractures and distortion illustrated were probably caused by rolling impact loads on fuselage and port wing.

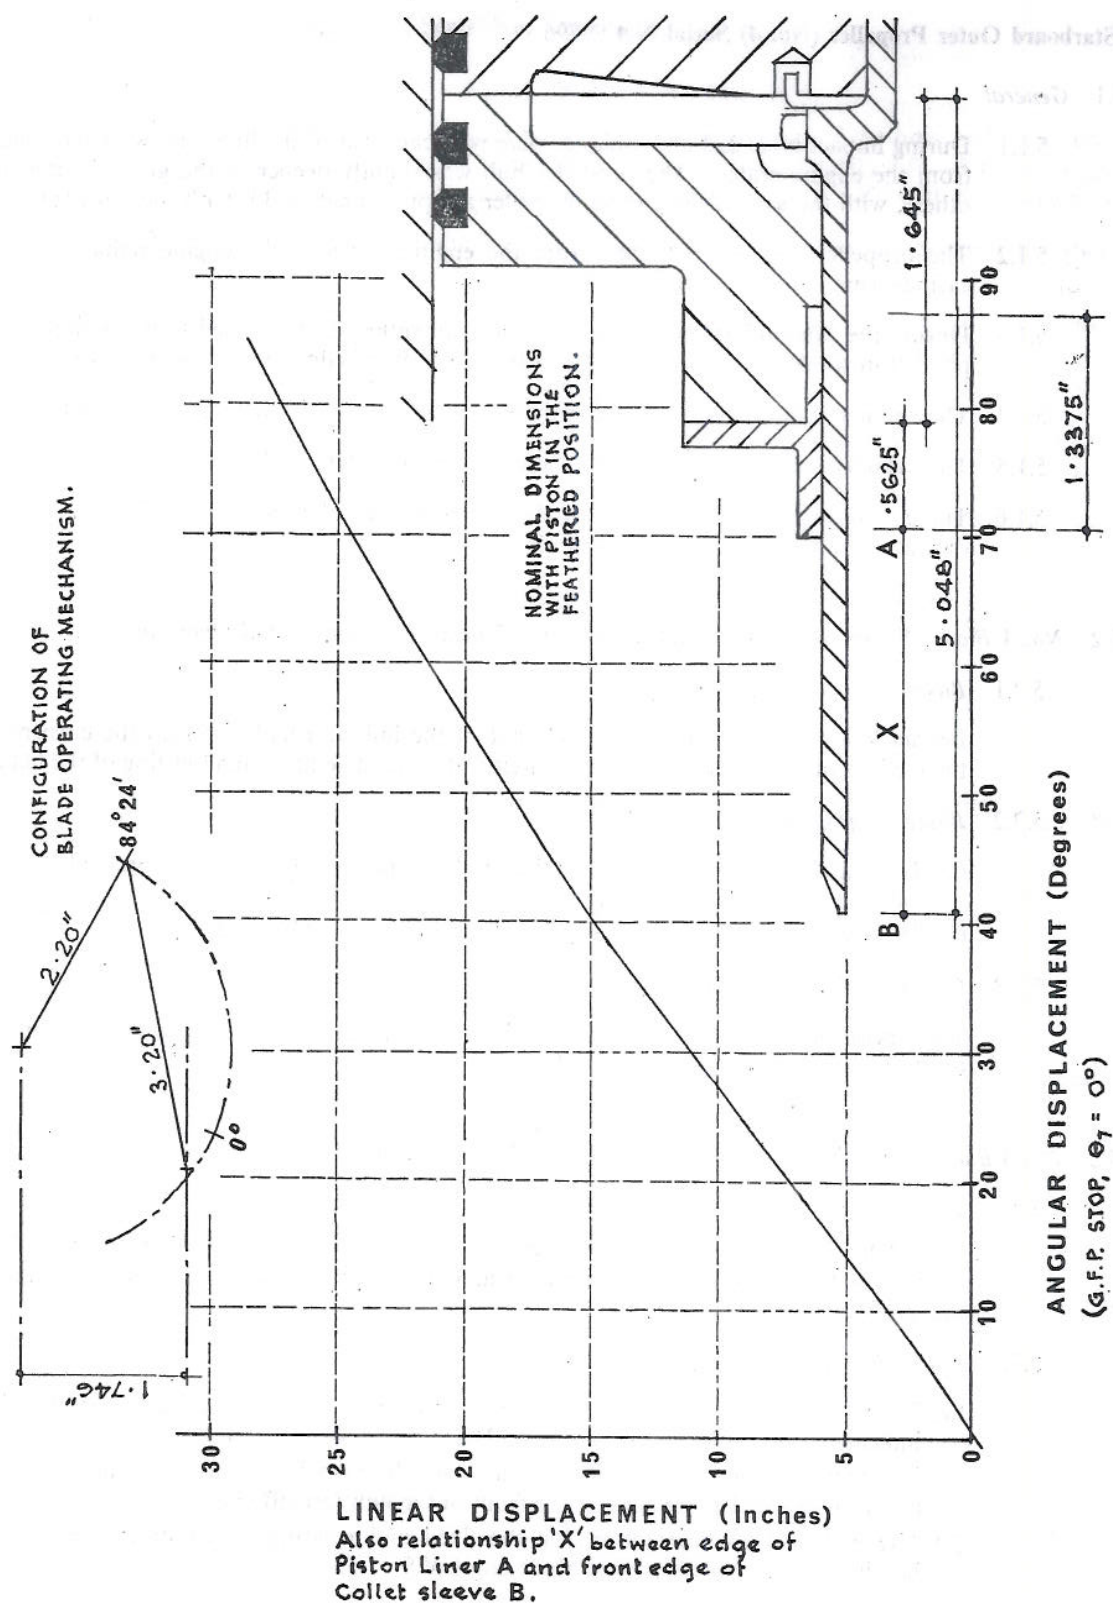
Graph No. H 0050

- 5.4.3 Since the main operating piston was found in approximately the flight fine pitch position, for the same reasons given previously in paragraphs 2.4.5 and 3.3.4 this propeller is considered to have been at  $24^\circ$  (flight fine pitch stop) at the moment of impact.

**TYPE R 130/4·20·4/12 E**

**4 BLADE - 20 ROOT PROPELLER. DART.**

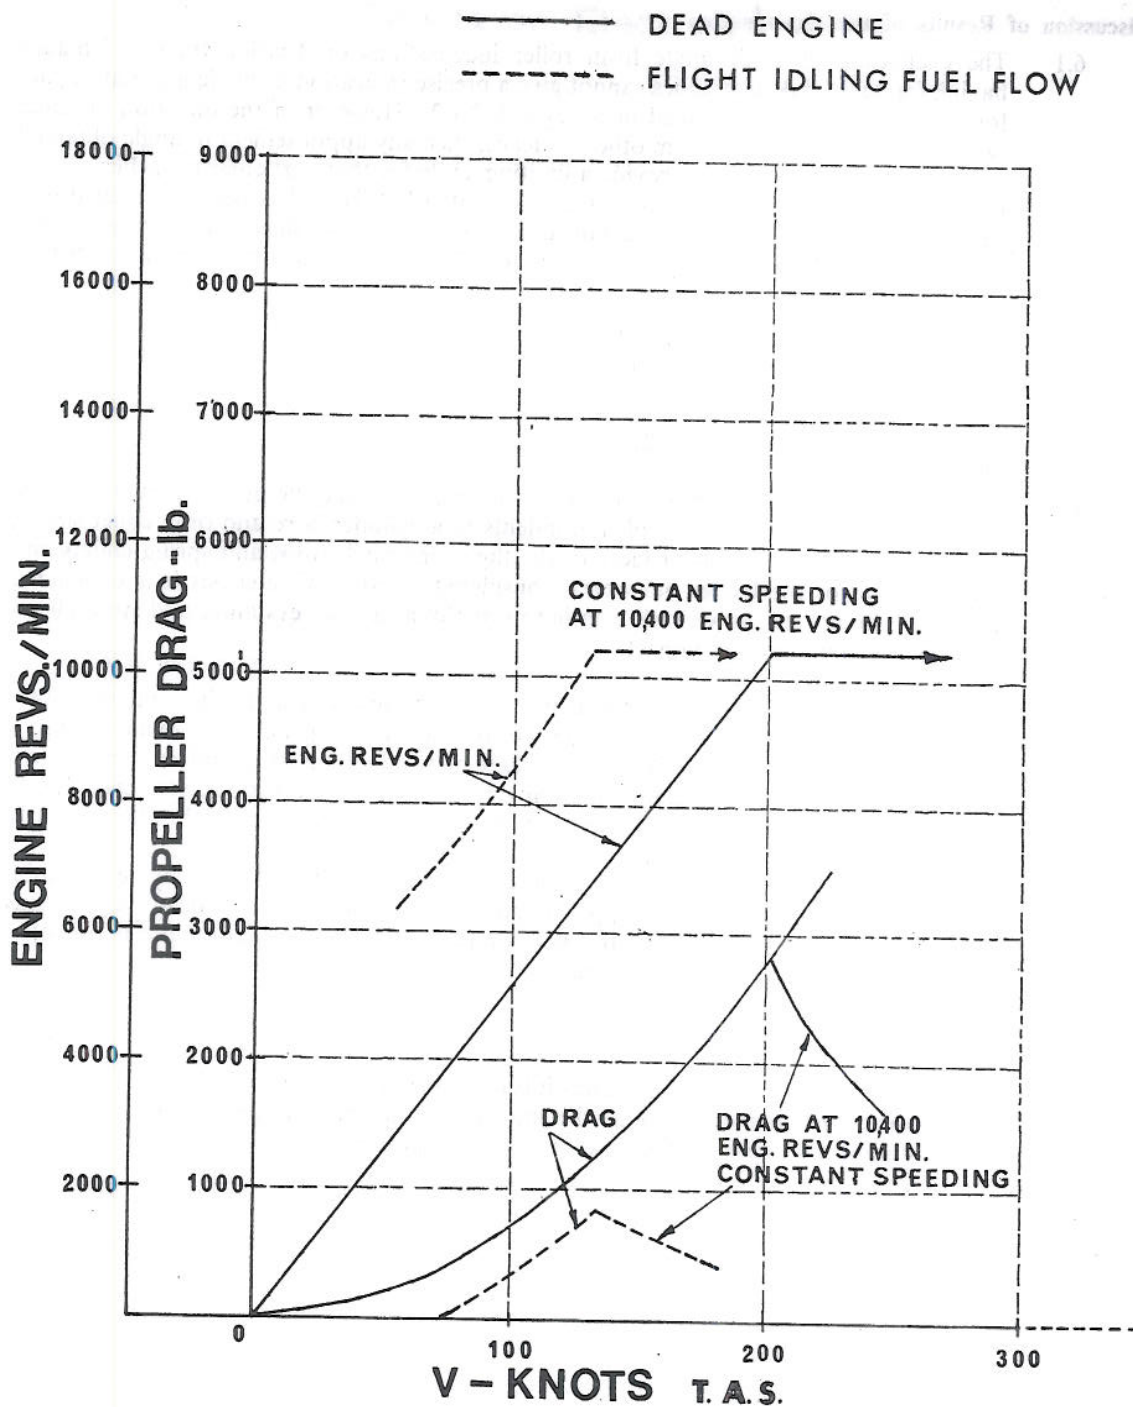
REF: PERFORMANCE OFFICE REPORT No.1011

**WINDMILLING DRAG AND  
ENGINE REVS/MIN. WITH  
A DEAD ENGINE, AND WITH  
FLIGHT IDLING FUEL FLOW,  
AT 24° STOP ANGLE.**
