# **Air Accident Investigation Unit Ireland**

**INTERIM STATEMENT**

**Sikorsky S-92A, EI-ICR**

**Accident to Sikorsky S-92A, EI-ICR at Black Rock, Co. Mayo on 14 March 2017**

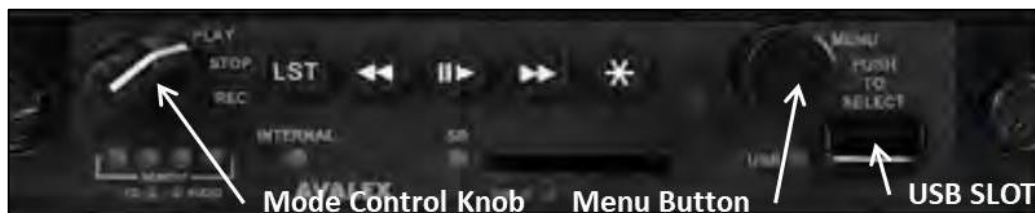
**Photo No. 3:** Avalex AVR-8240-XM Digital Video Recorder

The helicopter was fitted with an AVR-8240-XM Digital Video Recorder (DVR) manufactured by Avalex Technologies Corporation (**Photo No. 3**). The DVR provides the capability of recording video from the Wescam MX-15i EO/IR<sup>17</sup> Camera System. The system is self-contained within the control panel in the SAR Operator's console and interfaced to the SAR Operator's mission video display for EO/IR video playback. The DVR contained 16 GB<sup>18</sup> internal memory, and the capability to add either a SD Flash Card or a USB<sup>19</sup> Flash drive for recording. Both memory devices are removable. The DVR was controlled by the use of a *Mode Control* knob to select PLAY, STOP or REC (record) functions, and a *Menu* button which provided access to optional functions such as video quality selection and storage locations for the recorded video data.
