# **Air Accident Investigation Unit Ireland**

## **SYNOPTIC REPORT**

**Cessna TU206G Stationair 6, G-SKYE  
Near Abbeyshrule, Co. Longford  
21 June 2014**

AAIU Report No: 2015-017  
 State File No: IRL00914045  
 Report Format: Synoptic Report  
 Published: 21 September 2015

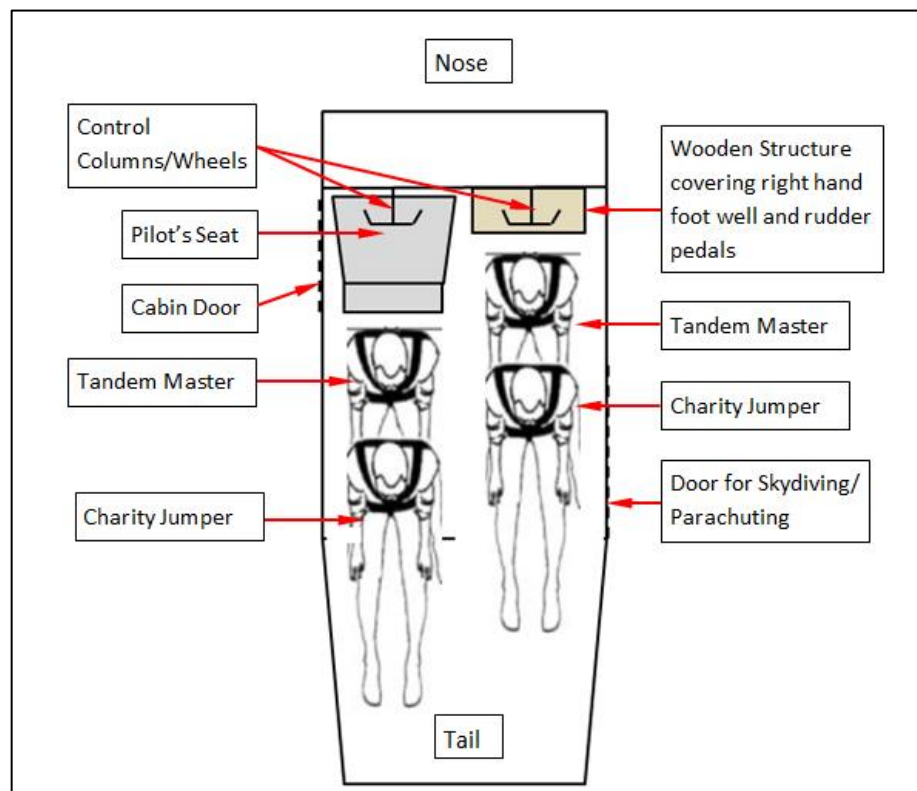
**Figure No 1:** Passenger layout on G-SKYE (Illustrative purposes only).

**Figure No. 1** below illustrates how the skydivers, all of whom were facing rearwards, were carried on the aircraft during the accident flight. One of the Tandem Masters was seated with his back/parachute pack against the wooden structure used to block off the right hand foot well area, leading to damage to this structure during the forced landing (**Photo No. 2**).

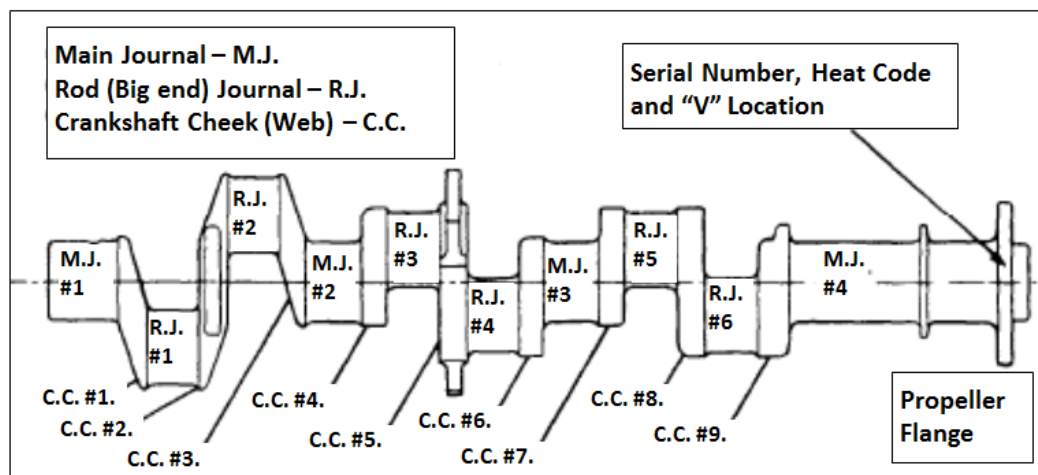
**Figure No. 2:** Crankshaft component identification (Ref. Teledyne-Continental CSB 96-8).

On this engine type, all crankshaft components are numbered from aft to forward. The number four main journal (M.J. #4) is the most forward, closest to the propeller flange and is supported by two separate main bearings, numbers four and five. All crankshaft bearings are of the 'plain' type (**Section 1.12.11** refers). The Engine Manufacturer refers to the crankshaft webs as '*cheeks*', and the big-end journals as '*rod journals*' (**Figure No. 2**).

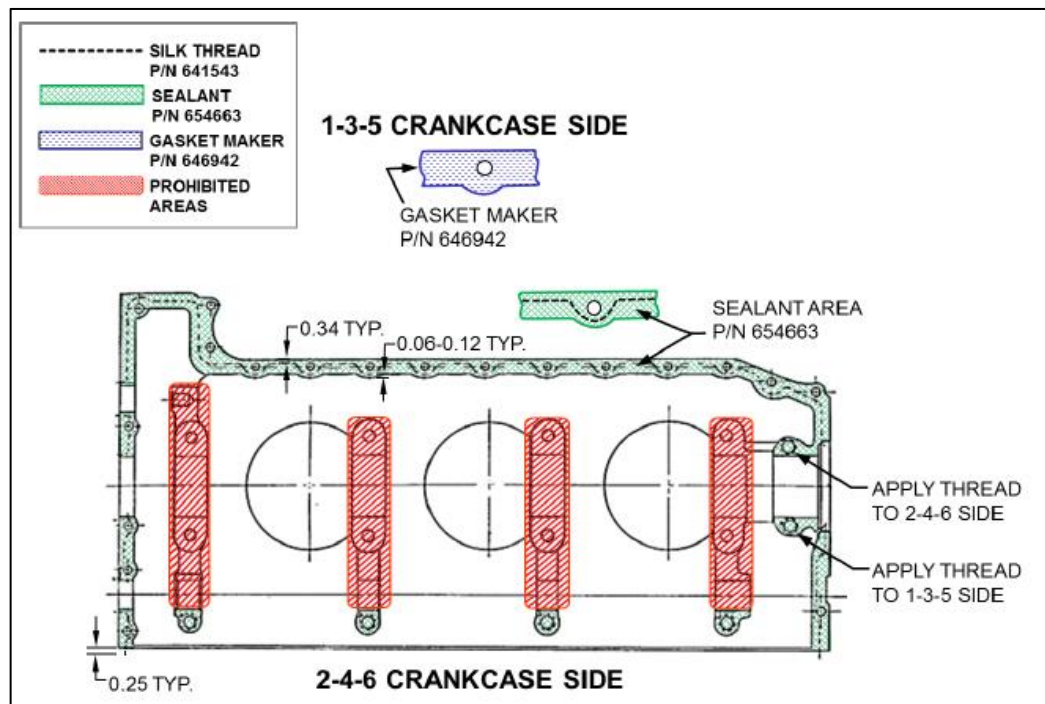
**Figure No. 4:** Revised sealant and thread application diagram as contained in SIL 99-2C.

The SIL was revised on 17 October 2005 (SIL 99-2B). However, the sealants authorised for use on the crankcase parting surfaces remained unchanged. The SIL was further revised on 16 September 2014 (SIL 99-2C) and now includes enhanced sealant and silk thread application diagrams. The diagrams utilise colour coding to indicate where the sealant and thread is required and where it is prohibited (**Figure No. 4**).

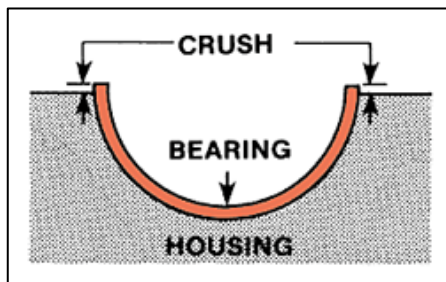
**Figure No. 6:** Bearing Crush/Nip.

Crankshaft main bearings comprise of two halves or shells, manufactured from a metal alloy, usually containing lead. The outside diameter of the bearing shell is slightly larger than the diameter of the crankcase bearing housing/saddle. As a result, when a bearing shell is installed in its housing during engine reassembly, its edges normally stand slightly proud of the housing. The amount the edges stand proud is known as bearing crush/nip (**Figure No. 6**). When the crankcase halves are bolted together, and the through-bolts are tightened to the correct torque value, the bearing is pressed into its housing. This results in an interference fit which prevents bearing movement during engine operation. In addition, each bearing shell normally contains a lug/tang, which sits into a dedicated notch in the bearing housing/saddle and ensures the correct location of the bearing during assembly and also prevents bearing movement. The Engine Manufacturer’s Service Bulletin, SB 96-7B, contains a ‘*Caution*’ outlining that the through bolts must be torqued on both sides to prevent bearing shift (**Figure No. 7**).

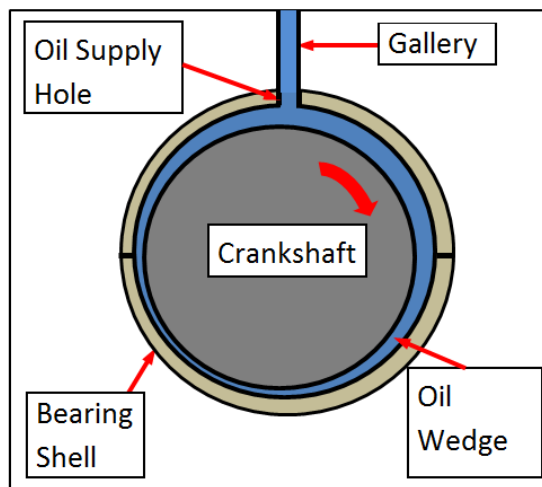
**Figure No. 8:** Hydrodynamic Lubrication.

Main engine bearings rely on hydrodynamic lubrication to prevent metal to metal contact between the surface of the rotating crankshaft and the stationary bearing when the engine is running. When the engine starts to run, oil under pressure is supplied from a gallery through a hole in the bearing shell. The oil is 'dragged' by the rotating crankshaft and forms a wedge which supports the crankshaft in the bearing (**Figure No. 8**). For hydrodynamic lubrication to occur, a certain amount of clearance must exist between the crankshaft journals and the bearings. This clearance is checked during engine assembly. Work pack records indicate that the clearance at engine overhaul was within limits (**Section 1.12.2.1** and **Appendix A, Table No. A3**).
