Air Accident Investigation Unit Ireland

SYNOPTIC REPORT

ATR 72-212A, EI-FAX

30 September 2015

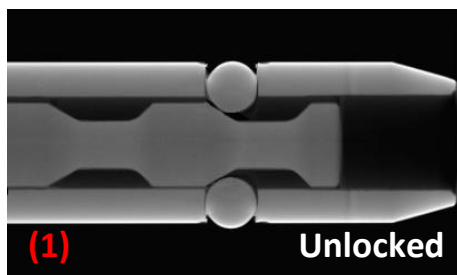
Graphic No. 1 Shows plunger in retracted (unlocked) position

To install the pin, the plunger is displaced, which allows the ball bearings to move inwards, permitting the pin to be inserted into the locating holes, **Graphic No. 1**. When the plunger is released, a spring mechanism returns the plunger to the locking position and the ball bearings are pushed outwards, locking the pin in place, **Graphic No. 2**.

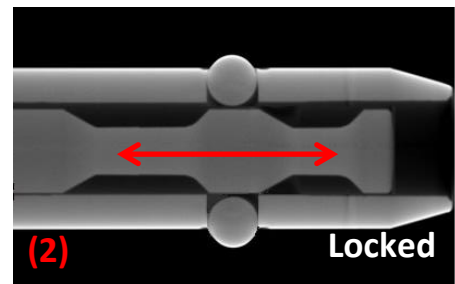
Graphic No. 2 Shows plunger in normal (locked) position. Red arrow indicates plunger movement

The Investigation obtained the quick release pin that was in use at the time of the accident. The handle and plunger were found to operate only partially in the pull direction and the locking ball bearings were found retracted and could not be pushed out into the locking position using the plunger. Inspection revealed that whilst the pin would fit correctly into the locating holes of the cross-brace and stanchion, the pin could not be locked in position. **Graphic No. 1** above shows the plunger in the condition as found by the Investigation, with the locking balls retracted.

Examination of the X-Ray photographs revealed that the shoulders of the spring housing, intended for seating the small washer, showed signs of damage and wear, with the shoulders becoming worn and rounded, allowing the small washer to migrate out of position, jamming the plunger.
