Air Accident Investigation Unit Ireland

SYNOPTIC REPORT

SERIOUS INCIDENT Sikorsky S-92A, EI-ICG Hook Head, Co. Wexford

6 December 2015

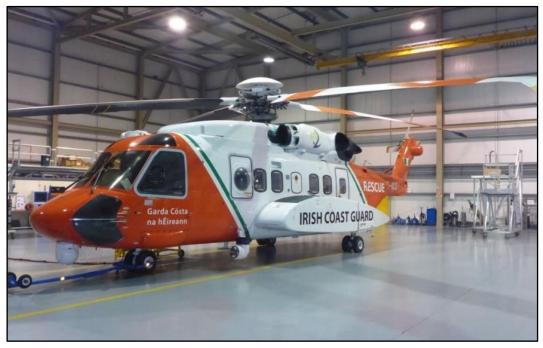
Photo No. 1: Sikorsky S-92A EI-ICG

The Sikorsky S-92A is a twin-engine, medium weight helicopter. It is powered by two General Electric CT7-8A turbo shaft engines that drive a four-bladed, fully articulated main rotor and a four-bladed tail rotor. The helicopter has a maximum cruising speed of 151 kts. The helicopter was registered as EI-ICG (**Photo No. 1**) and configured for SAR operations. This configuration included auxiliary fuel tanks that increase the maximum range to 801^{16} NM, thermal imaging cameras, a searchlight, a radio-altimeter and an Automatic Identification System (AIS) which is described in **Section 1.8.2**. The helicopter did not sustain any damage as a result of the serious incident.

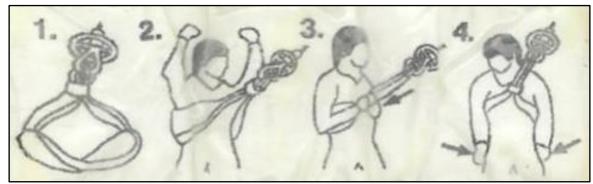
Photo No. 3: Instructions to operate the Helicopter Rescue Strop as sewn onto webbing.

The two ends of the strop pass through a sliding woggle which allows the strop to be drawn close to the torso of the wearer. Instructions for the correct use of the strop are attached to the webbing in the form of a pictorial guide (Photo No. 3). Prior to ascent, the strop is positioned around the casualty's torso and under the arms with the pad at the back and the sliding woggle at the front.

Step four of the instructions requires the casualty to keep their hands beside their body. A handling loop on the outside of the strop enables the winch operator to draw the casualty into the cabin after they are winched up to the helicopter door.

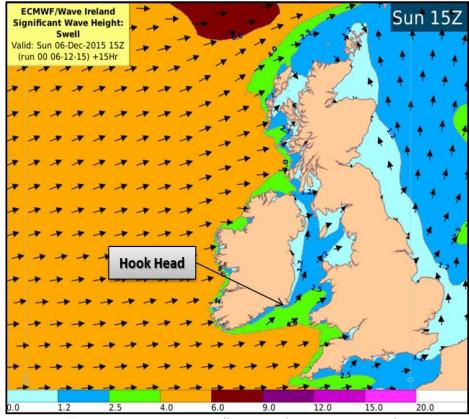
Figure No. 1: Forecast Swell 6 December 2015 at 15.00 hrs

The Investigation also requested information about the sea conditions at the time of the rescue. **Figure No. 1** shows the *Wave Height (Swell) Chart* in metres for 15.00 hrs on the day of the occurrence. This chart depicts the result of meteorological activity on sea conditions.

These charts indicate that the forecasted height of the waves in the vicinity of Hook Head were not greater than 2.5 metres at 15.00 hrs. The forecasted sea conditions at 12.00 hrs were of similar magnitude. A photograph taken at 14.00 hrs approximately (Photo No. 5) depicts relatively benign offshore sea conditions. Historic tidal data from the Irish Marine Institute for Dunmore East (approx. 5 km NW of Hook Head) for 6 December 2015 indicated that High Tide was at 13.42 hrs and that the sea temperature at the time was 11°C.

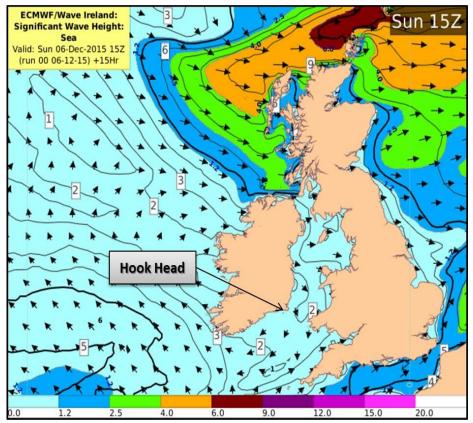
Figure No. 2: Forecast Sea 6 December 2015 at 15.00 hrs

Figure No. 2 shows the Wave Height (Sea) Chart in metres for 15.00 hrs on the same day. This chart also includes the effect of additional factors, including the topography of the seabed, direction of the swell relative to the coastline and local wind effects.
