Air Accident Investigation Unit Ireland

FORMAL REPORT

**Laser Z200, PH-LSR
Abbeyshrule, Co. Longford
20 March 2016**

AAIU Report No: 2017 - 012
 State File No: IRL00916016
 Report Format: Synoptic Report
 Published: 13 November 2017

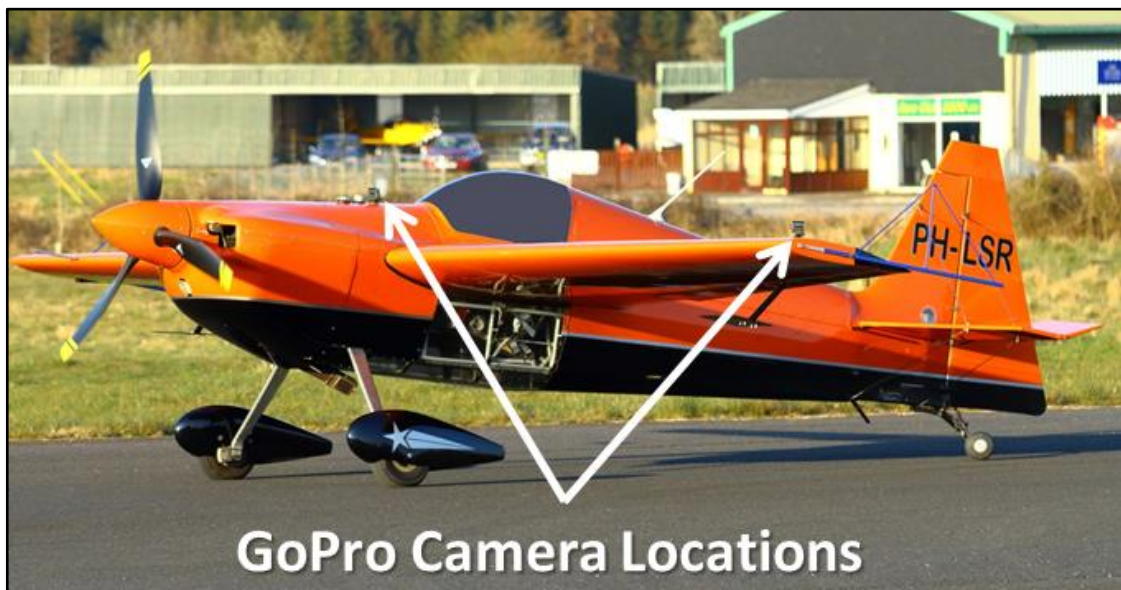
The aircraft was fitted with mounting plates in two positions for *GoPro* video cameras. Photographs taken one week prior to the accident (**Photo No. 1**) did not show any evidence of cameras mounted on the aircraft. However, components from two *GoPro* cameras were located within the wreckage field. A photograph (**Photo No. 5**) taken just prior to take-off by an eyewitness recorded the location of the cameras during the flight.

Photo No. 5: Location of *GoPro* Cameras during accident flight (Cockpit obscured)

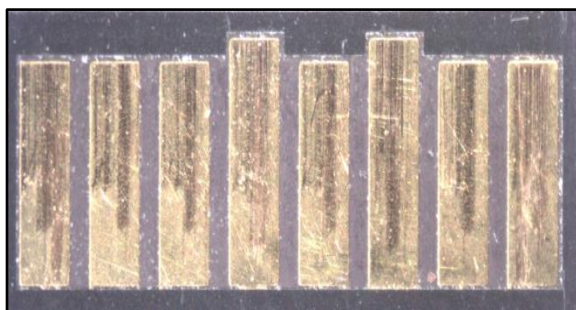
The SDHC memory cards were numbered in accordance with the respective camera; *SDHC Card 1* came from *Camera 1* and *SDHC Card 2* came from *Camera 2*. The SDHC memory cards were examined under a microscope for physical damage (**Photo No. 8** and **Photo No. 9**). The metallic strips on both memory cards appeared to be physically undamaged and showed signs of routine wear and tear associated with insertion and removal of each memory card from the memory card slot in the respective camera. Once it was established that the memory cards appeared to be physically intact, a working copy was made of both SDHC cards for diagnostic purposes.

Photo No. 8: Image of *SDHC Card 1*

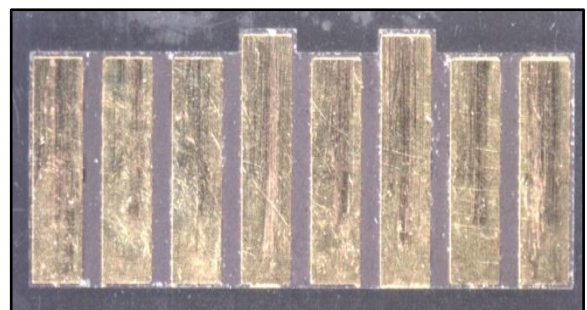
Photo No. 9: Image of *SDHC Card 2*
