Air Accident Investigation Unit Ireland

FORMAL REPORT

**BRM Aero, Bristell NG5, G-OJCS
Belan, Co. Kildare**

13 June 2019

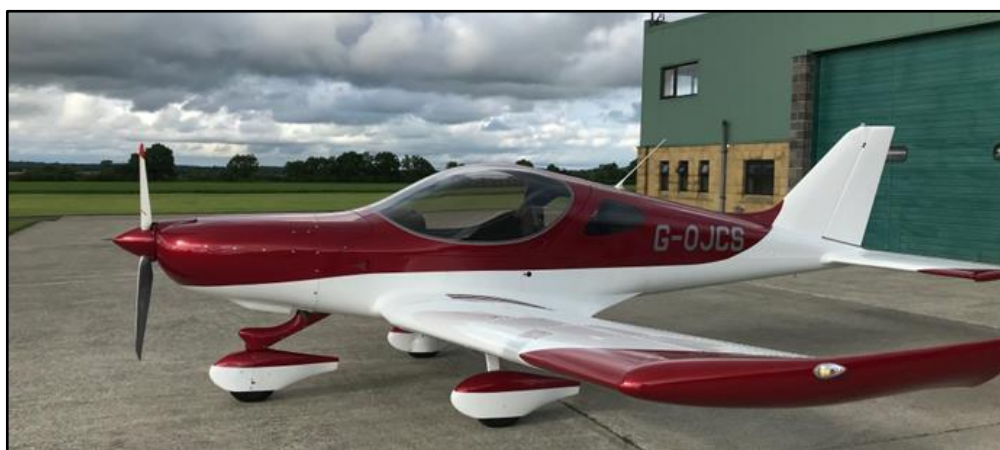
The Bristell NG5 '*Speedwing*' aircraft, (**Photo No. 1**), is a single-engine, all metal, low-wing monoplane of semi-monocoque construction with two side-by-side seats. The aircraft is equipped with a fixed tricycle undercarriage with a steerable nose-wheel. The subject aircraft was fitted with a Rotax 912 ULS, 4-cylinder, 4-stroke engine.

Photo No. 1: The accident aircraft.

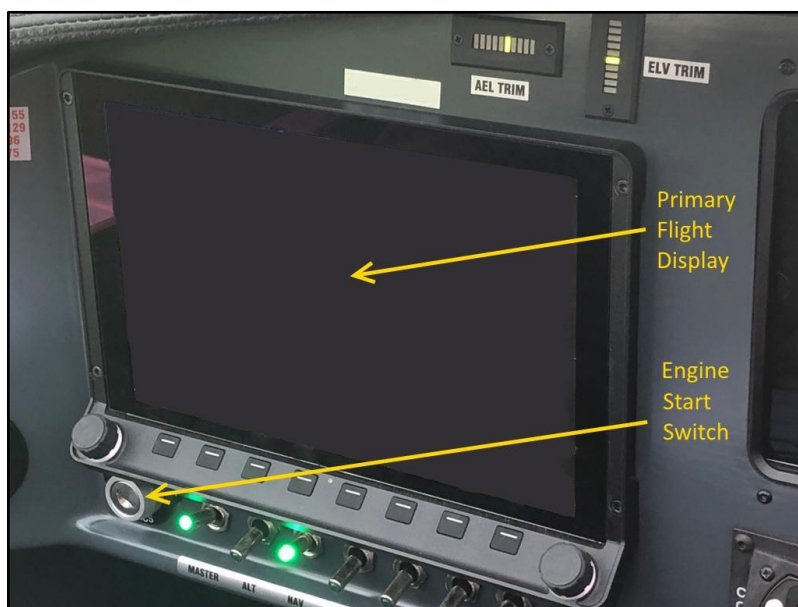
The aircraft was equipped with dual flight controls, allowing persons seated in either the left or right seat to control the aircraft. A key-operated engine start switch was located on the far left side of the main instrument panel, in front of the left seat, where the cockpit side wall meets the instrument panel (**Figure No. 1**). The start switch cannot be reached by a person seated in the right seat, with their shoulder straps securely fastened.

Figure No. 1: Location of Engine Start Switch

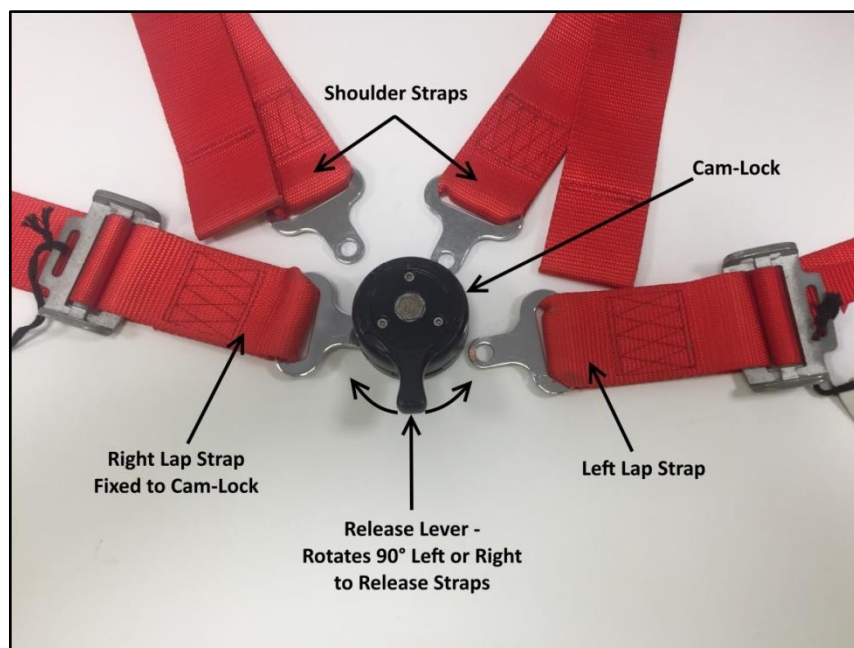
Each of the two seating positions in the aircraft was equipped with a four-point restraint harness. Each harness consisted of two lap straps, and two shoulder straps. The straps were anchored to the aircraft structure. There was no inertial release mechanism on the shoulder straps. One lap strap was permanently attached to a rotary cam-lock mechanism, into which the other lap strap and the two shoulder straps could be secured. Once latched, the straps released by rotating a lever located on the cam-lock mechanism approximately 90° left or right of its neutral position (**Photo No. 2**); all straps are released at the same time.

Photo No. 2: Aircraft Left Seat Harness (with release lever shown in neutral position)

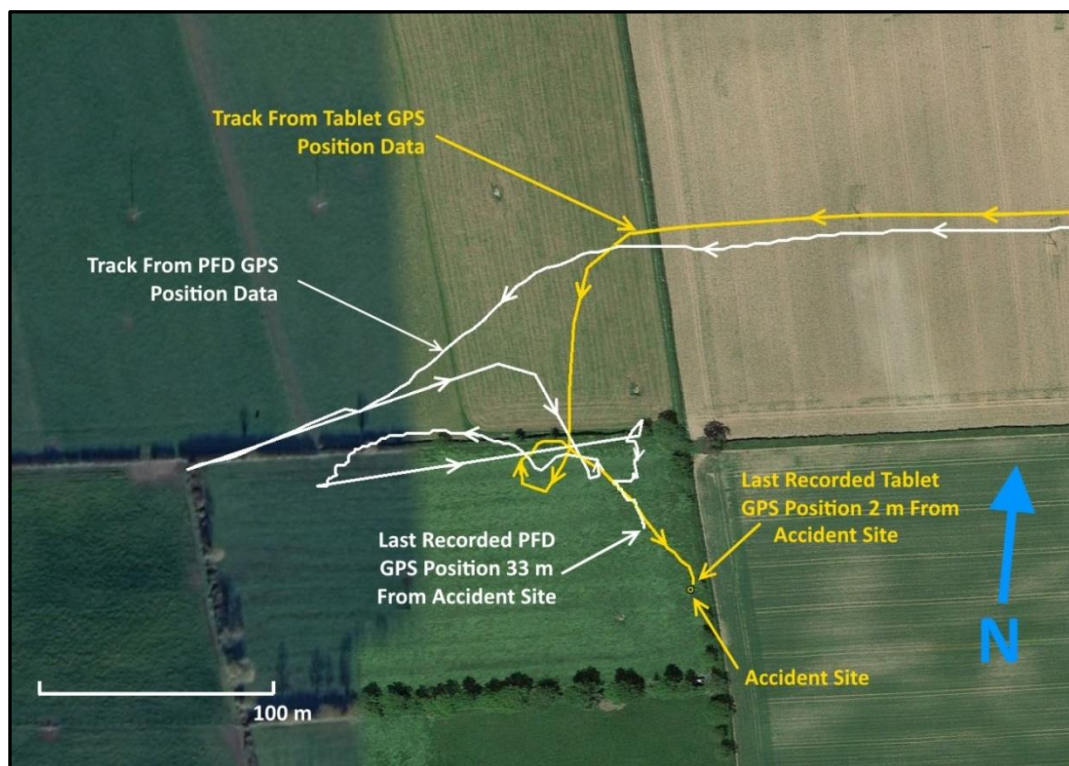
The yellow line in **Figure No. 5** shows the ground track of the aircraft, as recorded by the tablet-based navigation application, in the final 38 seconds preceding the impact (the white line shows the ground track as recorded by the PFD, see **Section 1.11.4.3**).

Figure No. 5: Ground track of aircraft from both the Tablet Application (Yellow), and the PFD GPS data (White)

A portion of the ground track from the tablet application suggests the aircraft performed a tight 360° right orbit prior to tracking towards the accident site. The final position recorded by the tablet navigation system was approximately 2 m from the accident site.

A plot of the aircraft track in the final 38 seconds, using recorded GPS latitude and longitude from the PFD is shown in white in **Figure No. 5, (Section 1.11.3.1)**. As the ground track could not have been followed by the subject aircraft, and the final recorded aircraft position is approximately 33 m northwest of the accident site, this shows that the recorded GPS positions from the PFD data became inaccurate during the final moments.

Aircraft position data (as recorded by the PFD), and therefore the aircraft ground track and groundspeed, as indicated by the white ground tack shown in **Figure No. 5, Section 1.11.3.1**, also became invalid which was likely due to shielding of the GPS antenna. However, engine RPM, indicated airspeed, vertical acceleration, pressure altitude and vertical speed, continued to be recorded with values that were regarded as valid.

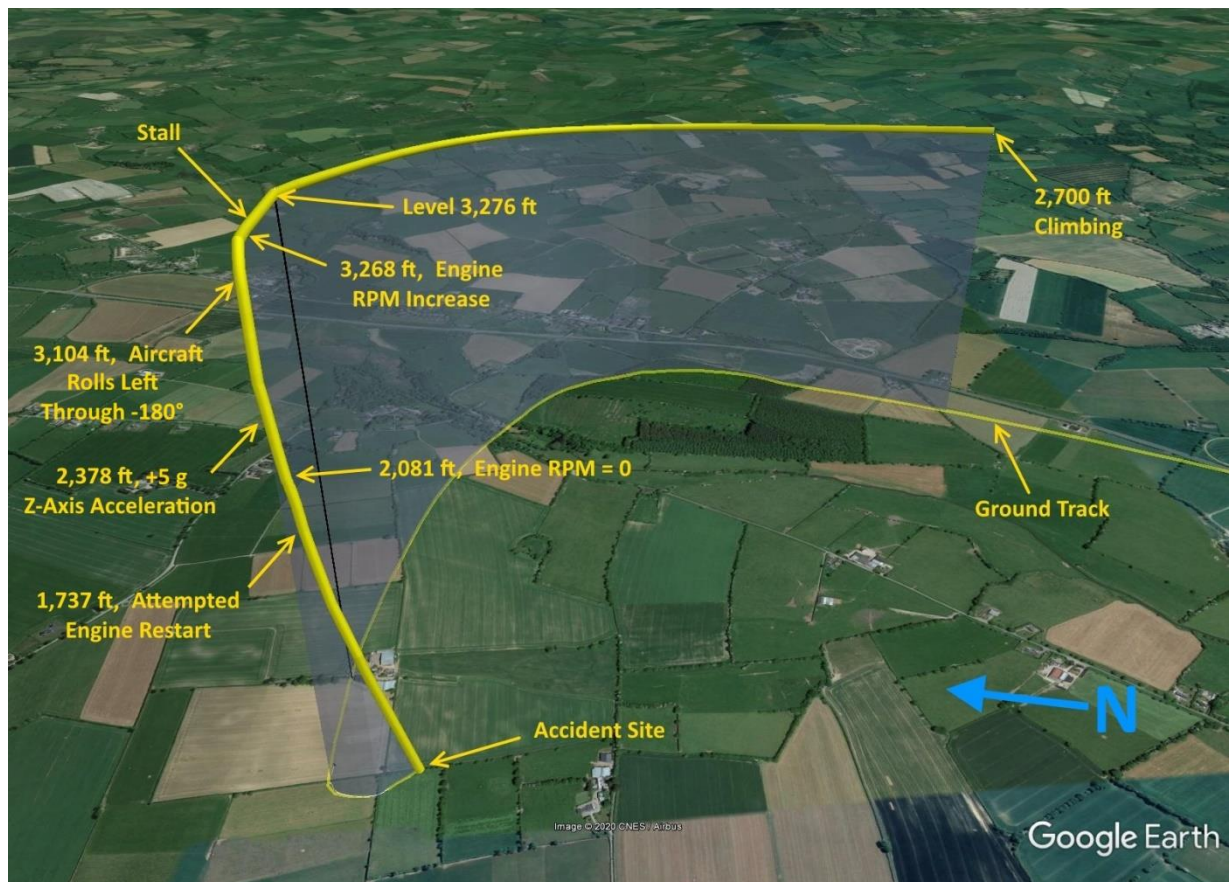
The Investigation therefore used a smoothed flight path, from the final descent from 3,276 ft until impact, onto which other data has been mapped, **Figure No. 6**.

Figure No. 6: 3D Representation (smoothed) of flight profile from final descent from 3,276 ft until impact

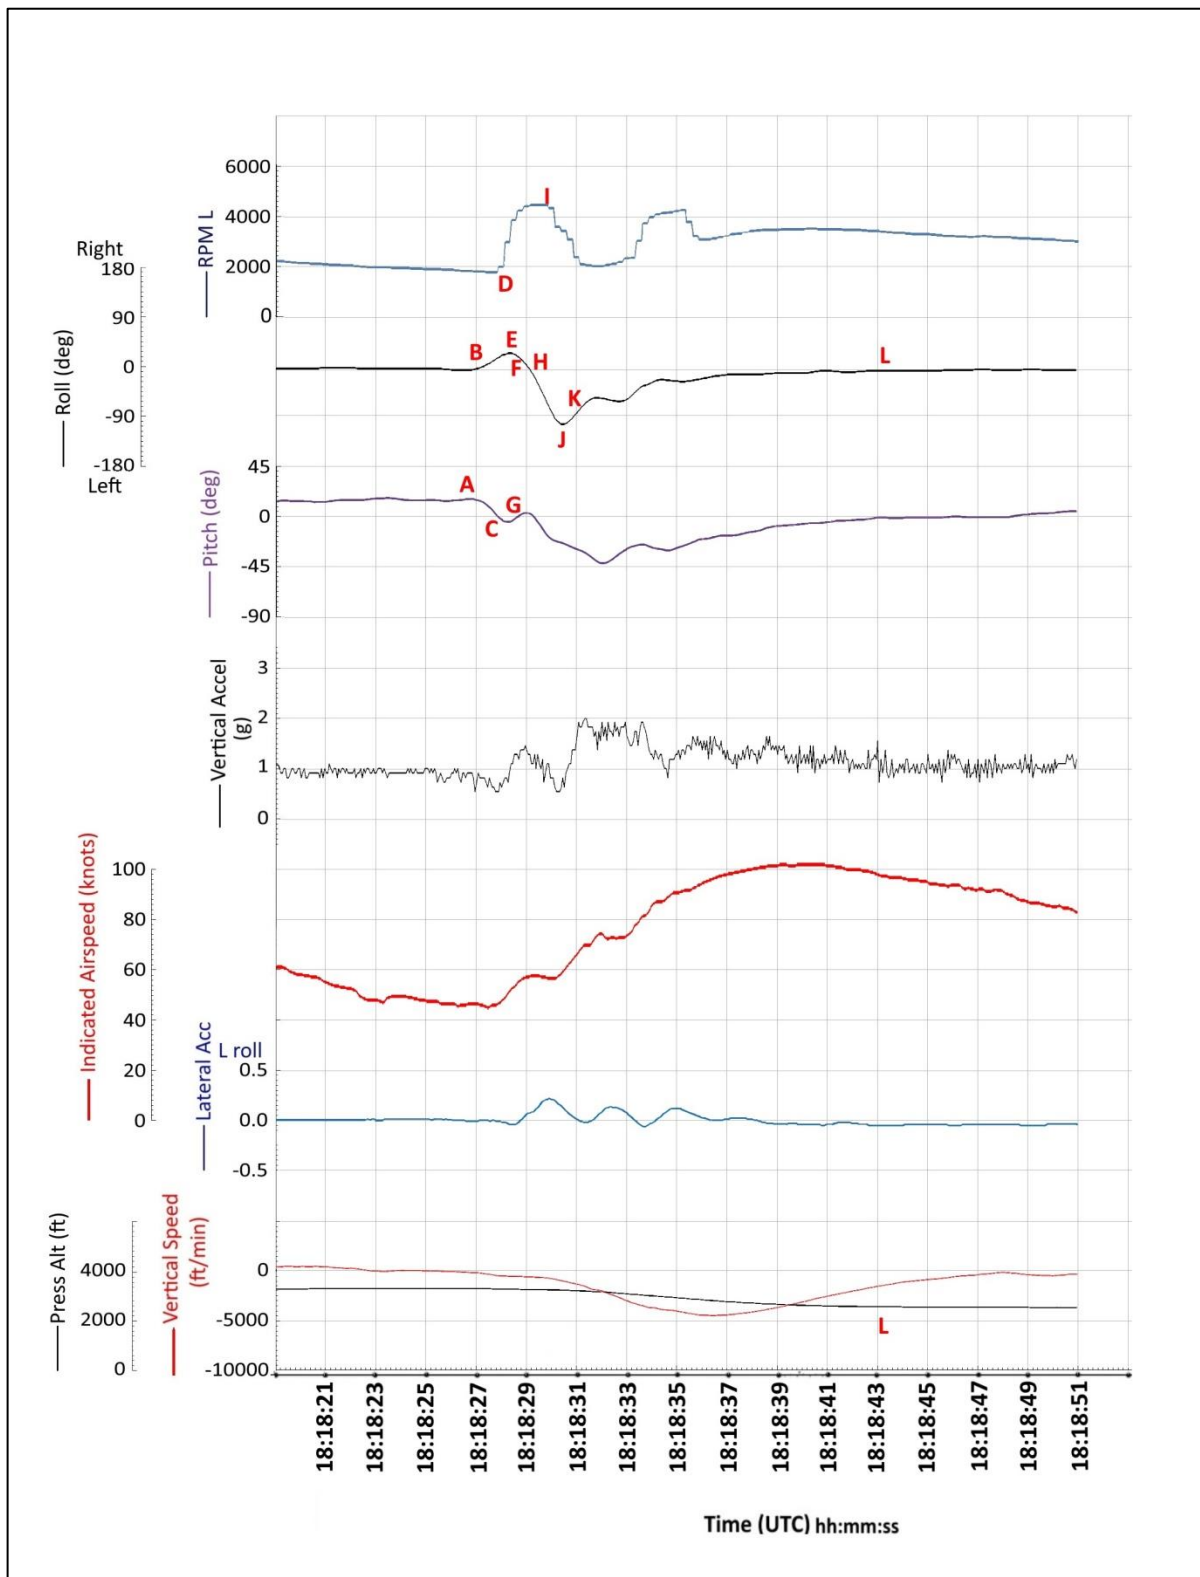
Using the PFD User-Accessible Data, **Table No. 5** and **Figure No. 7** show the sequence of events during this manoeuvre.

Figure No. 7: Graph of recorded user-accessible PFD data for the period 18:18:21 to 18:18:51, showing the manoeuvre at time 18:18:26
