Air Accident Investigation Unit Ireland

SYNOPTIC REPORT

ATR 72-212A, EI-FCY

24 August 2016

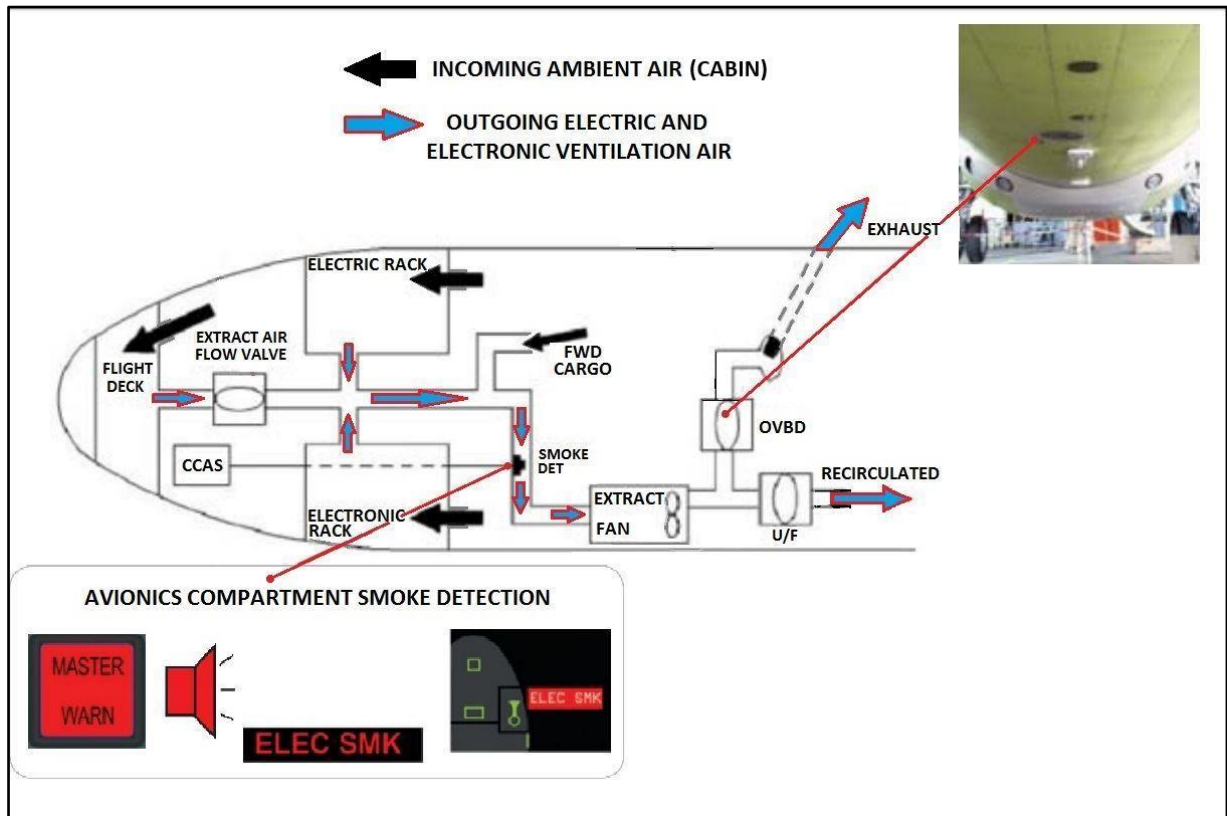
Figure No. 1: Schematic of Avionics Ventilation Air

As the smoke detector is located in the extract duct of the avionics bay, and is monitoring air from the Electric Rack, Electronic Rack and Flight Deck Electrical and Electronic Equipment, smoke detected could be from component(s) in any of these areas. A schematic diagram of the avionics ventilation air circuit is shown in **Figure No. 1**. A note in the QRH cautions flight crew that air conditioning smoke may also trigger an electrical smoke warning.
