Air Accident Investigation Unit Ireland

FACTUAL REPORT

BRM Land Africa, CS-UTN

Letterkenny Airfield, Co. Donegal

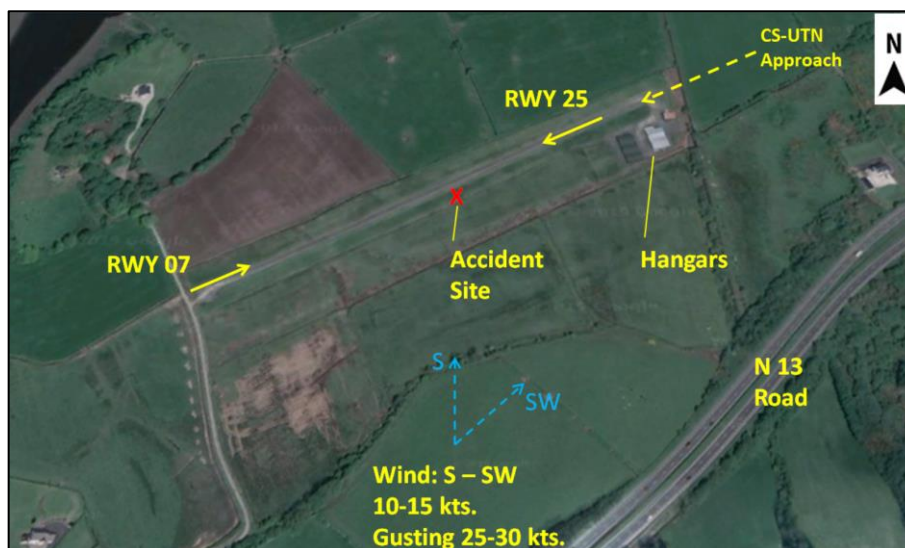
Figure No. 1: Aerial view of Letterkenny Airfield (Google Earth)

ELT is a privately owned airfield adjacent to the River Swilly and situated two nautical miles to the east of Letterkenny Town, Co. Donegal. The airfield has a paved runway, which is approximately 530 m in length and is orientated in a direction of 07-25. The airfield has two separate hangar structures and a small clubhouse situated to the left of the threshold of RWY 25 (**Figure No. 1**).

The Investigation was informed that, in southerly winds, local topographical features coupled with the position of the hangars on approach to RWY 25 could give rise to rapidly changing crosswind conditions. In order to lessen the effects of crosswind conditions, local custom and practice at the airfield was for pilots to 'land long' when approaching RWY 25.
