**Following the study
performed at the request of
The Minister in Charge of the Department for Public
Enterprise
on
the AER LINGUS VISCOUNT EI-AOM accident
occurred on March 24th, 1968
near TUSKAR ROCK
Ireland**

VOLUME II: APPENDICES AND ANNEXES

TOME 1: APPENDICES

November 27, 2001

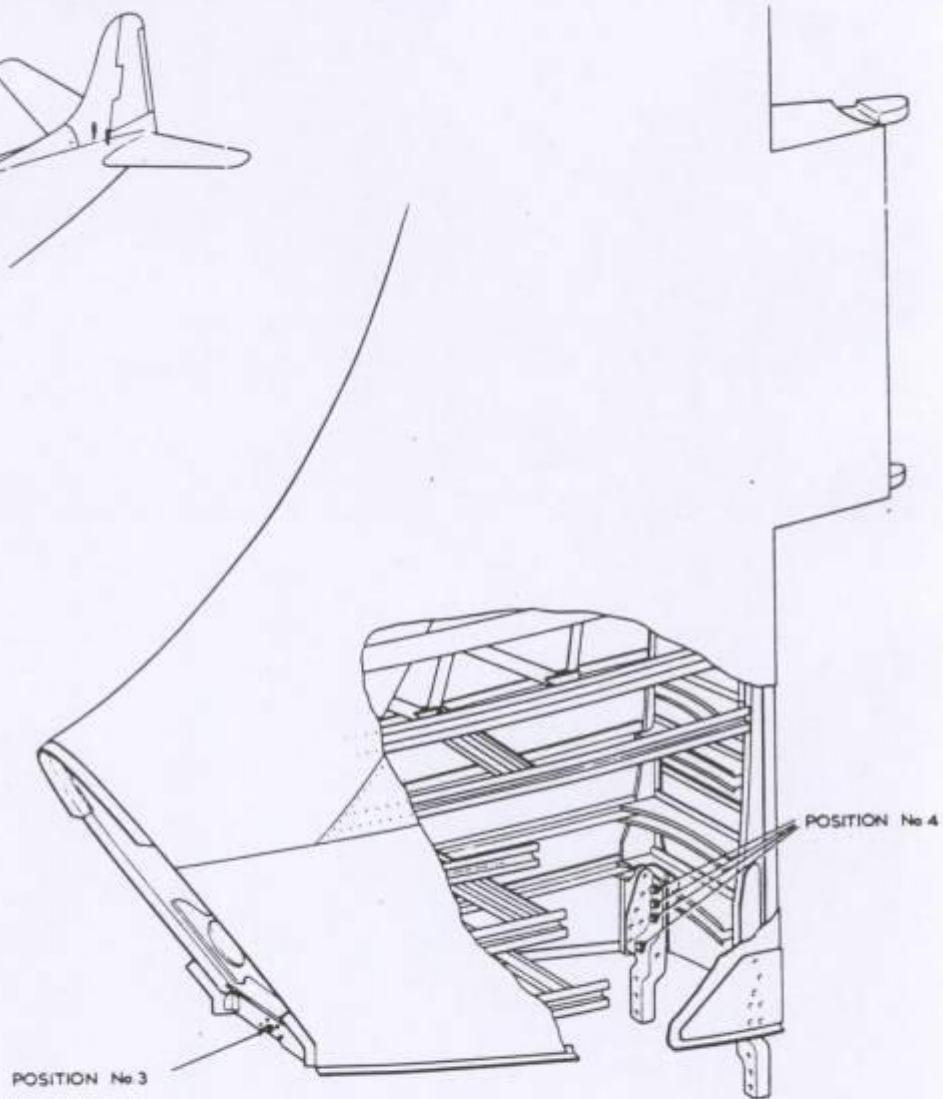
424 - FIG 1

Fig. 1: Fin Leading Edge to Fuselage (Station 871)

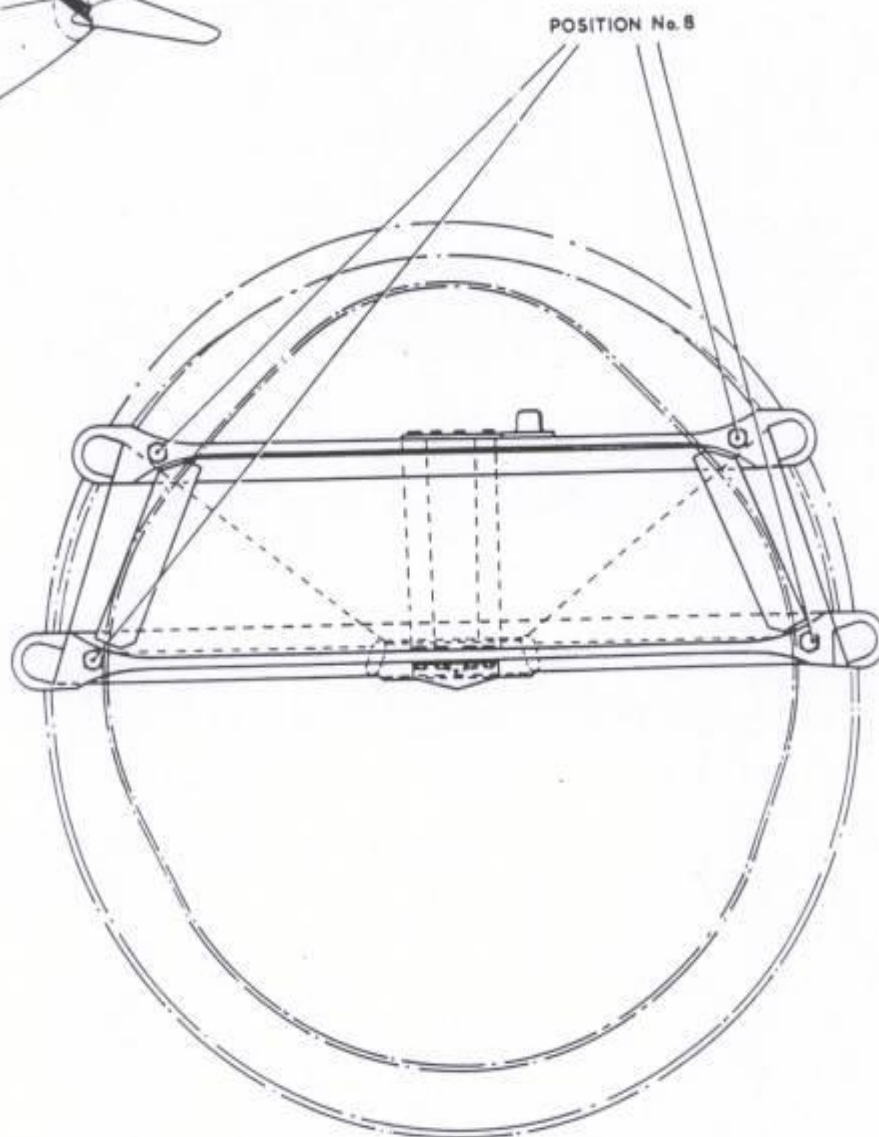
424 - FIG 2

Fig. 2: Tail Centre Section Spar to Fuselage (Station 934)

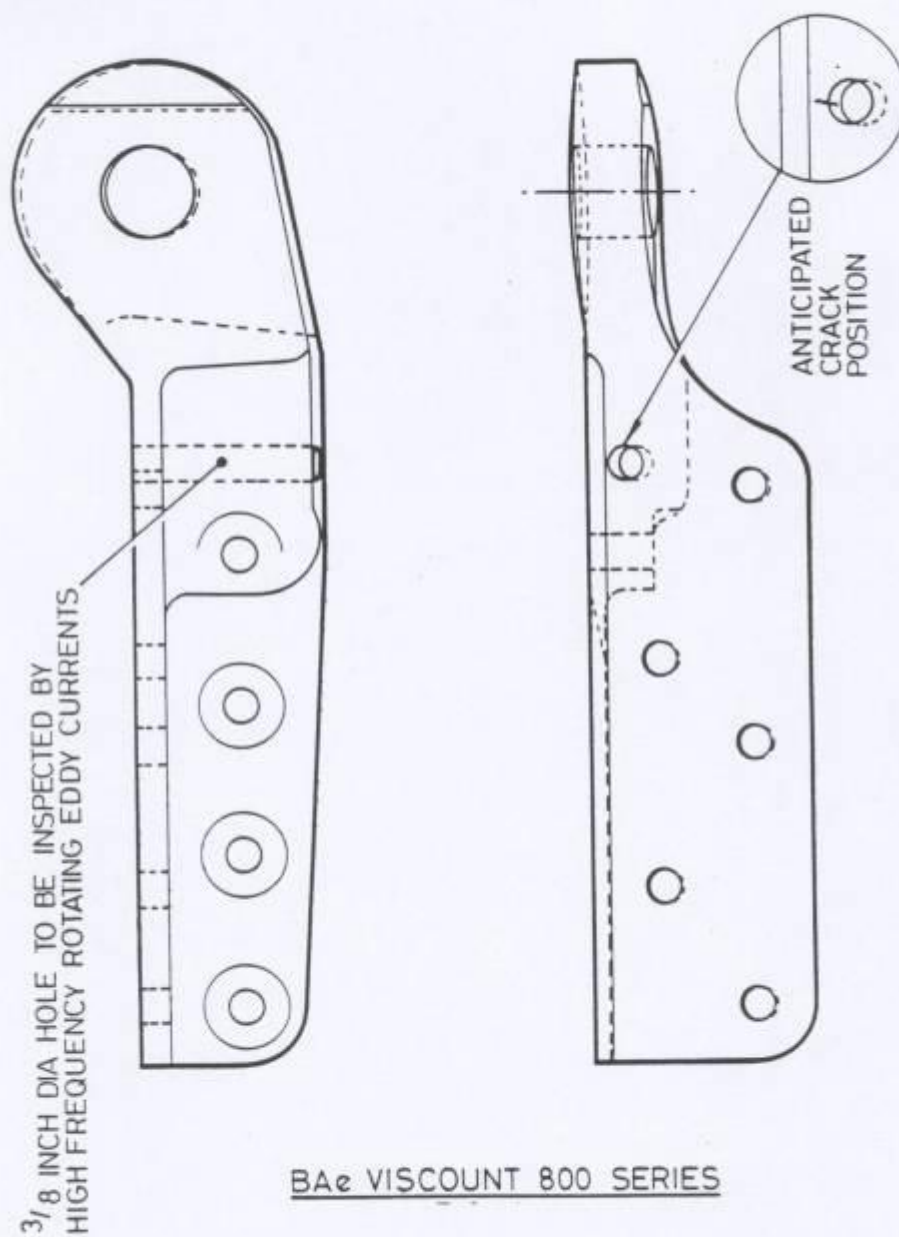
4C - FIG 2

- Fig. 1: Example of fatigue crack on the tailplane spar joint fitting
- Fig. 2: Typical position of a crack on the tailplane spar joint fitting
- Fig. 3: Idem (above view)
- Fig. 4: Areas of concern, corrosion related, in 1969

TAIL PLANE SPAR JOINT FITTING

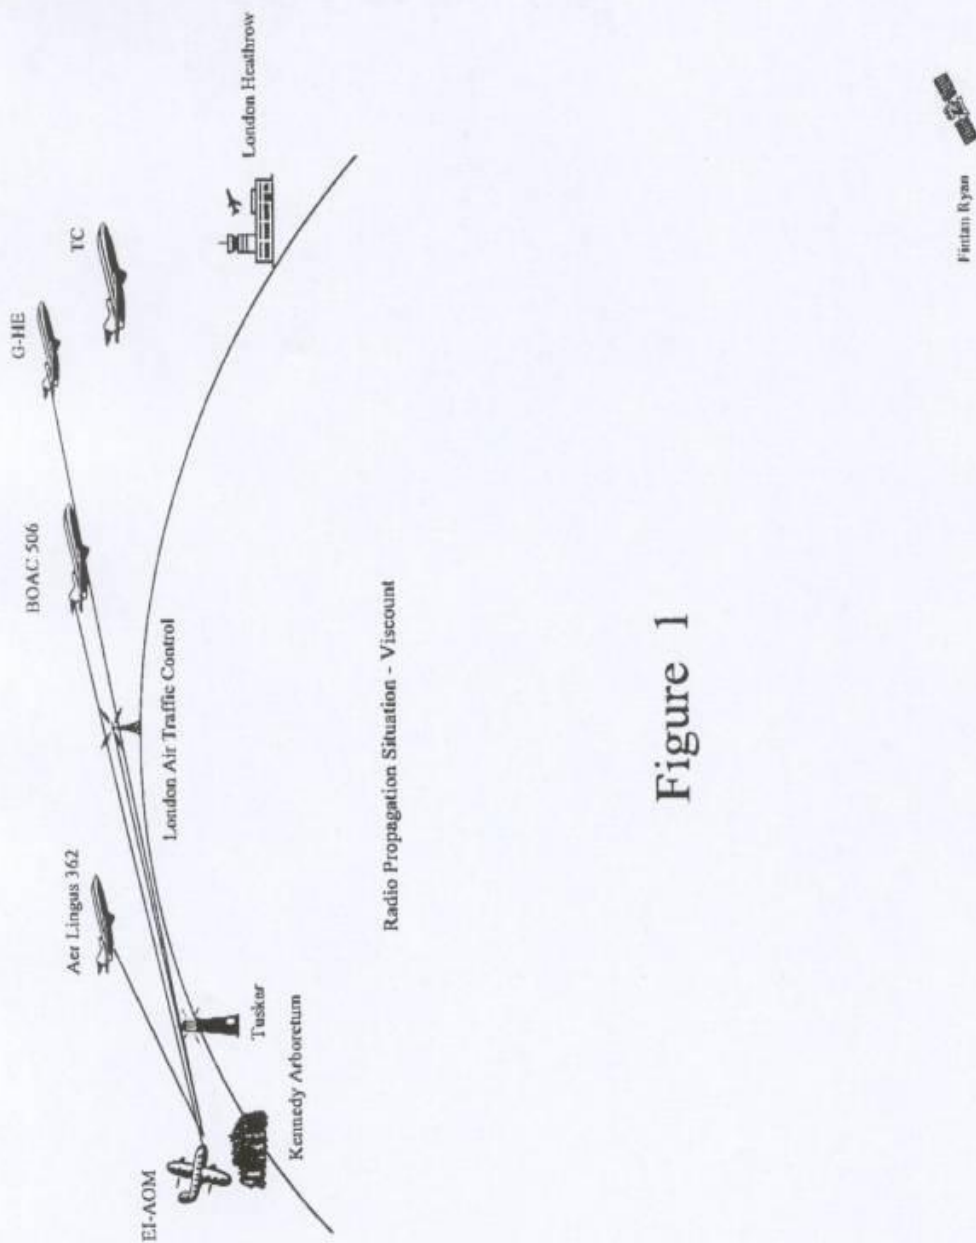
The radio line-of-sight concept for the Kennedy Arboretum case is illustrated in Figure 1

Radio Propagation Situation - Viscount
