Air Accident Investigation Unit Ireland

SYNOPTIC REPORT

Cessna 182L, EI-CDP

6 October 2018

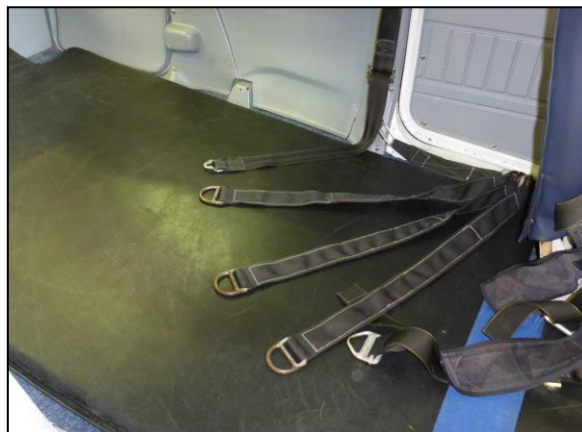
Photo No. 4: Skydiver restraint system

The four skydivers were sitting on a cushioned mat, and each was attached to the aircraft using restraint straps as shown in **Photo No. 4**. The Pilot was restrained using the lap strap.
