Air Accident Investigation Unit Ireland

FORMAL REPORT

**Rollason D.62B Condor, EI-BDX
Gibletstown, Duncormick, Co. Wexford**

6 October 2019

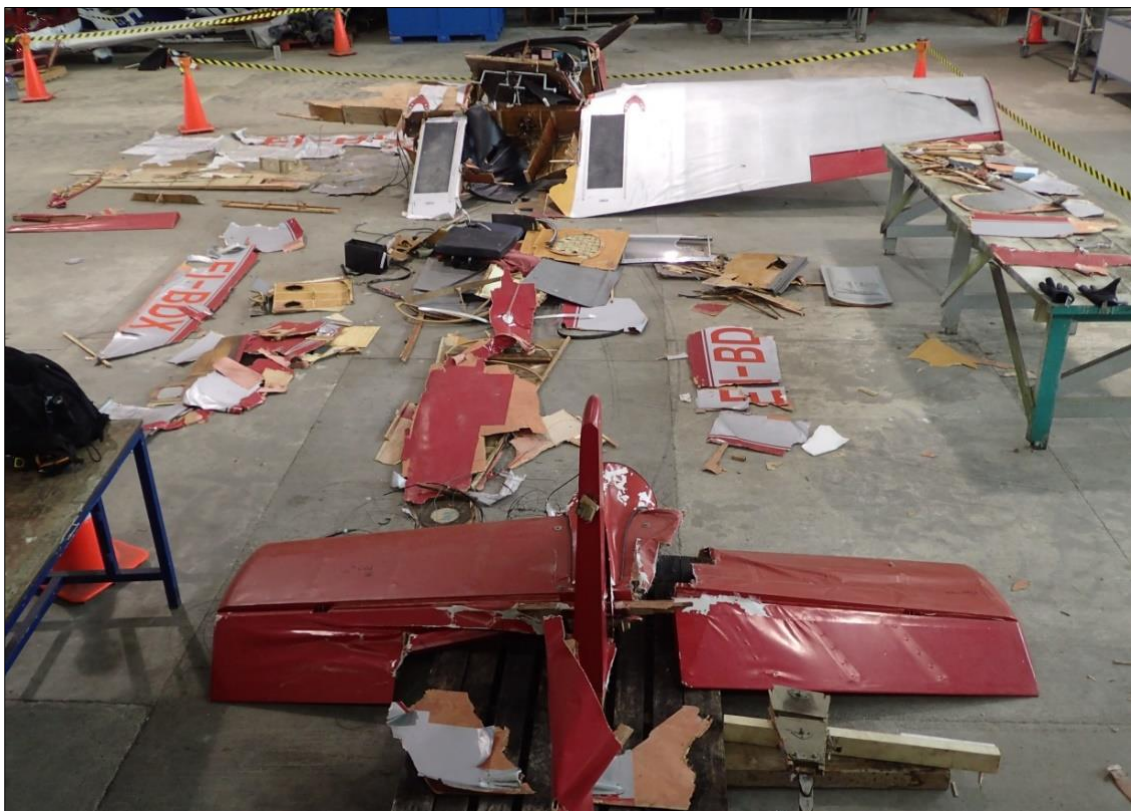
Photo No. 13: Wreckage layout EI-BDX

The AAIU conducted a detailed survey of the debris field. The wreckage was then recovered and brought under escort to the AAIU wreckage facility at Gormanston, Co. Meath. A wreckage layout was carried out (**Photo No. 13**). The cockpit area, including the seats and harness attachment points, had completely disintegrated.

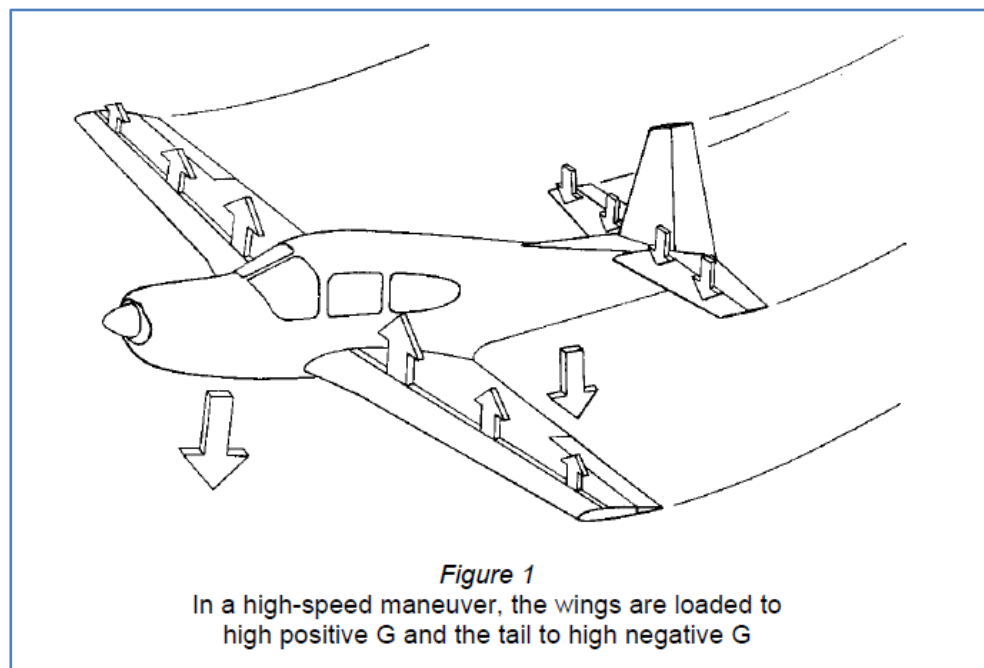
Figure No. 2: Figure from ICAO guidance on in-flight break-up investigation

In relation to point 12, the Investigation notes that the ICAO commentary was accompanied by three figures; these figures are reproduced at **Figure No. 2** and **Figure No. 3**.

'a possible/likely failure sequence was that the left wing failed first. The separated wing section impacted the tail, fin, and specifically the rudder, from the left side, causing both fin and rudder to separate. The right side of the horizontal stabiliser separated due either to impact with the separated left wing section, or the aerodynamic loading caused by the roll rate associated with the failure of the left wing, or a combination of these two effects'. (Figure No. 2 and Figure No. 3 from ICAO guidance, illustrate such a scenario.)

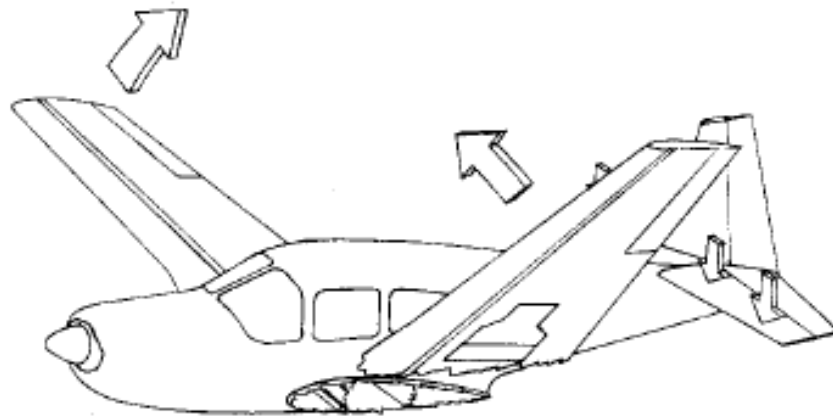
Figure 2
The wing fails due to excessive upward loading, the aircraft rolls abruptly

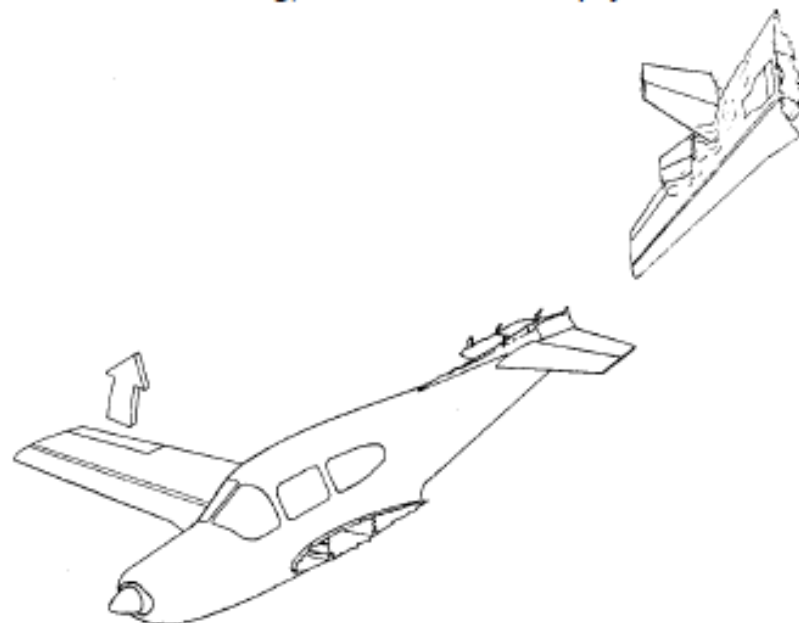
13. *Considering the damage pattern exhibited by the wreckage, a possible/likely failure sequence was that the left wing failed first. The separated wing section impacted the tail, fin, and specifically the rudder, from the left side, causing both fin and rudder to separate. The right side of the horizontal stabiliser separated due either to impact with the separated left wing section, or the aerodynamic loading caused by the roll rate associated with the failure of the left wing, or a combination of these two effects*
14. *As a general observation, and considering the age of the airframe, the wreckage condition suggested that the aircraft was in good condition and no evidence was found of age-related deterioration such as moisture ingress or glue joint failure that could have contributed to the failures of the structure that were identified during my examination.'*

Figure 3
The separated wing often strikes the tail causing secondary failures and / or smears.
